*Brisbane Office*  
*Job No: DL16/218*  
*Ref No: 11121*  
*Author: L. Slater*

16<sup>th</sup> November, 2016

**RE: LEVEL ONE COMPLIANCE REPORT FOR  
BULK EARTHWORKS FILLING OPERATIONS  
FLAGSTONE CITY STAGE 1C,  
JIMBOOMBA**

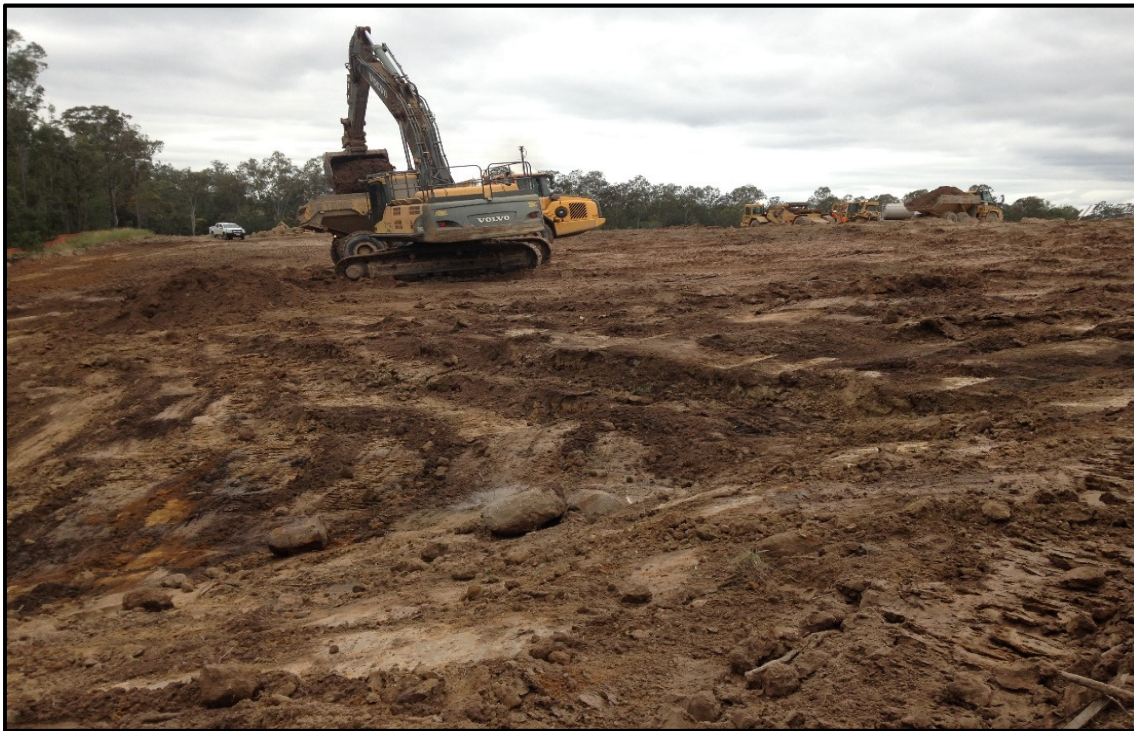
The fill areas at The Site were observed to be stripped and cleared of all visible organic matter, deleterious, loose and unsuitable materials to depths exposing competent ground.

- Sandy Clay (CI-CH) very stiff to hard, medium to high plasticity, fine to medium grained sand, grey brown mottled orange red and moist.

- Walk over assessments confirming that the competent ground was exposed.
- Proof roll testing using large sized truck carrying out multiple passes confirming no movement of the exposed natural foundation and existing fill.

**Picture 2: View of the Stripped Surface Prior to Filling Operations**

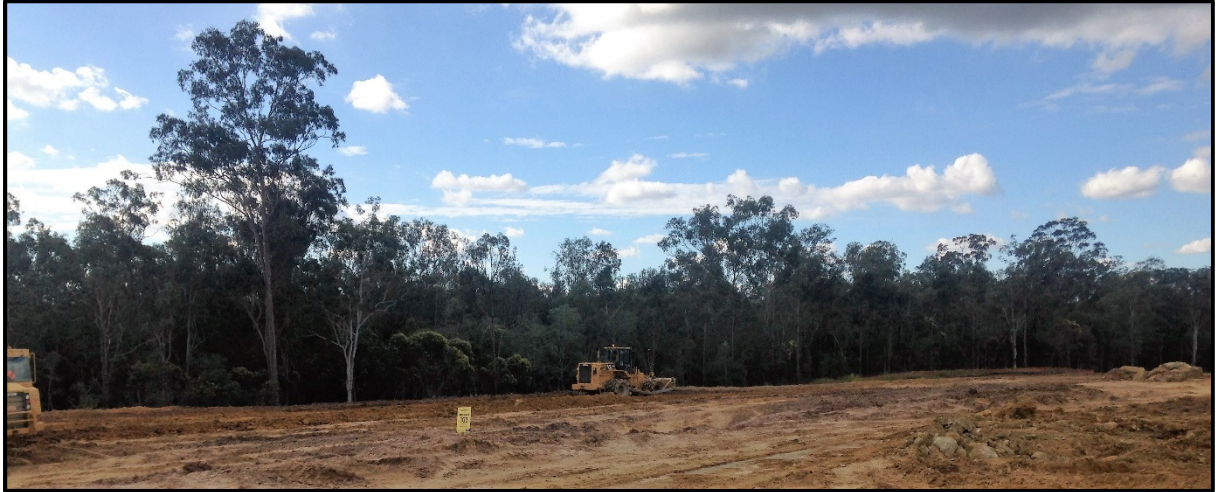
**Picture 3: View of the Site During Construction**

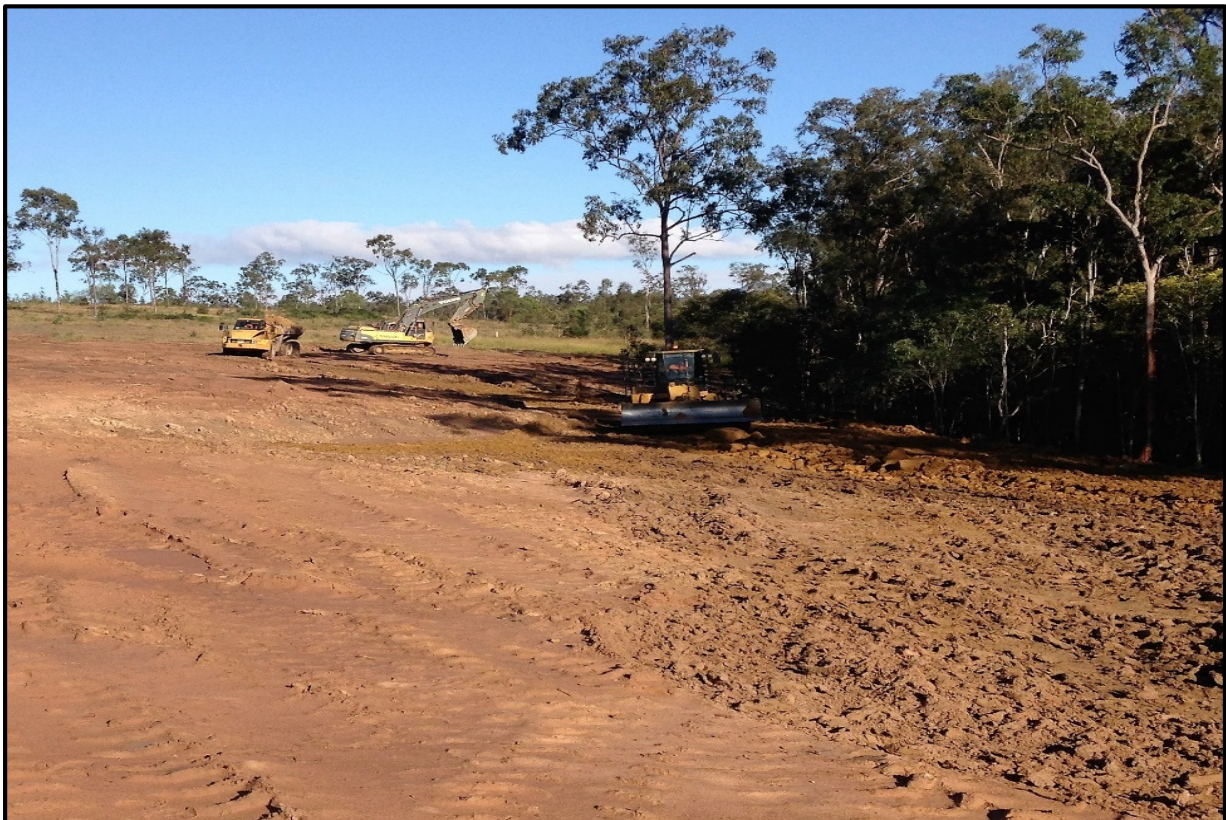
**Picture 4: View of the Site During Construction**
