Brisbane Office
Job No: DL16/214
Ref No: 10985
Author: L. Slater

5th October, 2016

**RE: COMPLIANCE REPORT FOR BULK EARTHWORKS FILLING OPERATIONS
FLAGSTONE CITY STAGE 1A,
FLAGSTONE, JIMBOOMBA**

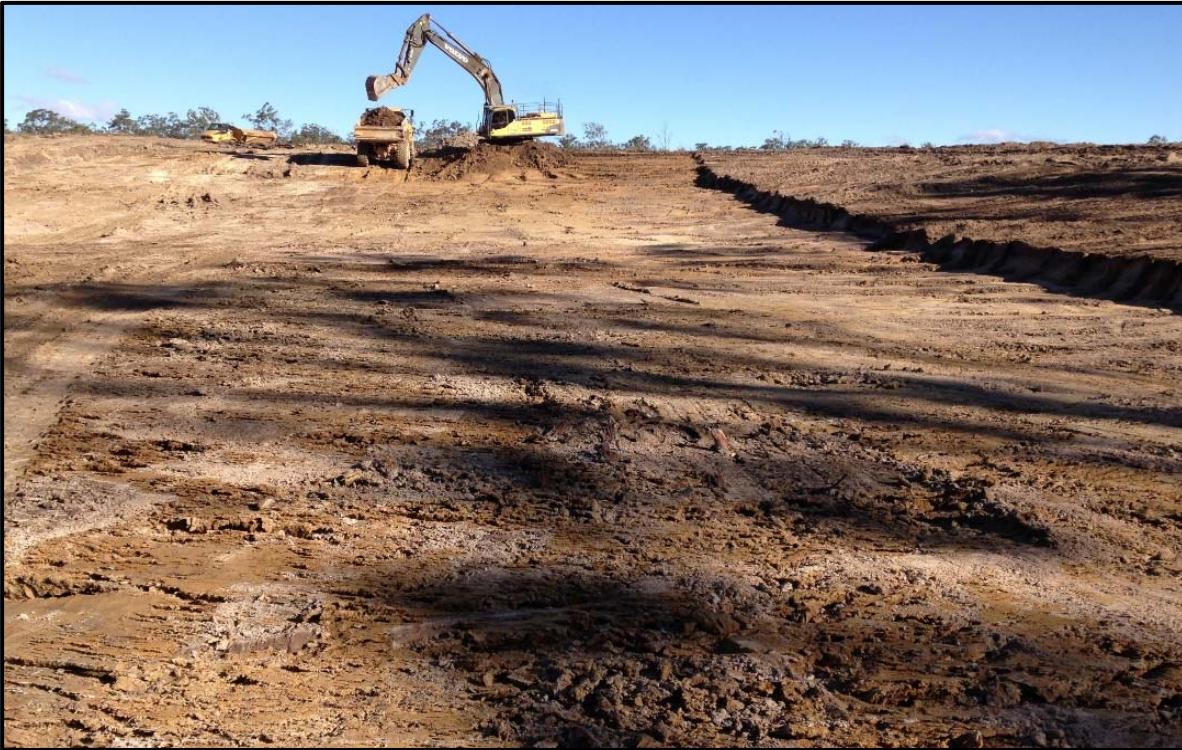
Picture 2: View of the Stripped Surface Prior to Filling Operations

The fill areas at The Site were observed to be stripped and cleared of all visible organic matter, deleterious, loose and unsuitable materials to depths exposing competent ground.

- Sandy Clay (CI-CH) at least very stiff, medium to high plasticity, fine to medium grained sand, grey brown mottled red brown and moist.

- Walk over assessments confirming that the competent ground was exposed.
- Proof roll testing using large sized truck carrying out multiple passes confirming no movement of the exposed natural foundation and existing fill (Ground).
