Brisbane Office
 Job No: DL16/216
 Ref No: 10986
 Author: L. Slater

6th October, 2016

**RE: COMPLIANCE REPORT FOR BULK EARTHWORKS FILLING OPERATIONS
 FLAGSTONE CITY STAGE 1B,
 FLAGSTONE, JIMBOOMBA**

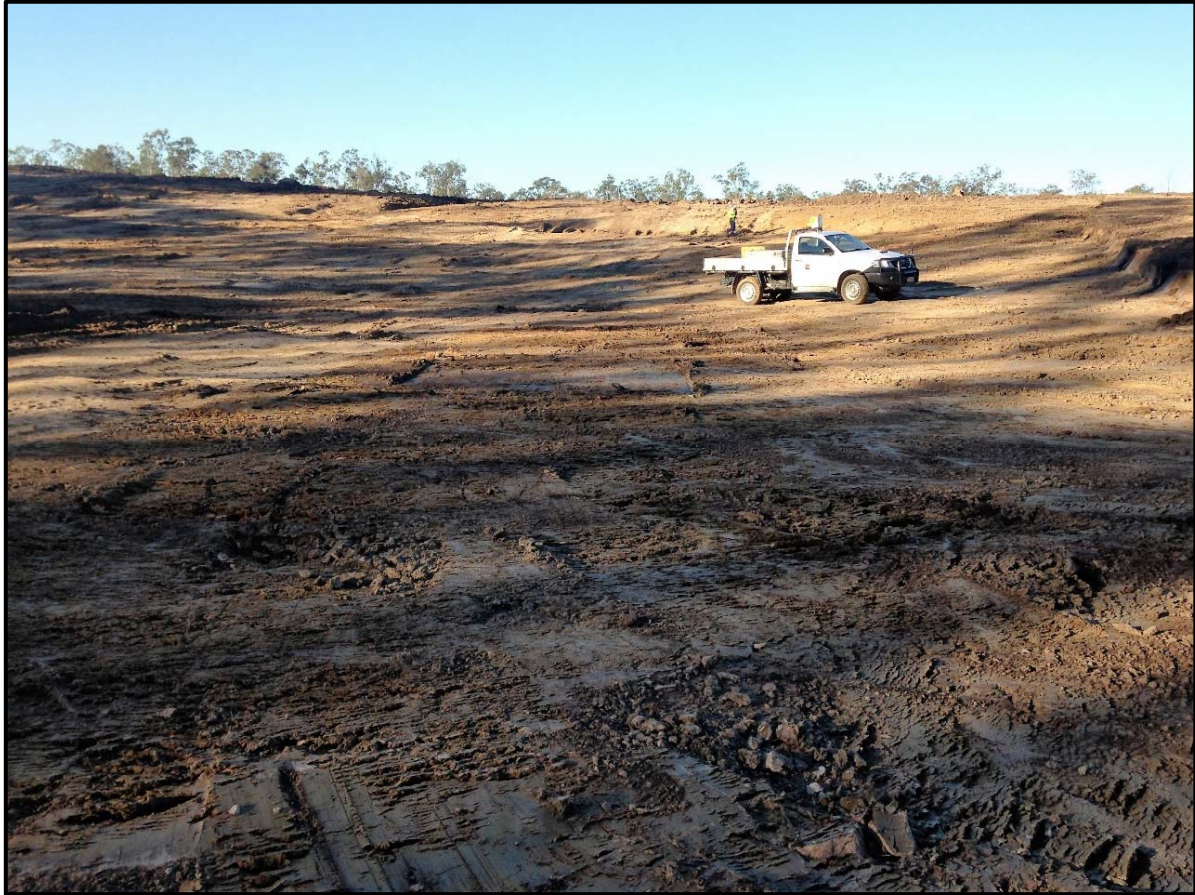
Picture 2: View of the Stripped Surface Prior to Filling

The fill areas at The Site were observed to be stripped and cleared of all visible organic matter, deleterious, loose and unsuitable materials to depths exposing competent ground.

- Sandy Clay (CI-CH) – Medium to high plasticity, fine to medium grained sand, grey brown mottled orange brown and moist.

- Walk over assessments confirming that the competent ground was exposed.
- Proof roll testing using large sized truck confirming no movement of the exposed natural foundation.

On this basis, the compliant assessments in accordance with above indicate that the exposed ground forming the fill foundation is capable of supporting new fill materials.

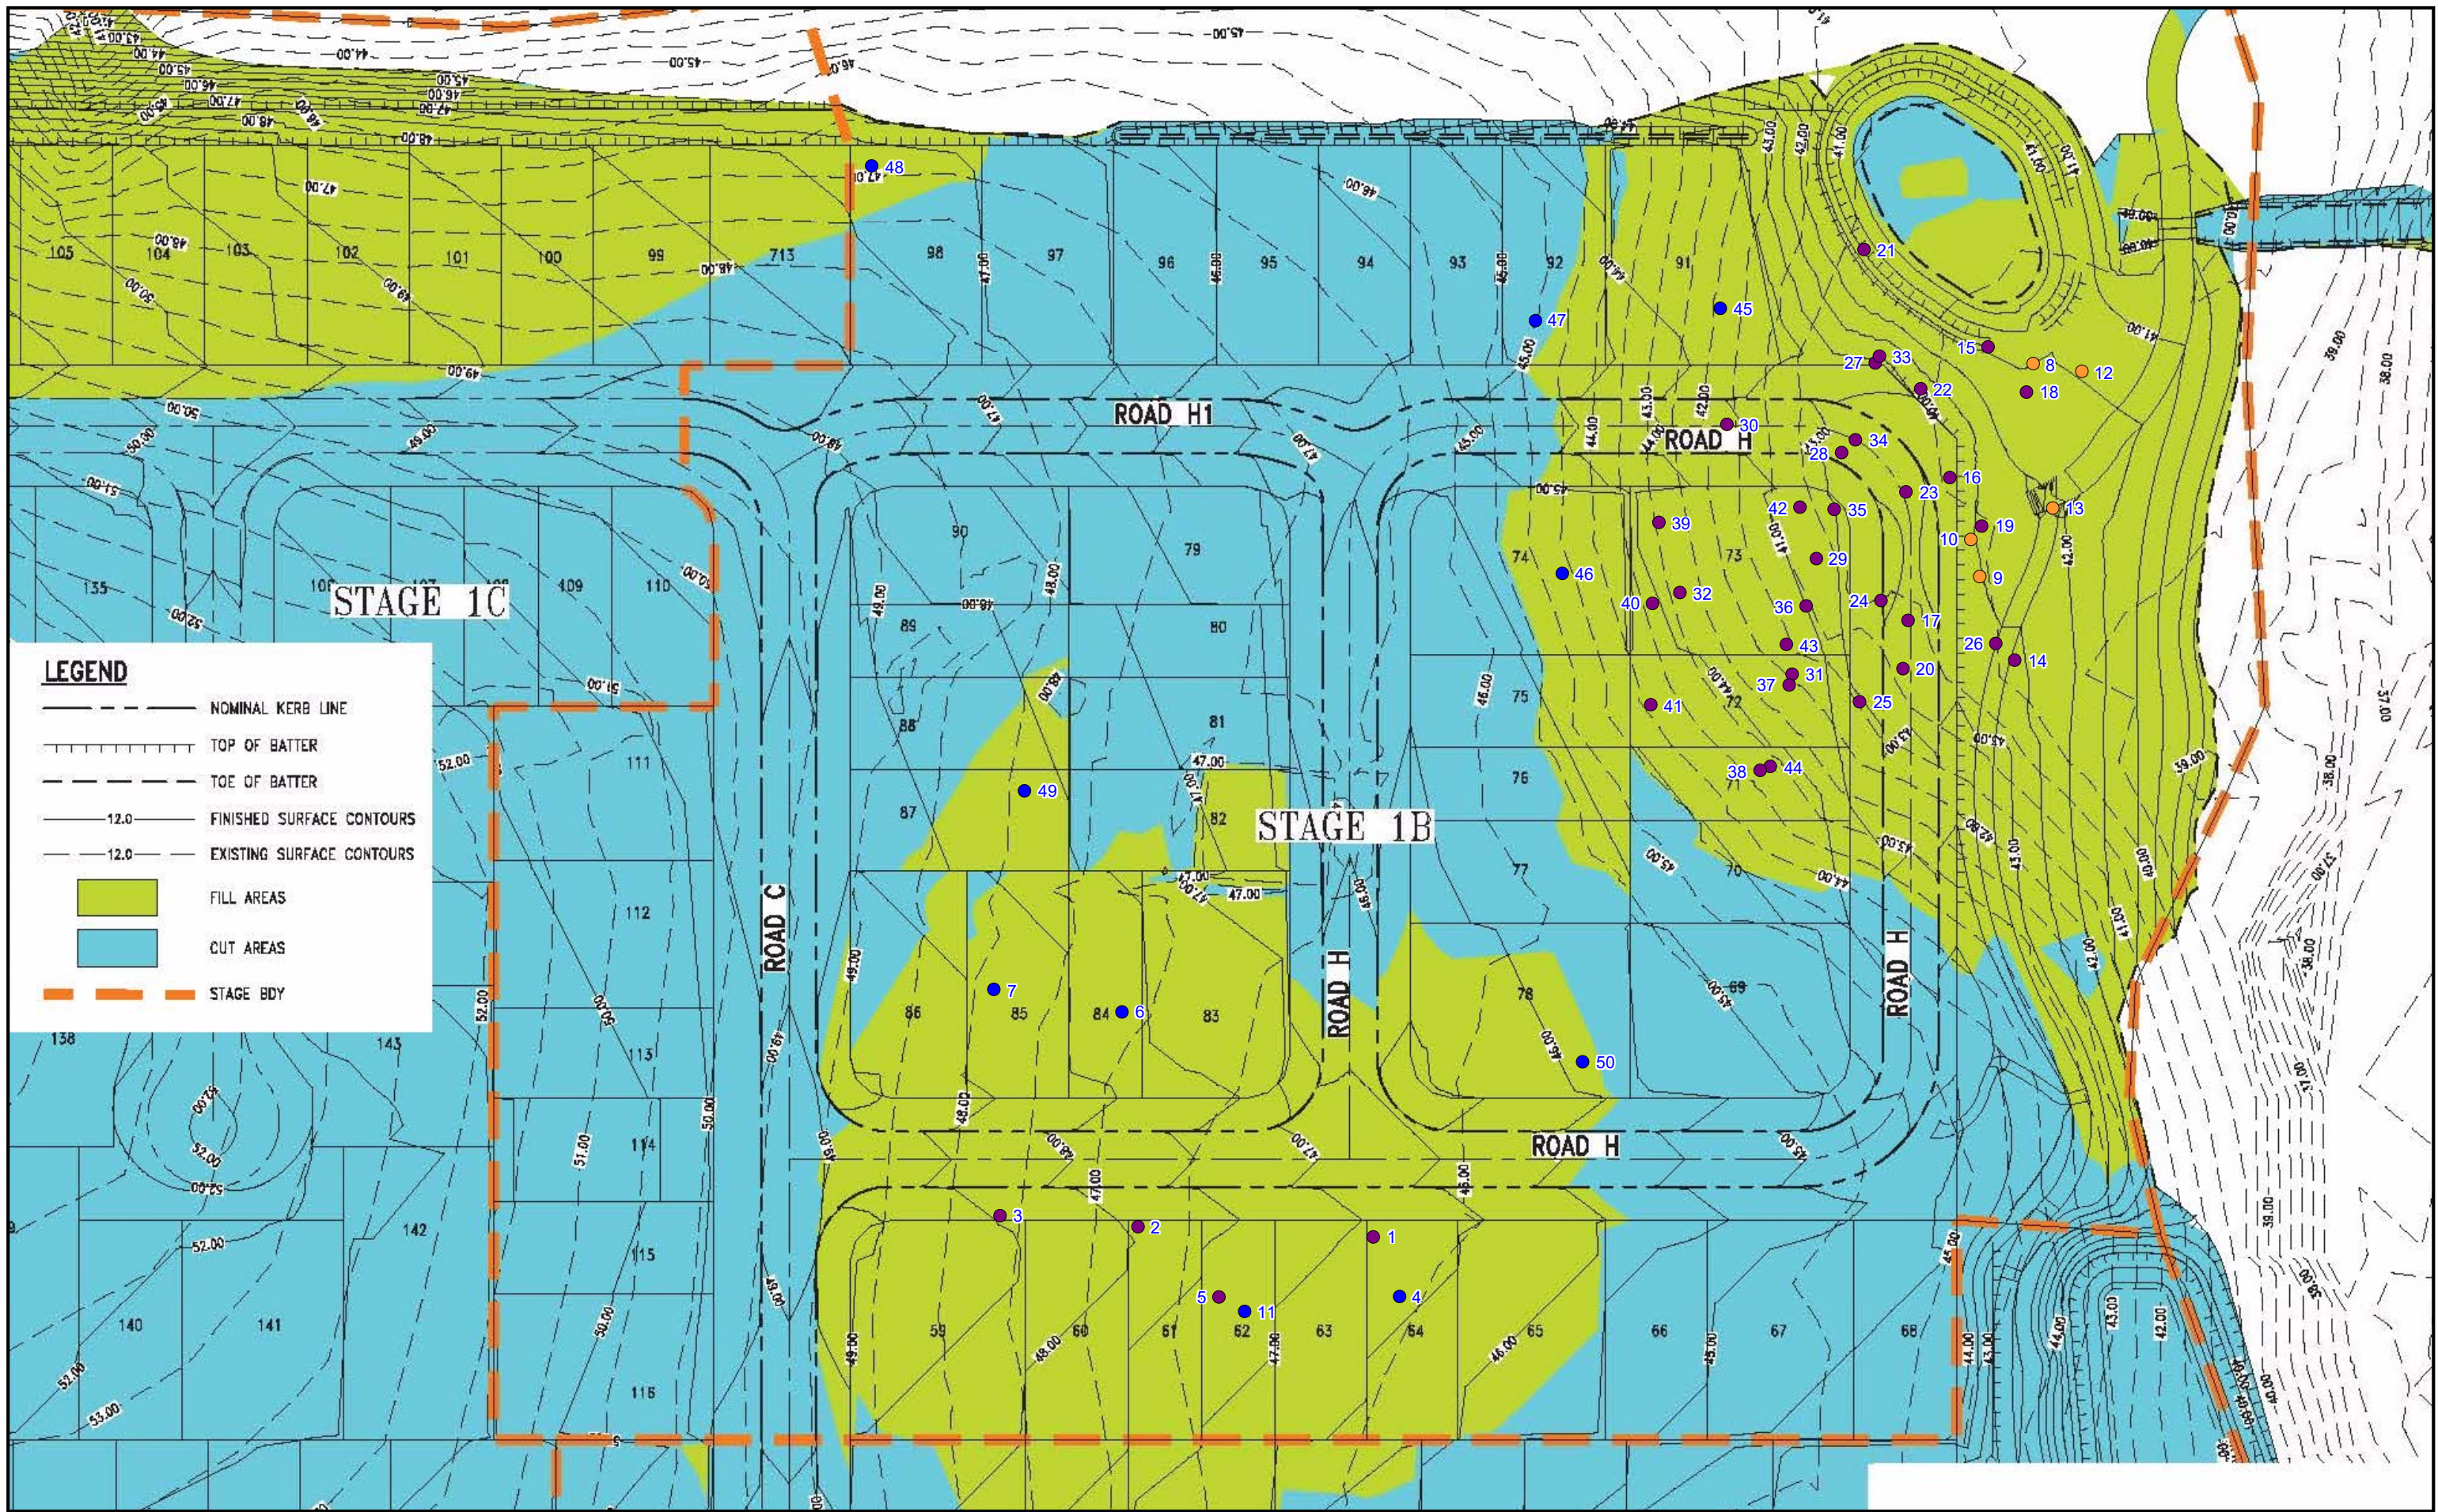
Site Plan Showing Test Locations

The Location of the field density tests are shown on the Site Plan contained in Appendix A. These test locations and levels were not obtained by survey and therefore should only be considered as approximate.
