Brisbane Office  
Job No: DL17/286  
Ref No: 12868  
Author: L. McDowall

18<sup>th</sup> January 2017

**RE: LEVEL ONE COMPLIANCE REPORT FOR  
BULK EARTHWORKS FILLING OPERATIONS  
FLAGSTONE CITY STAGE 1G, FLAGSTONE**

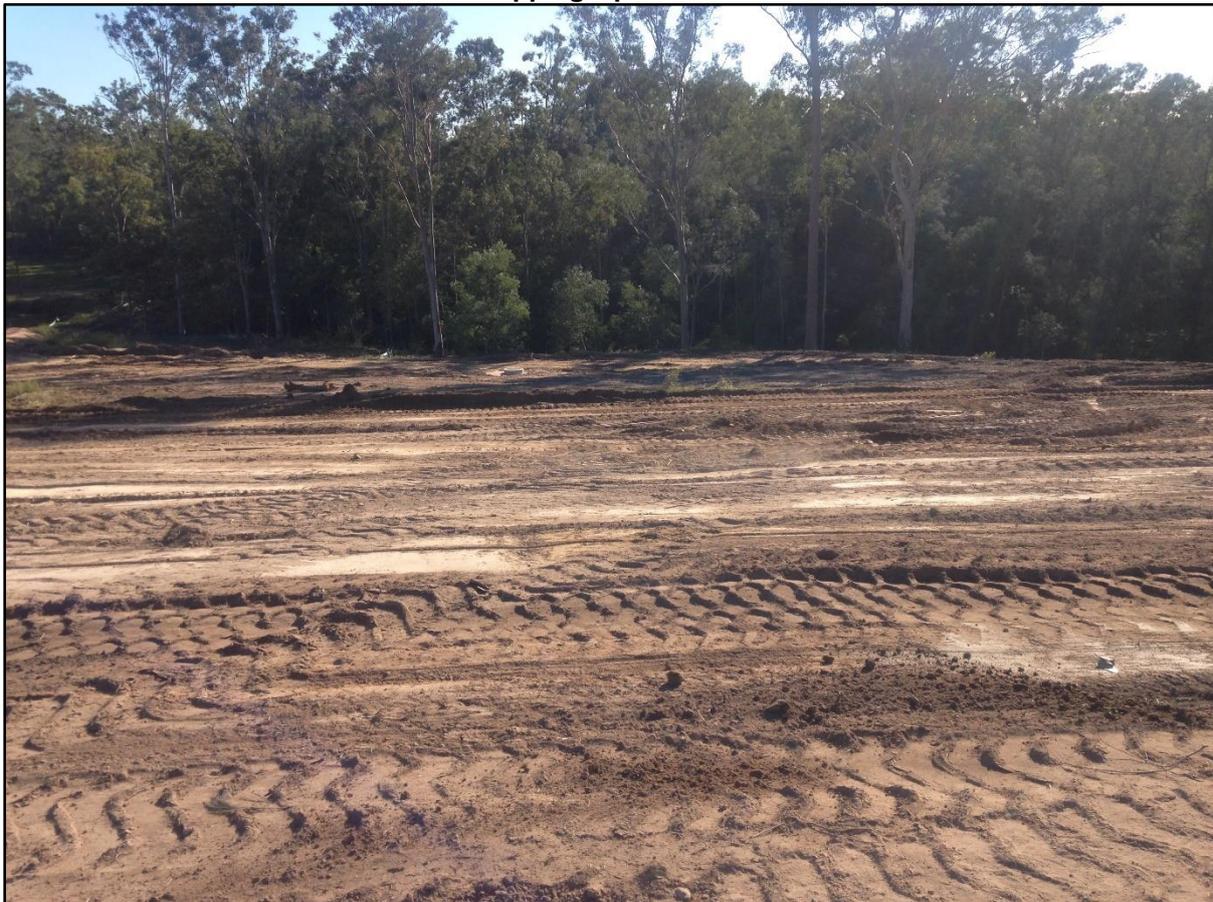
**Picture 2: View of the Stripping Operations Prior to Fill Placement**

The areas to be filled at The Site were observed to be stripped and cleared of all visible organic matter, deleterious, loose and unsuitable materials to depths exposing a competent natural foundation.

On this basis, the compliant assessments in accordance with above indicate that the exposed ground forming the fill foundation is capable of supporting new fill materials.

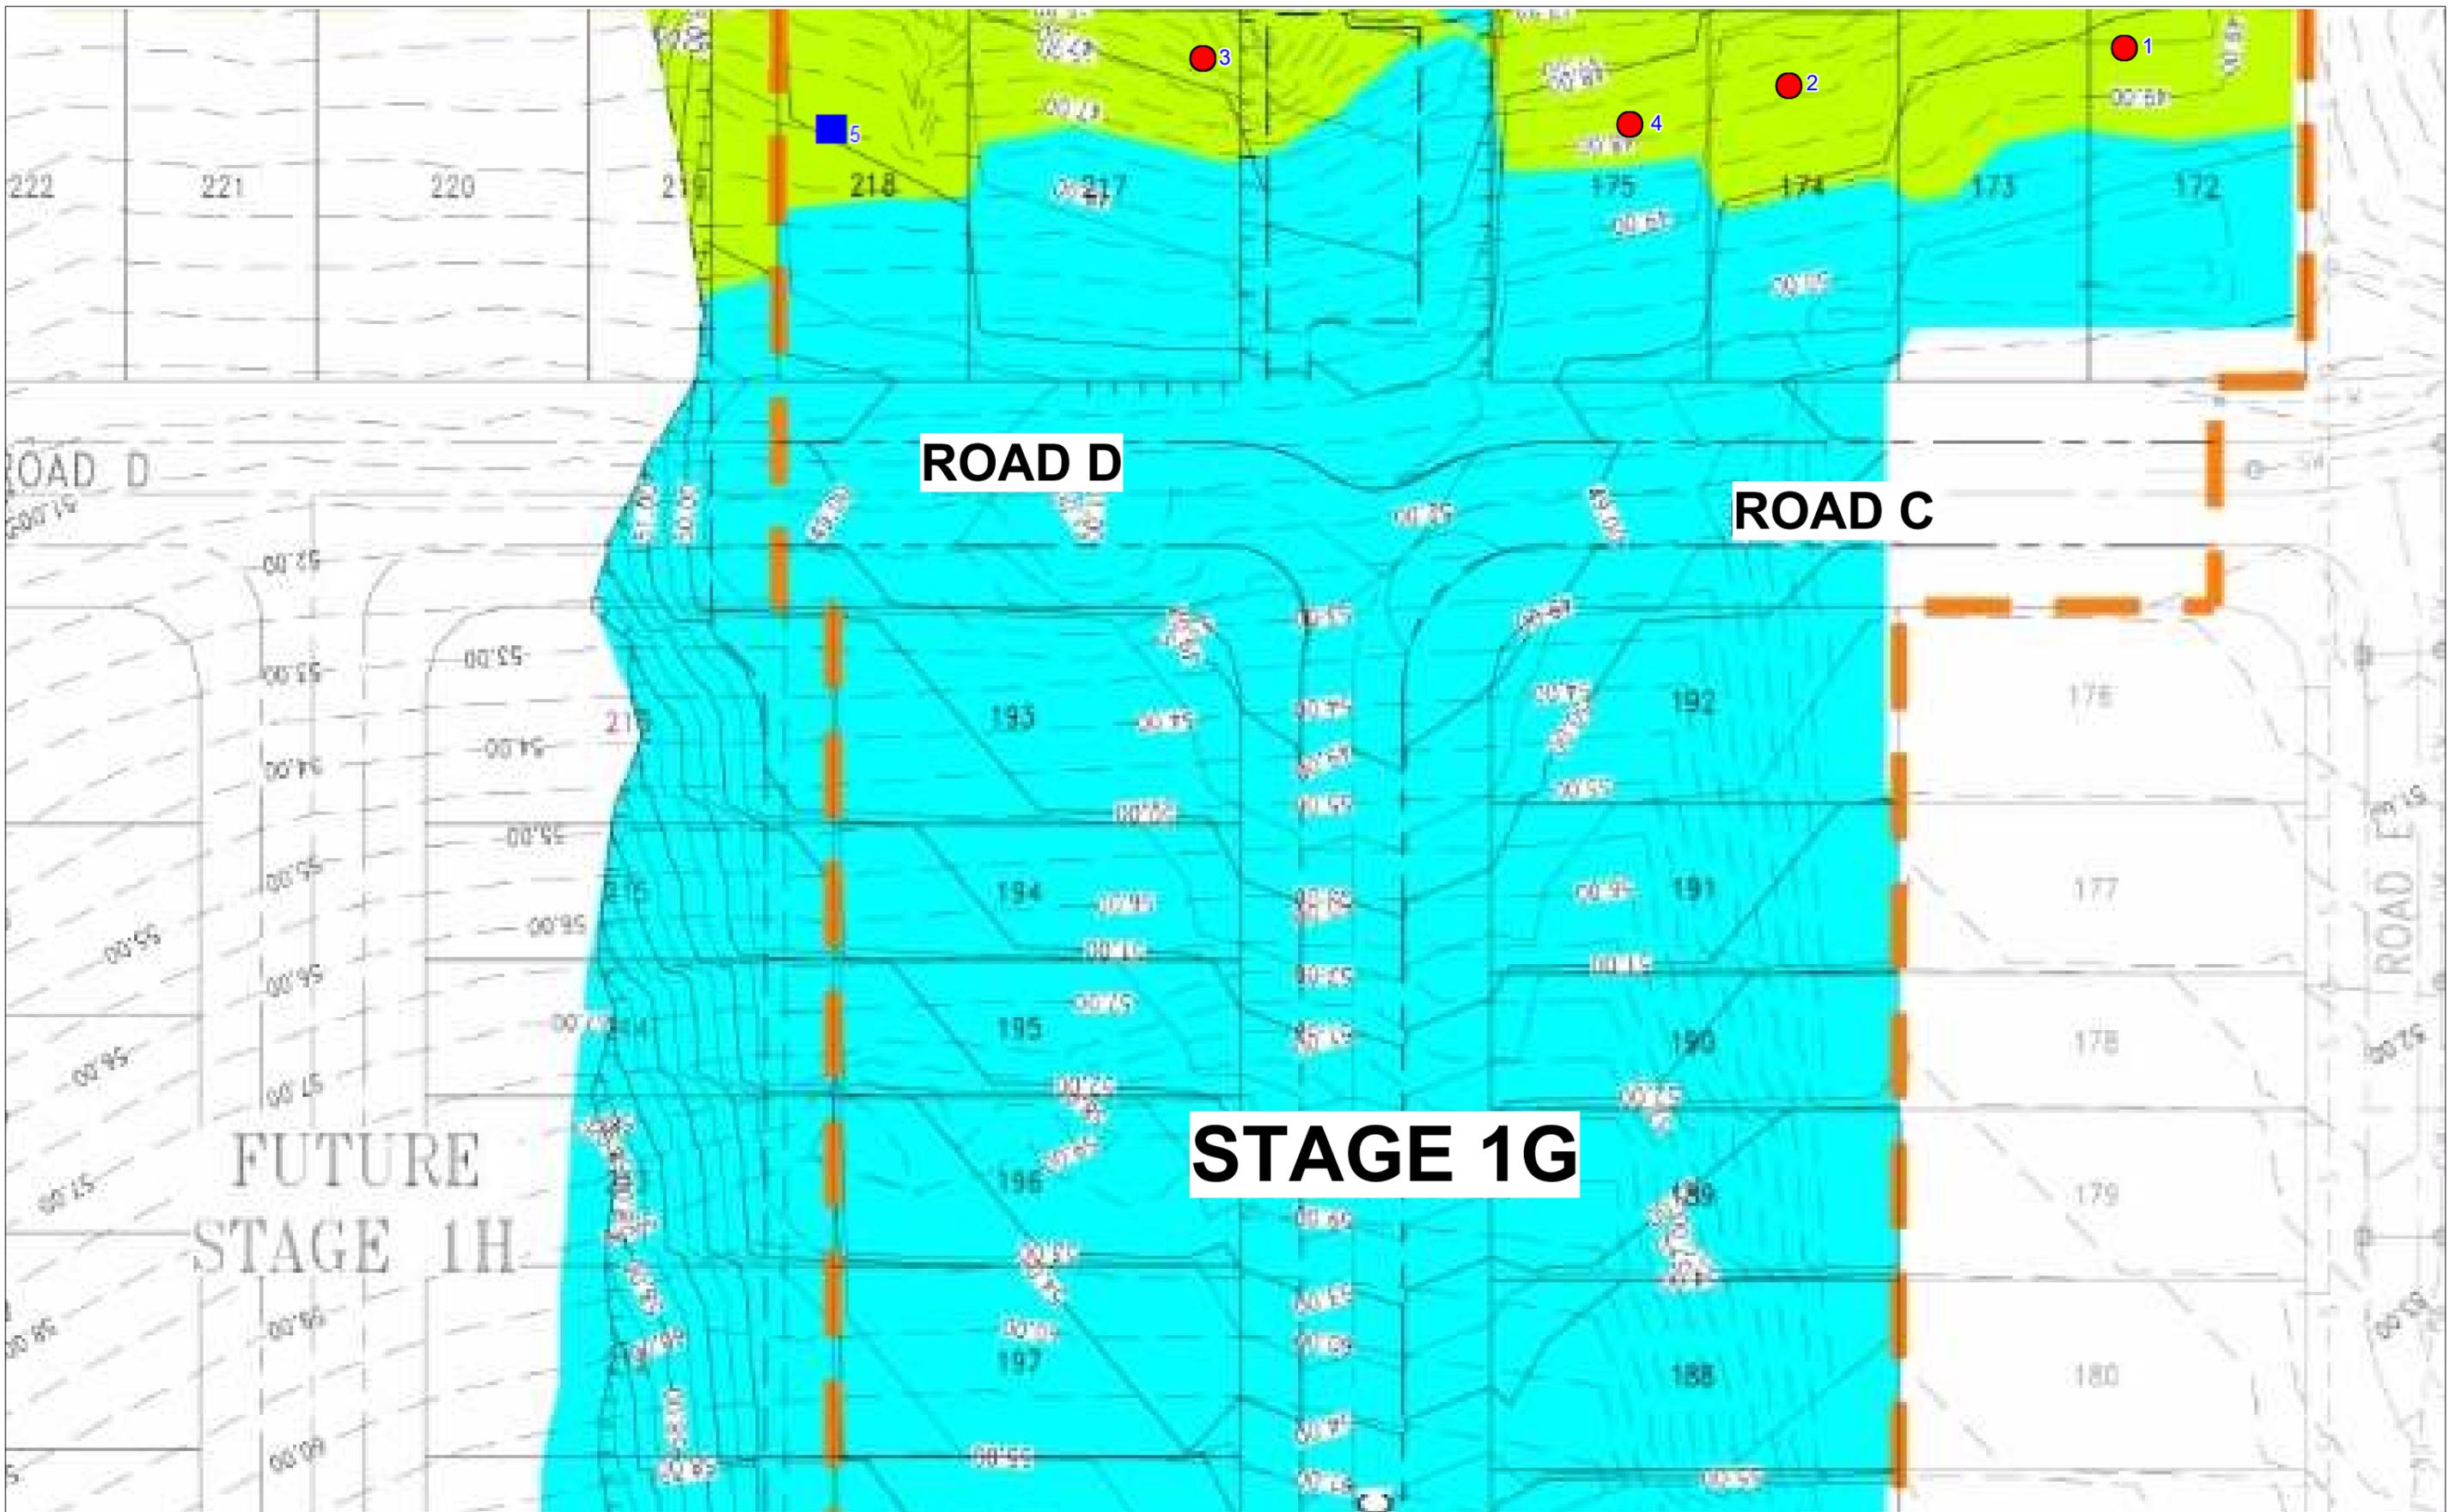
Map Description :	<b>EARTHWORKS FIELD DENSITY TESTING - Level 1 Inspection</b>		
Client :	ALLROADS PTY LTD		
Project :	<b>FLAGSTONE CITY, STAGE 1G</b>		
Project No :	DL17/286	Drawing No :	DL17/286 - 01
		Scale :	Not to Scale

The Location of the field density tests are shown on the Site Plan contained in Appendix A. These test locations and levels were not obtained by survey and therefore should only be considered as approximate.
