Brisbane Office
 Job No: DL17/343
 Ref No: 13020
 Author: L. McDowall

20th February 2018

**RE: LEVEL ONE COMPLIANCE REPORT FOR
 BULK EARTHWORKS FILLING OPERATIONS
 FLAGSTONE CITY STAGE 1H, FLAGSTONE**

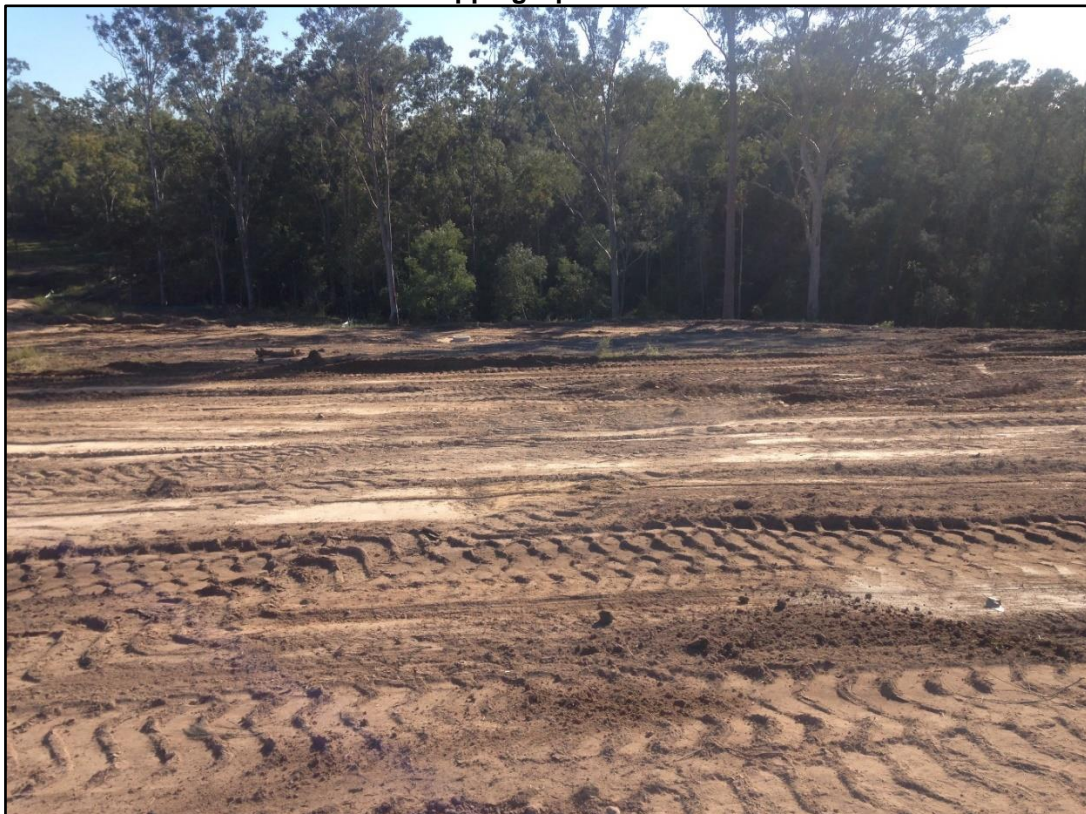
Picture 2: View of the Stripping Operations Prior to Fill Placement

The areas to be filled at The Site were observed to be stripped and cleared of all visible organic matter, deleterious, loose and unsuitable materials to depths exposing a competent natural foundation.

Following the stripped surface assessment of the fill areas, the natural fill foundation was approved for filling using the following process:

- Walk over assessments confirming that the competent ground was exposed.
- Proof roll testing using large sized and loaded truck confirming no movement of the foundation.
- Sloping areas to be filled were either benched prior to filling or fill was keyed into the slope during filling operations.

On this basis, the compliant assessments in accordance with above indicate that the exposed ground forming the fill foundation is capable of supporting new fill materials.

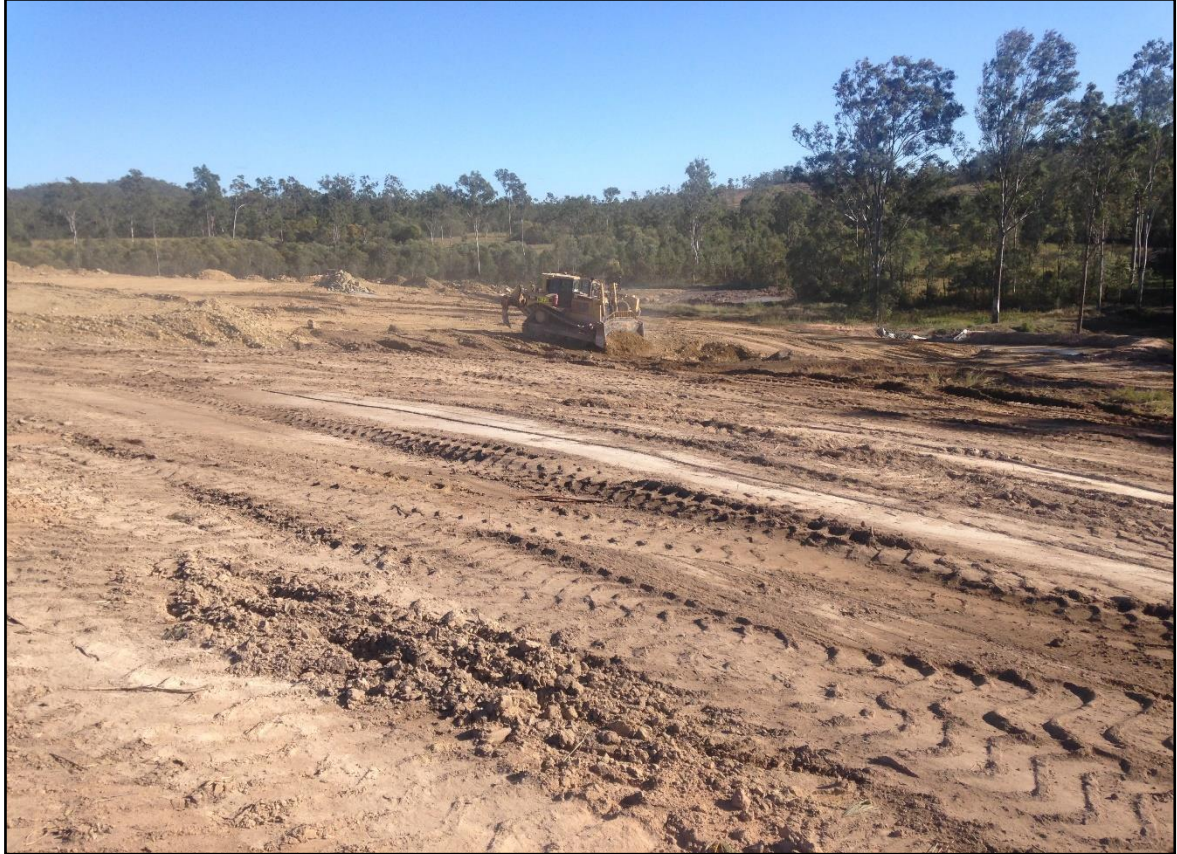
Picture 3: View of the Site During Construction

Our representative observed all the relevant earthworks operations including the stripped surface, filling operations and carried out field density tests in accordance with the required standards (AS3798, AS1289) and notes on Drawings.

It is confirmed that Level One Inspection and Testing has been carried out on the earthworks fill to form the residential Lots and embankments below subgrade. Based on the observations made by our Geotechnicians and the results of the field and laboratory tests, the placed and compacted fill at the above project has, as far as we have been able to assess, been constructed in general accordance with the intent of AS3798 and the Specifications.

The fill can be deemed as “controlled” as defined in AS2870 (Residential Slabs and Footings).

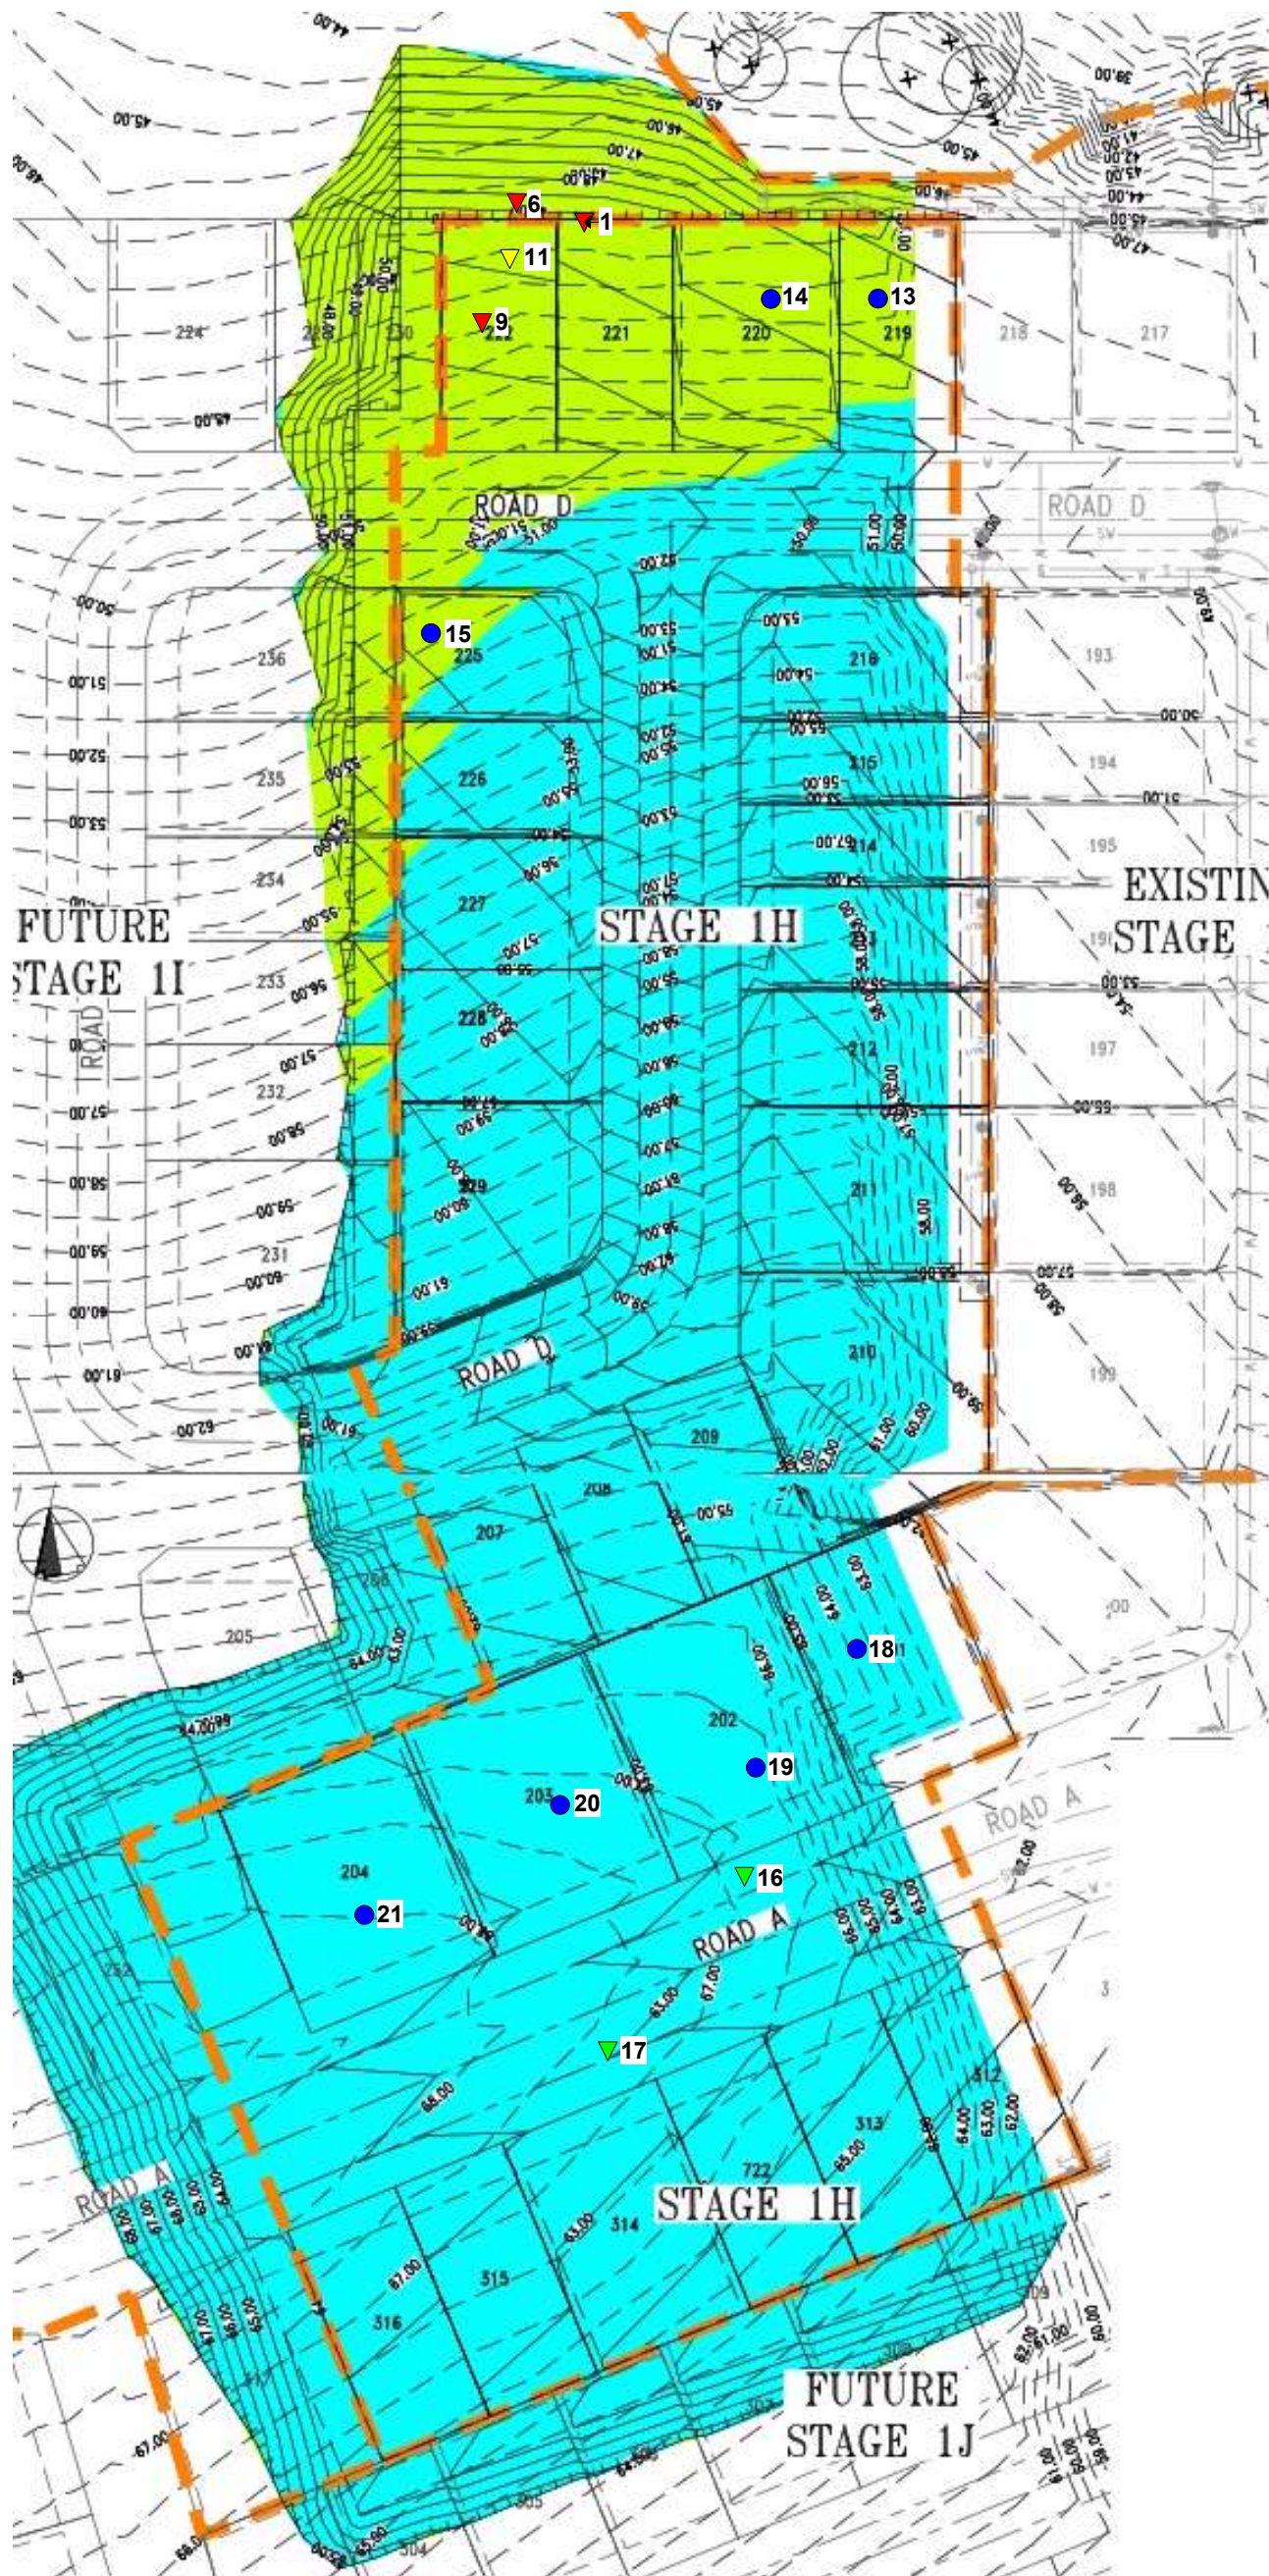
SITE PLAN
TEST LOCATIONS

The Location of the field density tests are shown on the Site Plan contained in Appendix A. These test locations and levels were not obtained by survey and therefore should only be considered as approximate.
