11th June 2018
Project No. SGS/17/020

RE: CERTIFICATE OF CONTROLLED FILLING
LOCATION: RIVERBANK STAGE 12B

LOT NO. 683

Field Density Ratio (HILF) Report

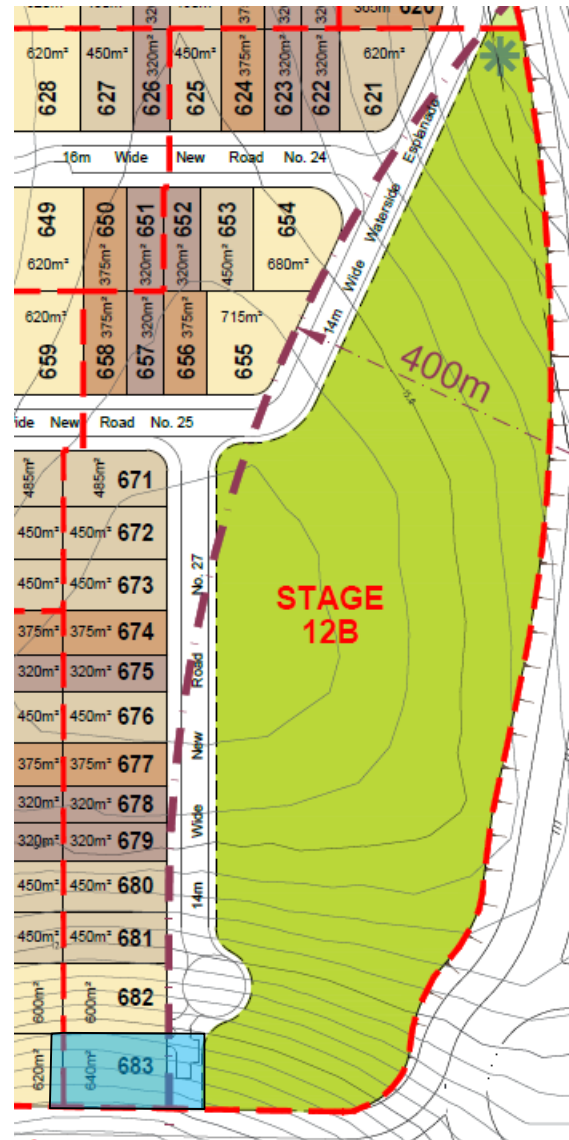
Based on the test results and site inspections, SGS Australia Pty Ltd concludes that the fill foundation to a depth of not less than 150mm and placement of compacted fill on Lot 683 as defined laterally in the attached drawing is considered to comply with the requirements of Table 5.1 of AS 3798 and the project specification.

Approximate lateral extent of Level 1 fill (controlled filling).
Controlled fill certification is limited to within this area. Unless specifically stated in the report, level 1 compaction control and certification does not address or include:

- backfill to service trenches and/or retaining walls (including boulder walls); and
- topsoil placed subsequent to completion of controlled filling.
