Brisbane Office
 Job No: DL17/133
 Ref No: 13195
 Author: L. McDowall

18th April 2017

**RE: LEVEL ONE COMPLIANCE REPORT FOR
 BULK EARTHWORKS FILLING OPERATIONS
 EDEN'S CROSSING ESTATE, STAGE 6
 MT JUILLERAT DRIVE, REDBANK PLAINS**

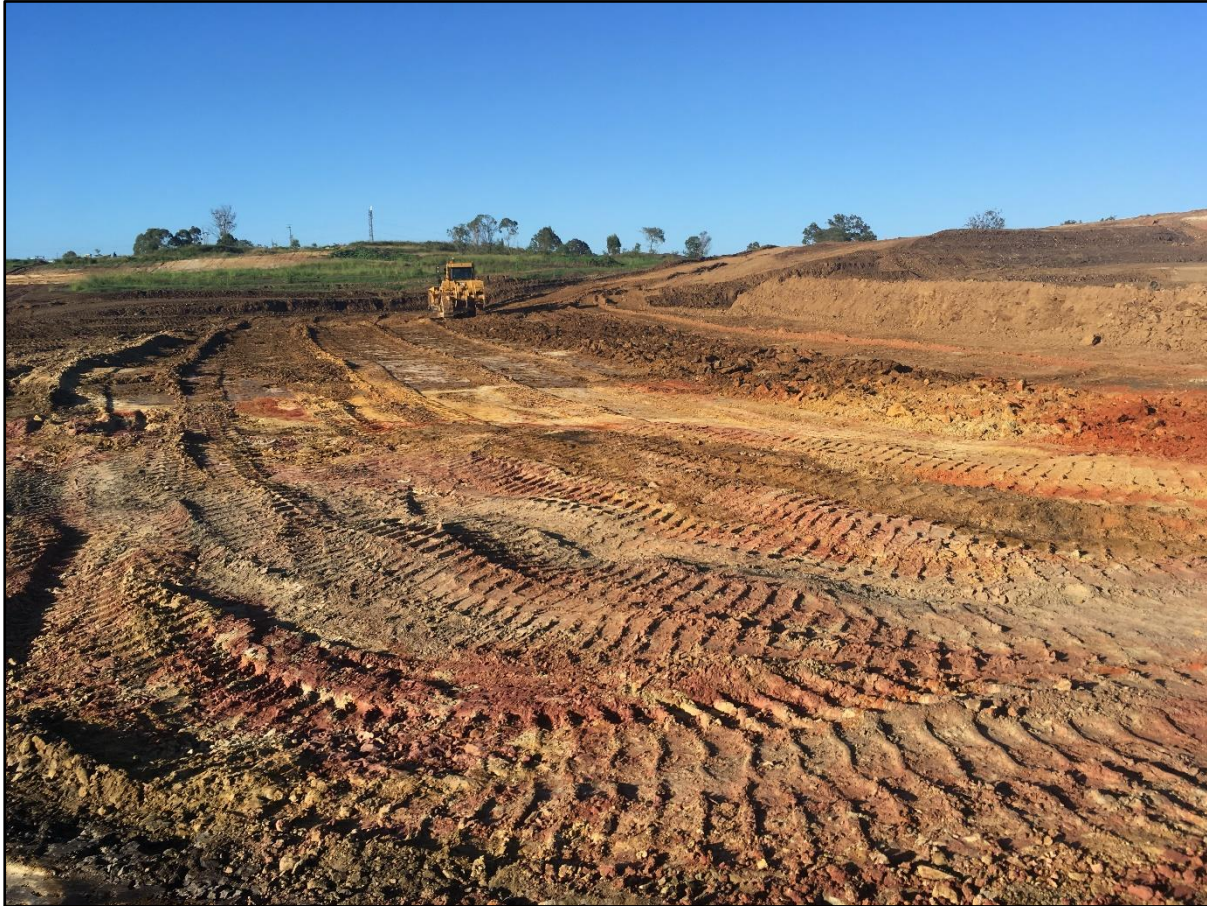
Picture 2: View of the Stripped Surface Prior to Filling Operations

The fill areas at The Site were observed to be stripped and cleared of visible organic matter, deleterious, loose and unsuitable materials to depths exposing suitable natural ground or existing controlled fill.

Following the stripped surface assessment of the fill areas, the fill foundation was approved for filling using the following process:

- Walk over assessments confirming that the competent ground was exposed.
- Proof roll testing using large sized truck carrying out multiple passes confirming no movement of the exposed fill foundation.

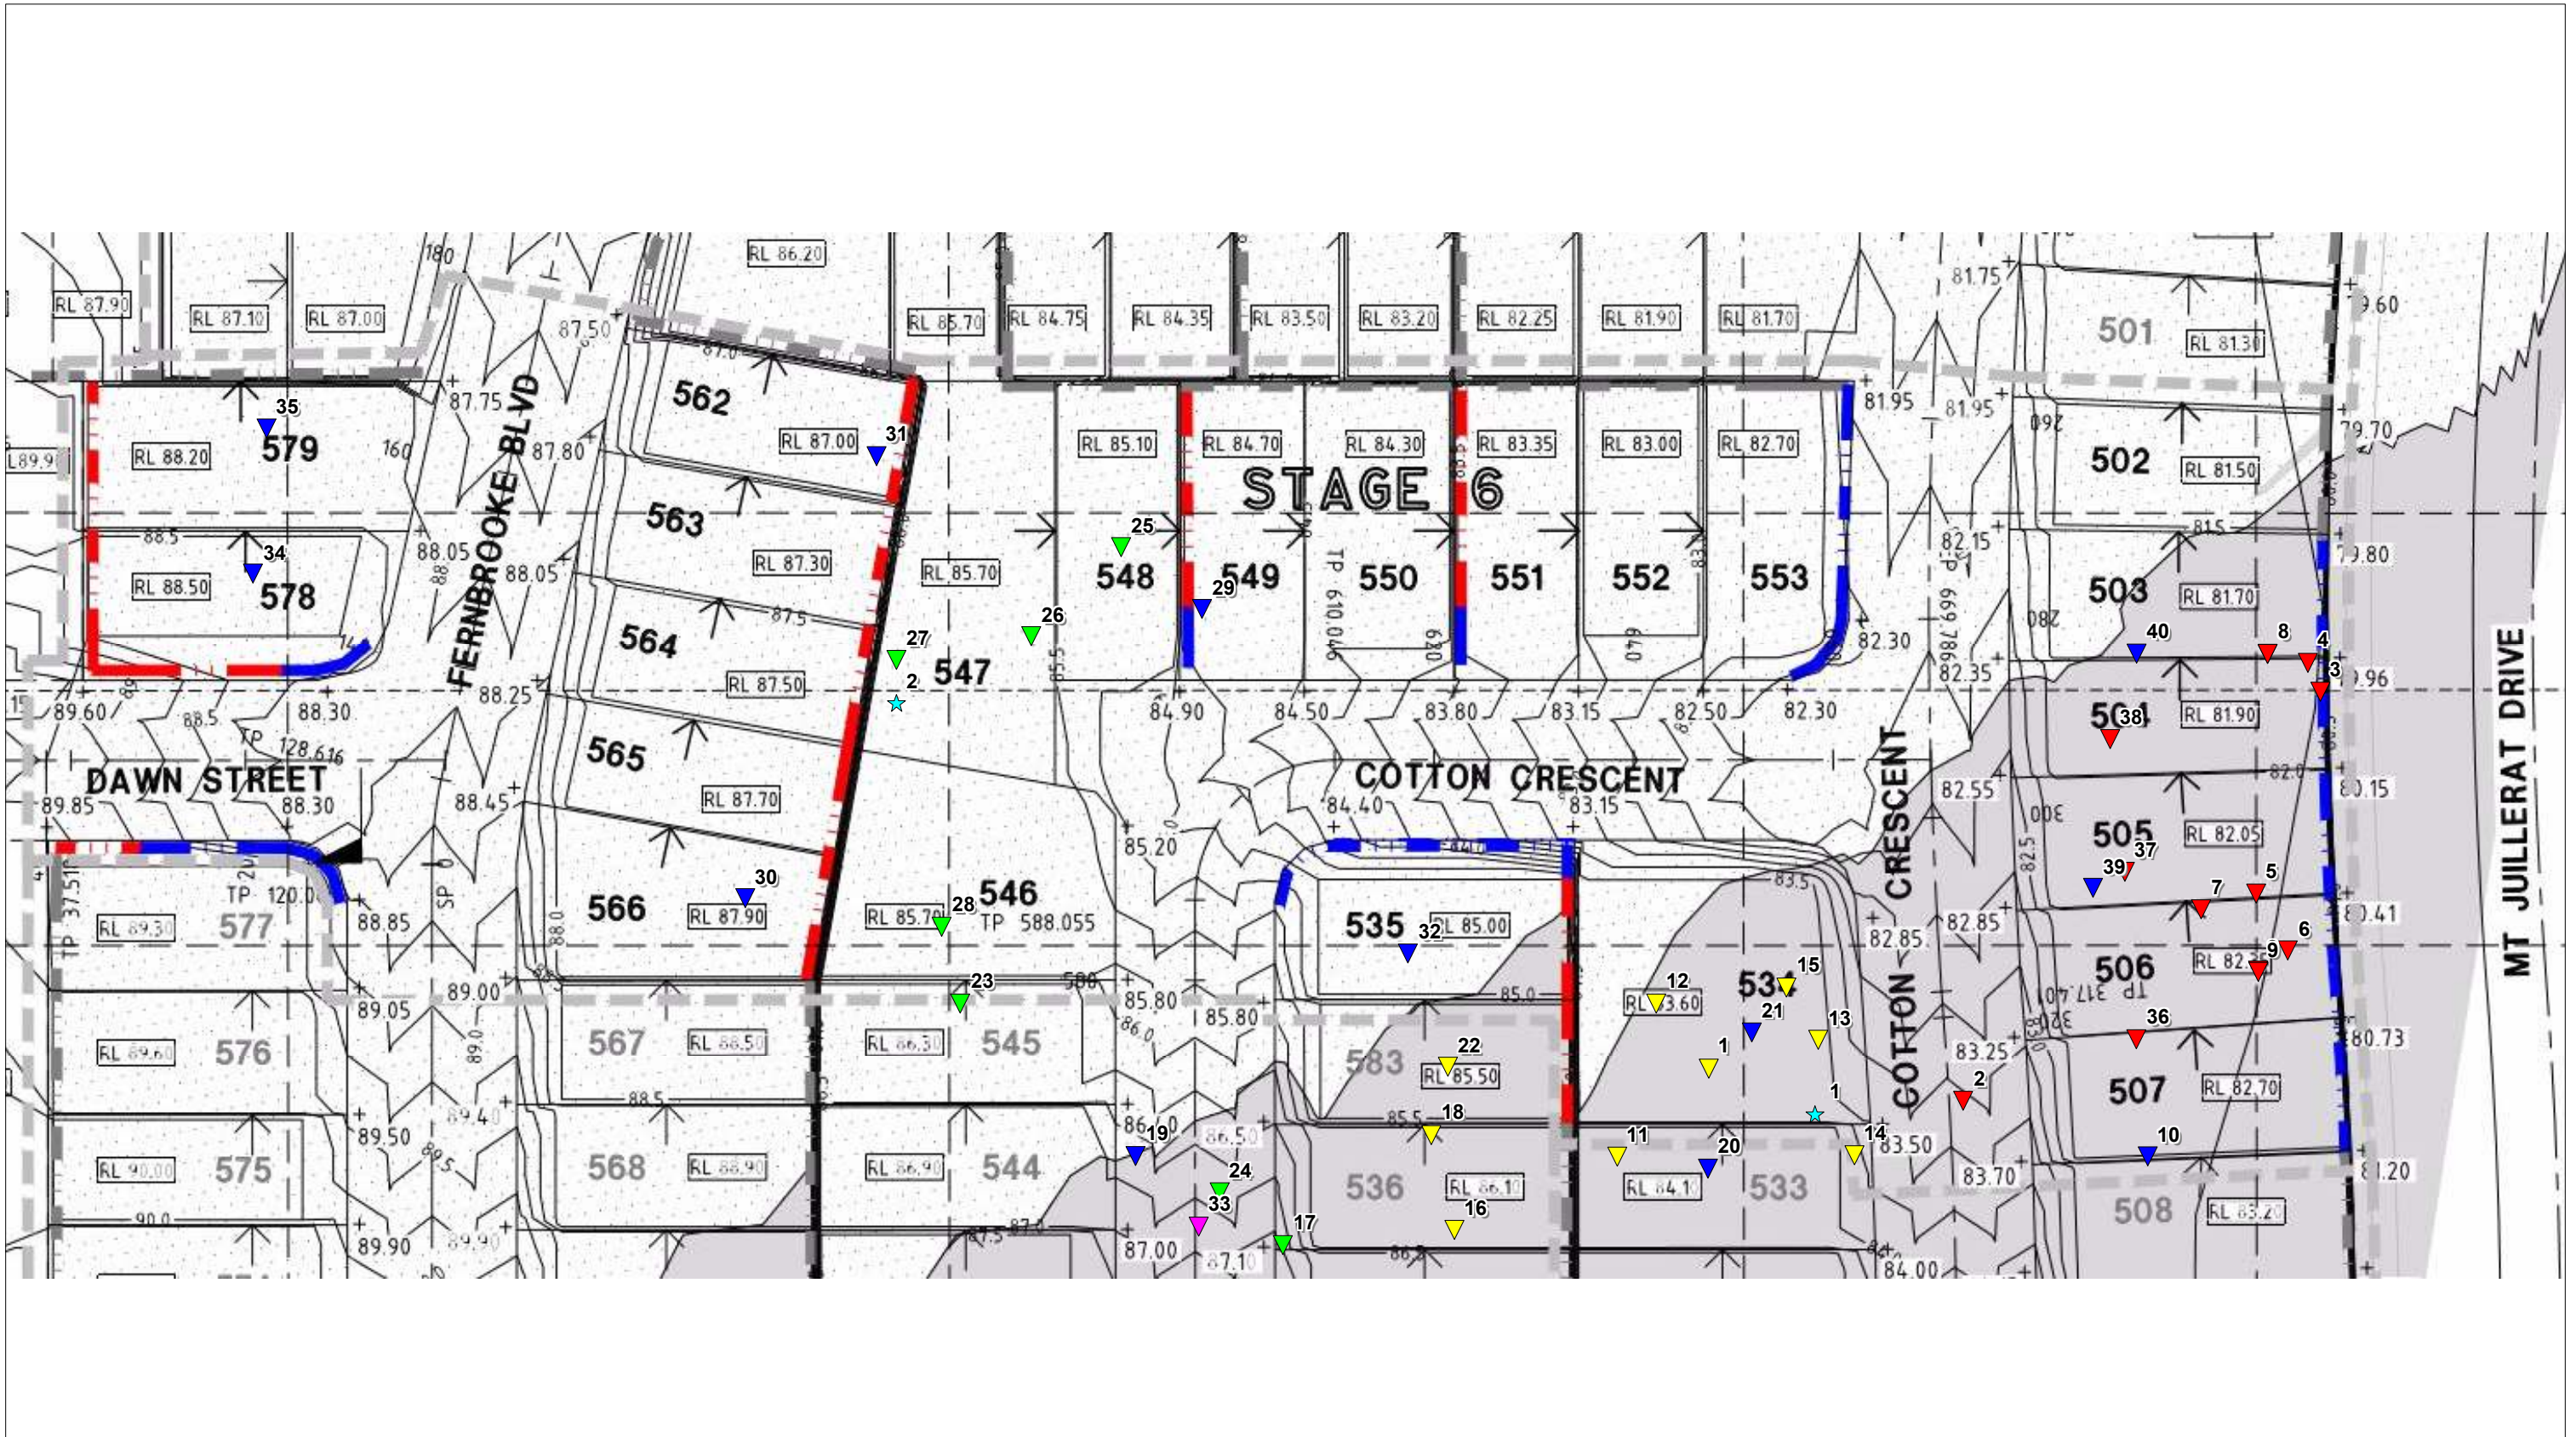
**Site Plan
Test Locations**

The Location of the field density tests are shown on the Site Plan contained in Appendix A. These test locations and levels were not obtained by survey and therefore should only be considered as approximate.
