20 January 2016

ADDENDUM TO THE BUSHFIRE HAZARD ASSESSMENT REPORT FOR STAGE 11 OF SPRING MOUNTAIN ESTATE, GREENBANK - UPDATED BUSHFIRE ATTACK LEVEL (BAL) ASSESSMENT

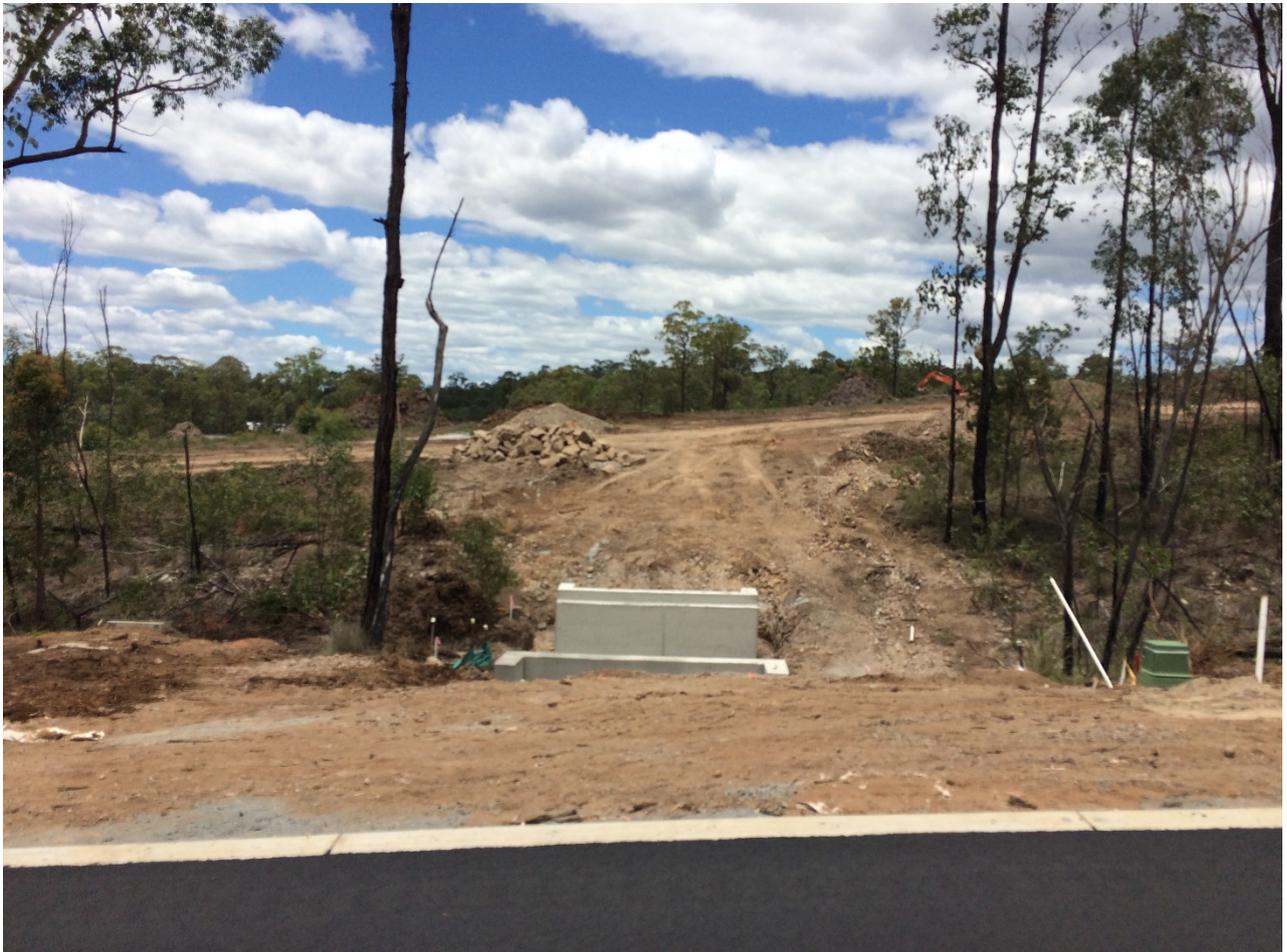
In the first instance, the area of vegetation originally classified as Closed Scrub has been significantly modified in order to rehabilitate (including weed management), stabilise (erosion management) and formalise drainage for the creek located in this area, and to form access bridges across the waterway, servicing lots 1114 to 1119. These works have significantly changed the context of the vegetation in this location to the point where its ability to support any tangible level of bushfire activity is limited. The vegetation retained in this location is substantially fragmented by the road and driveway bridges such that connectivity to nearby vegetation is removed. The works undertaken within the creek itself also limit the ability for the regrowth of significant levels of vegetation. Whilst some regrowth can be expected, particularly with regard to understorey regrowth, it is not anticipated the fuel load in this exclusive area will increase to a level where it would present a significant fire risk. The (non-continuous) strip of vegetation in this location is less than 20m in width and is not within 20m of other classified vegetation and therefore constitutes low-threat vegetation in accordance with Section 2.2.3.2 of AS3959-2009.

Figure 1: Example of bridge crossing the waterway fronting lots 1114 to 1119, further fragmenting this narrow strip of vegetation

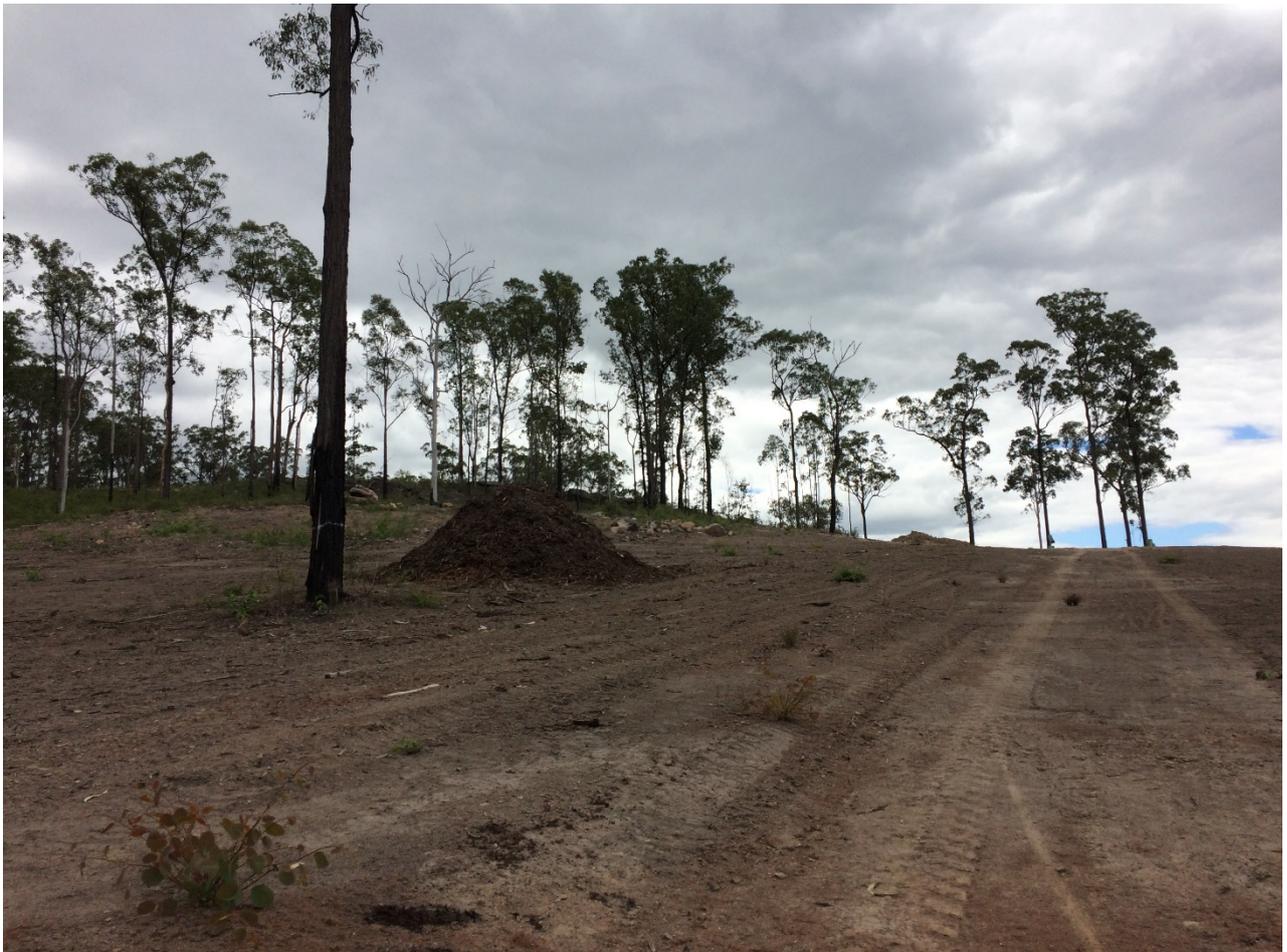
Figure 2: View to the north-east toward the southern rocky outcrop area from the fire trail access between lots 1105 and 1106

Notwithstanding the above, it is further noted the vegetation in this particular location is consistent with Woodland pursuant to Table 2.3 of AS3959-2009, rather than Open Forest as originally classified. There is very little in the way of ground or surface (shrub) layer, instead the understorey comprises either grass or rock, particularly on the southern slopes. With specific regard to a separate rock ledge occurring on lot 1107, the vegetation retained in this location is sparse with trees and comprises no understorey. Grass and shrubs are limited in extent by the rocky nature of the ground. Consistent with the other rocky outcrop to the north, this area is consistent with Woodland, rather than Open Forest pursuant to Table 2.3 of AS3959-2009. Refer to Figure 2.
