# 11 Ecology

## 11.1 Terrestrial flora and fauna

**Googong Environmental Assessment**

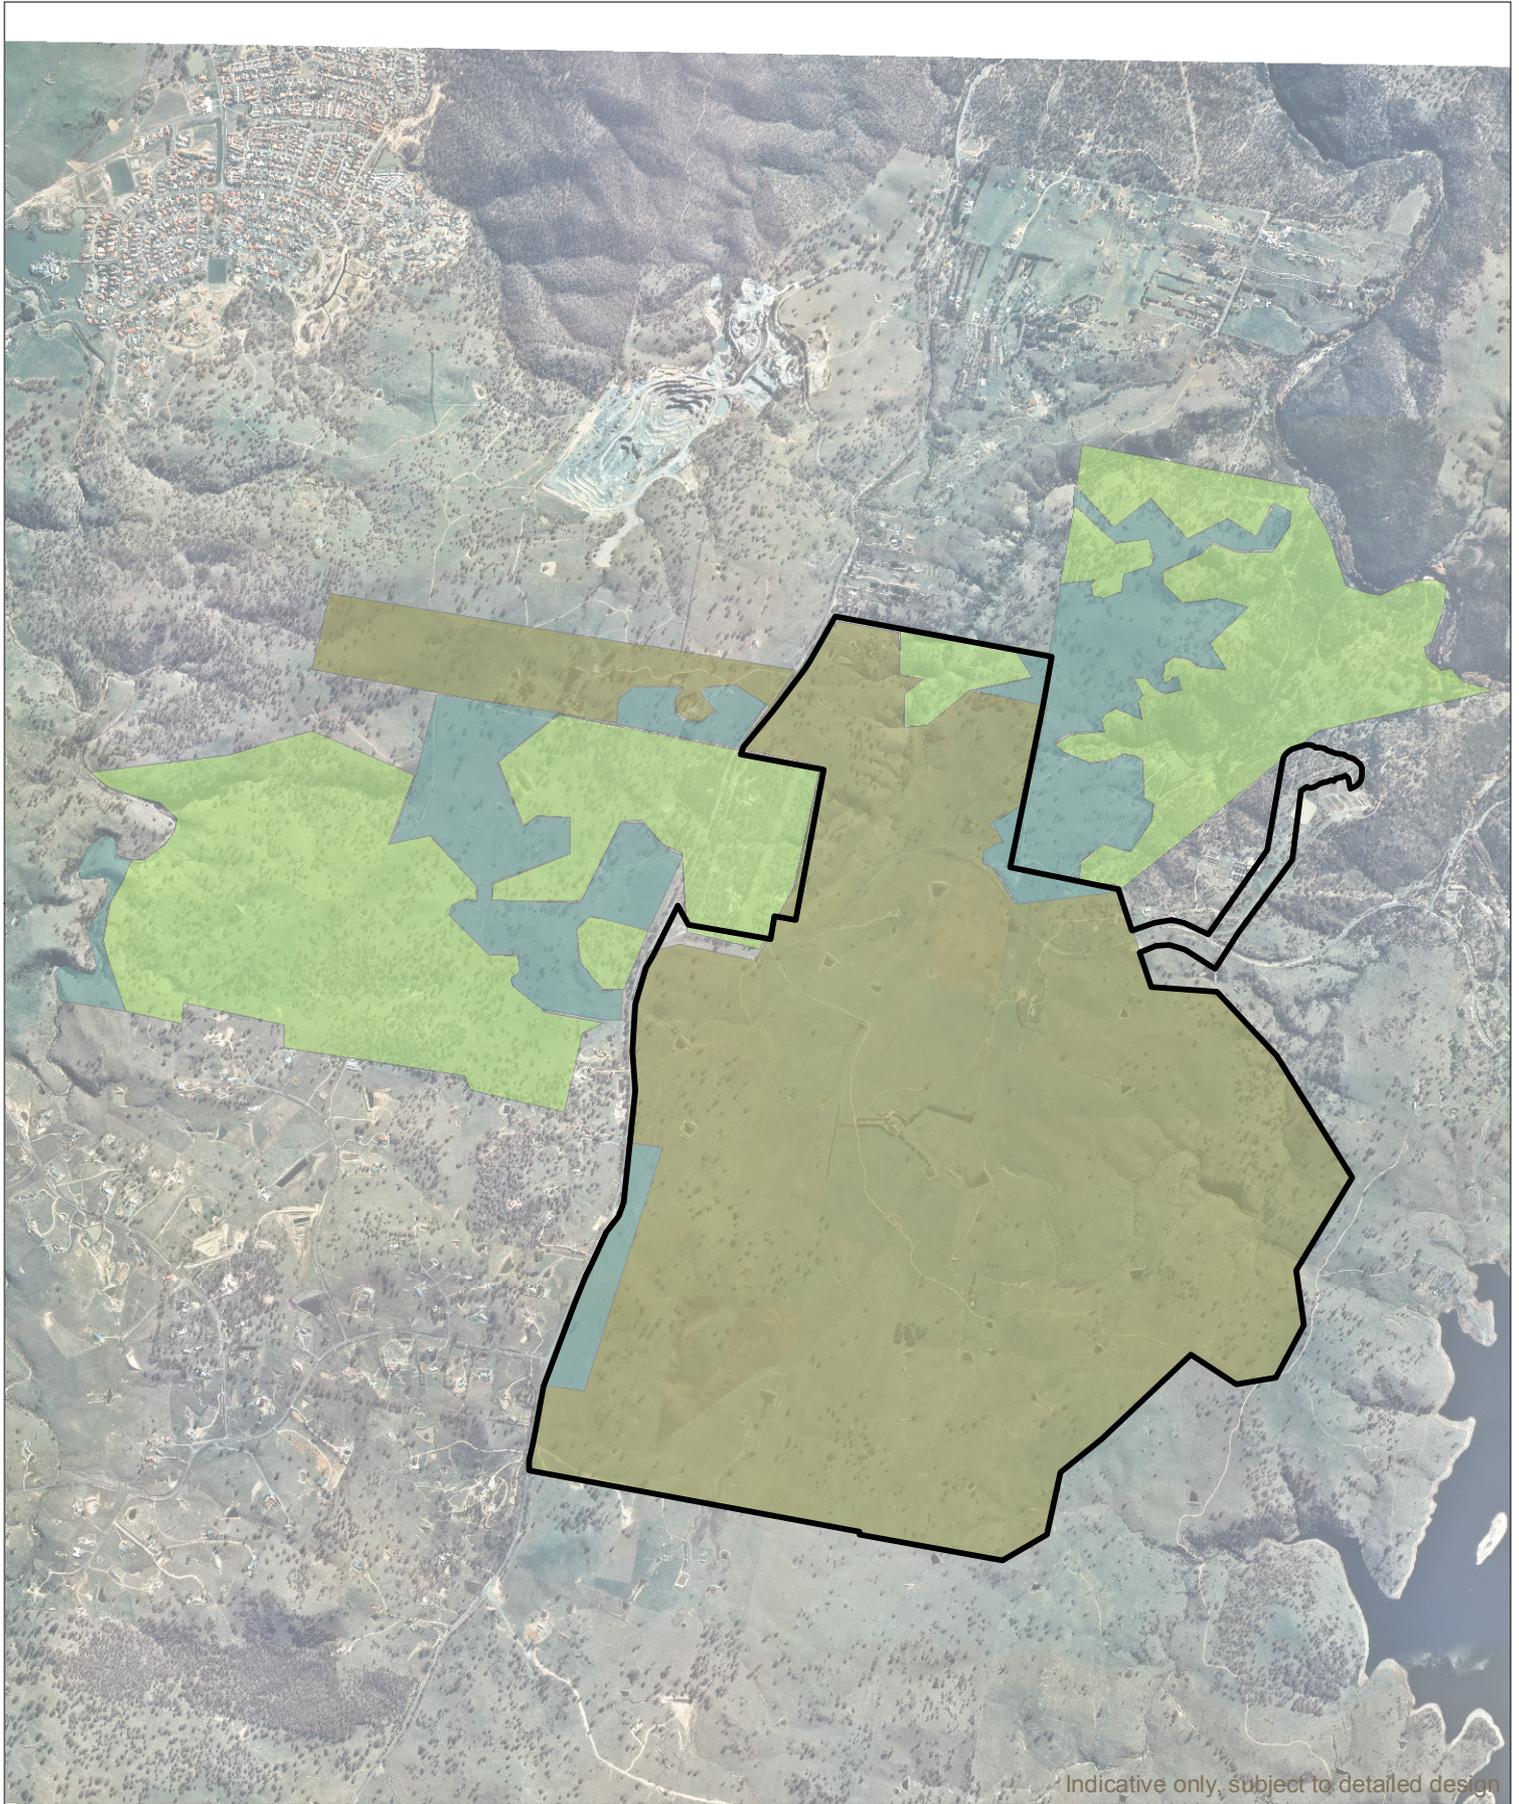
**Figure 11.1** Vegetation communities (adapted from Googong LES 2004)

- Exotic grassland and agriculture
- Native grassland
- Woodland and forest
- Study area 2010

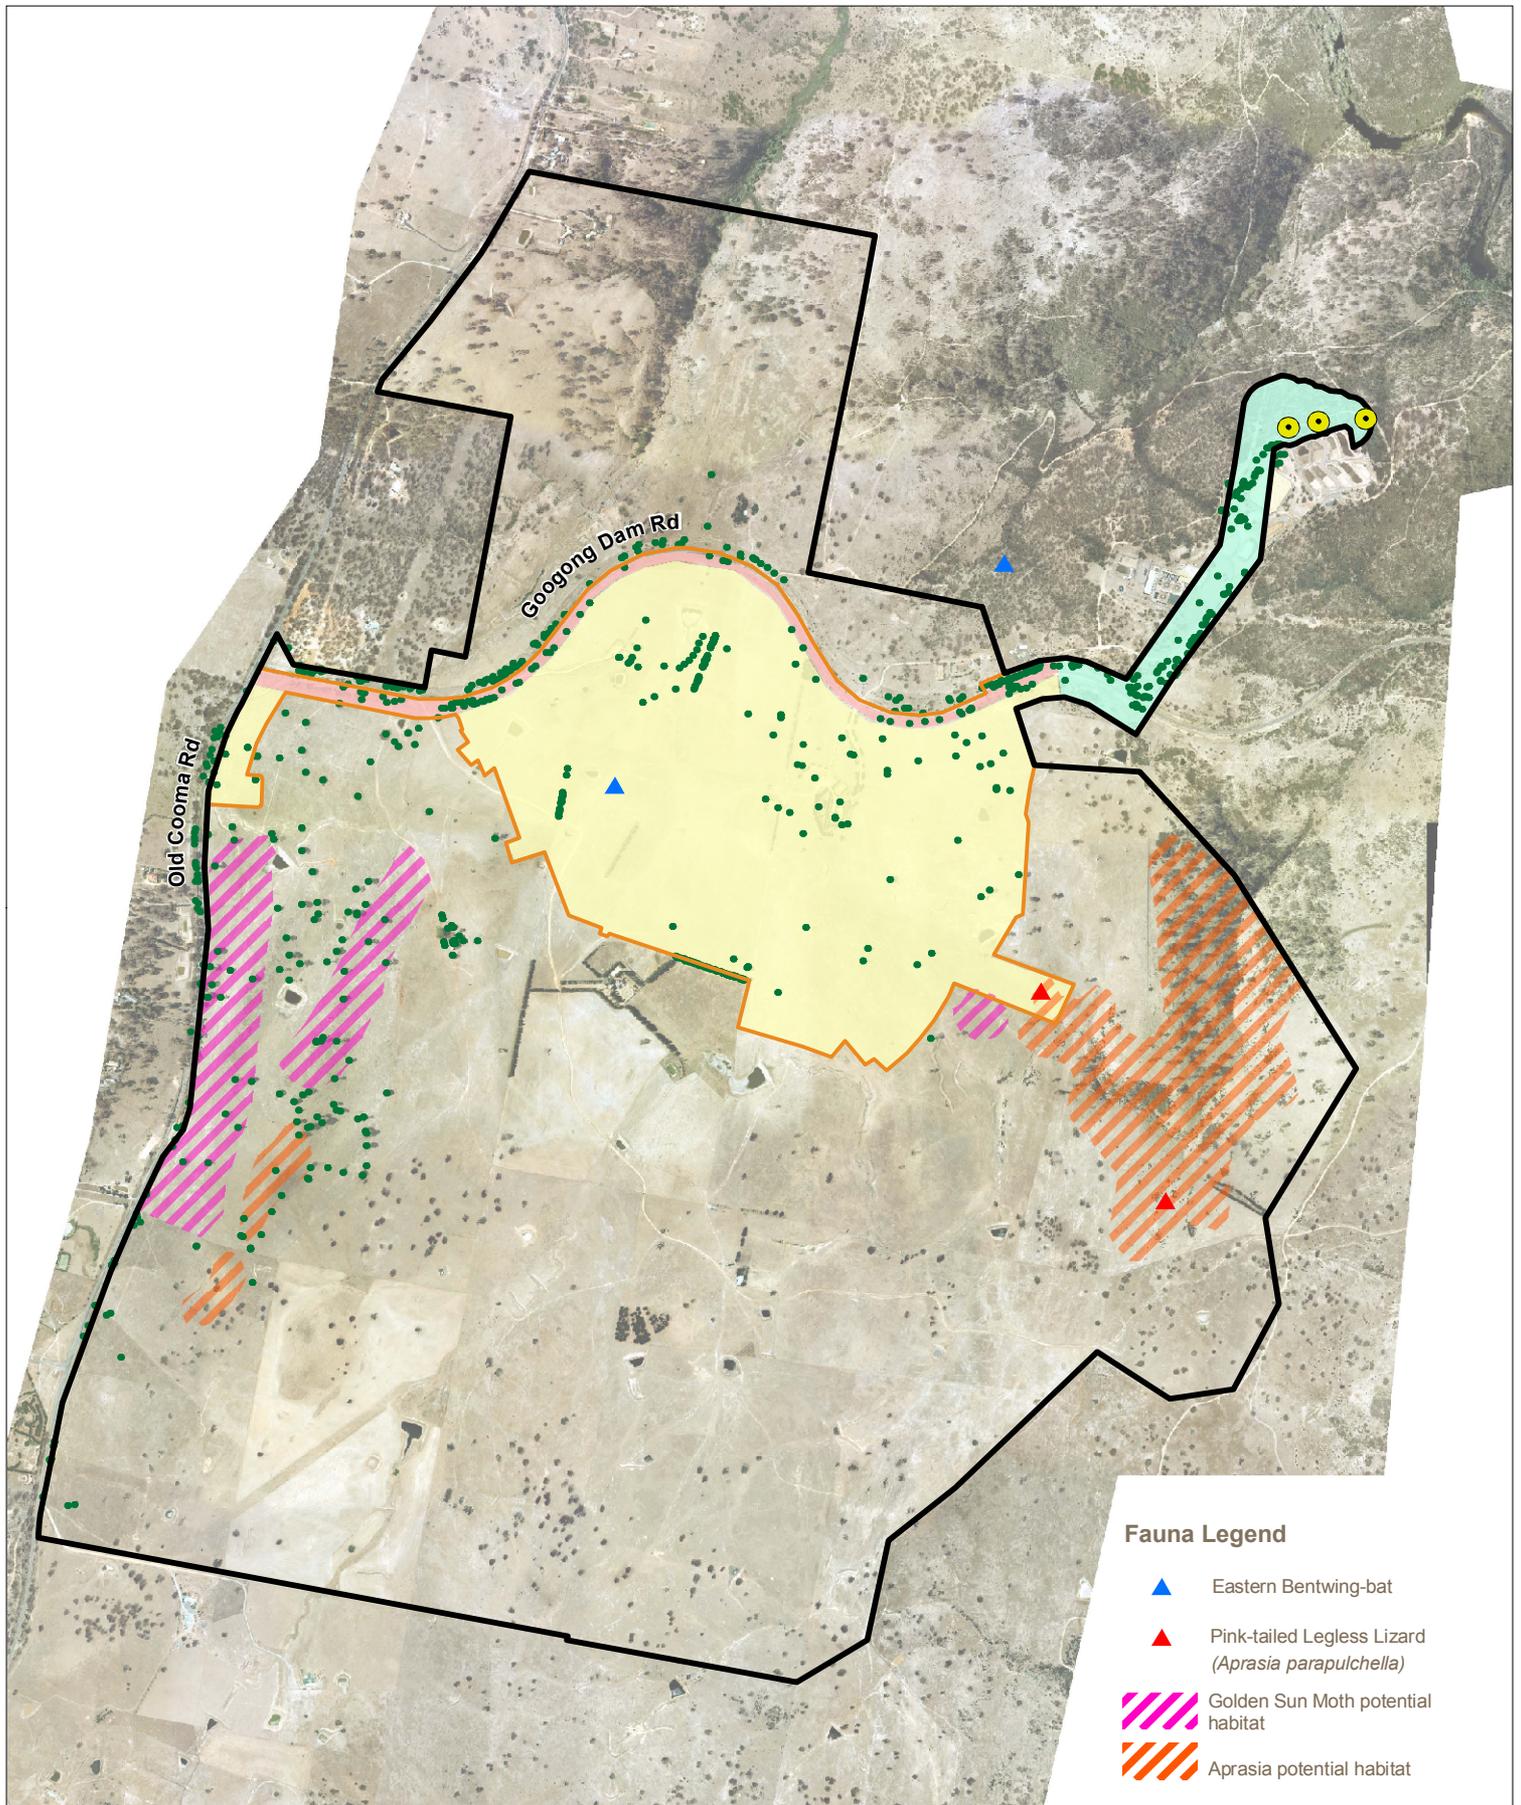
**Figure 11.2** Vegetation communities, flora and fauna

- Trees included in aborist study
- Hoary Sunray population
- Grassland with scattered trees
- Disturbed and rehabilitated area
- Roadside vegetation
- Subject site
- Study area

- ▲ Eastern Bentwing-bat
- ▲ Pink-tailed Legless Lizard (*Aprasia parapulchella*)
- Golden Sun Moth potential habitat
- Aprasia potential habitat

In terms of Stage 1 of the Project, the 2008 field surveys found that there are four vegetation communities within the subject site (see Figure 11.2). These communities are:

- Pink-tailed Legless Lizard (*Aprasia parapulchella*). This species was found in the south-east of the study area, within the Montgomery's Creek corridor. Potential habitat for this species was also identified at Hill 800, although targeted surveys did not find any individuals and it is unlikely that a population would exist in that area of the site. The potential habitat for this species was mapped and is shown in Figure 11.2.

Further surveys (undertaken during the 2009 flying season) have been completed for the Golden Sun Moth and results are presented in Appendix O. These surveys found that neither Golden Sun Moths nor any pupae casings were present. Hence, it is concluded that the species does not occur within the study area and the potential habitat shown in Figure 11.2 is not of conservation value for this species.

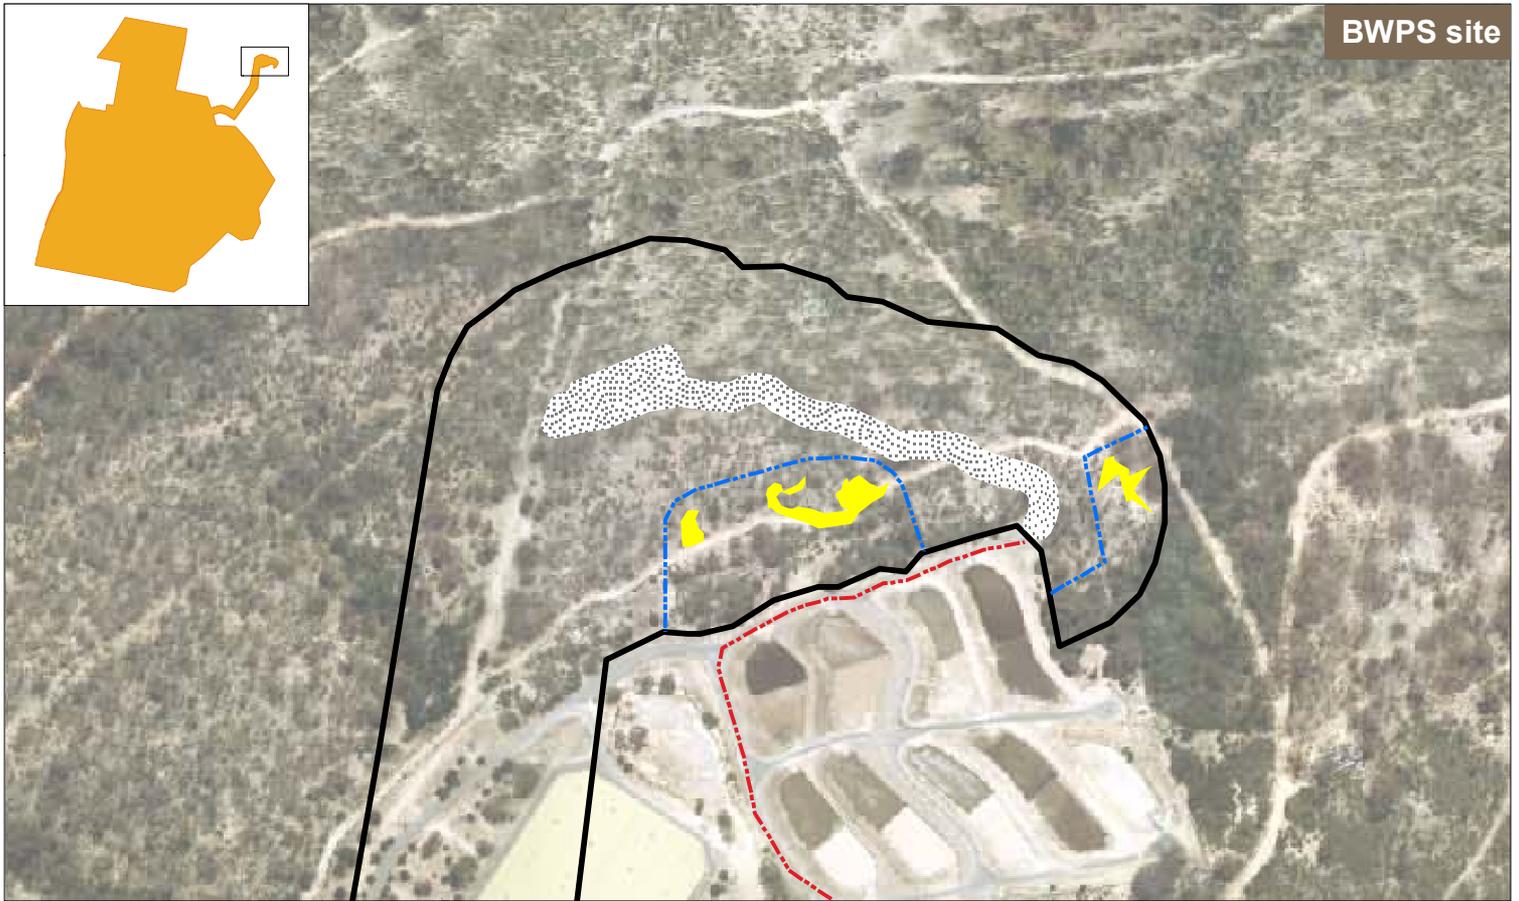
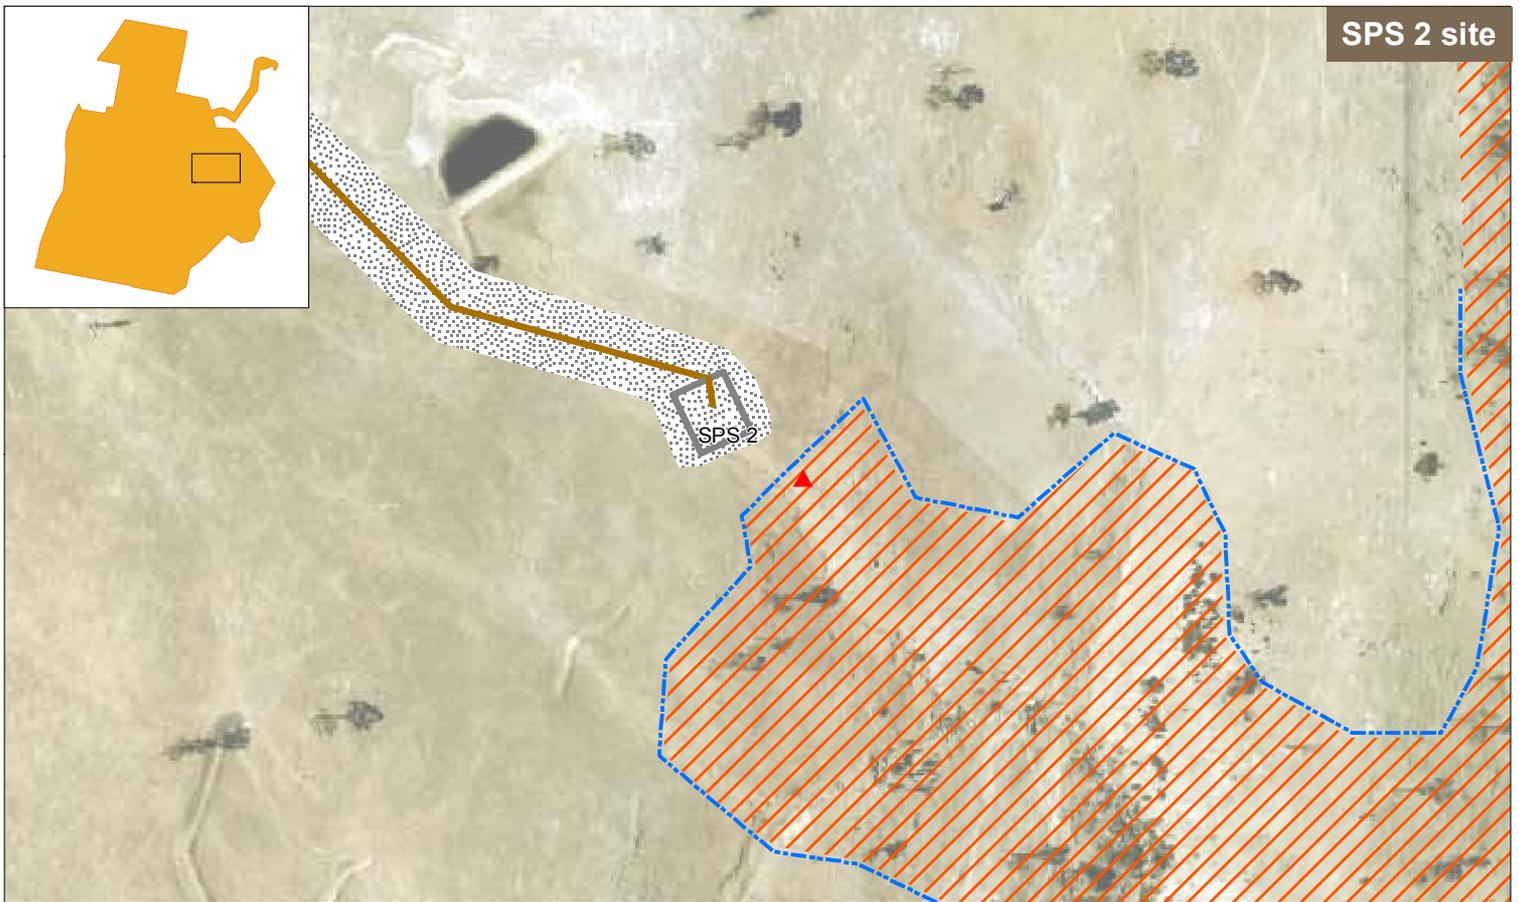
**Figure 11.3** Threatened flora and fauna protection measures

Access road and construction footprint
-

Hoary Sunray population
-

Exclusion fence (approximate)
-

Access route to BWPS site
-

Sewage rising main
-

Pink-tailed Legless Lizard record
-

Pink-tailed Legless Lizard potential habitat

- The BWPS and access road would be located outside the recorded locations of the Hoary Sunray and measures would be implemented to avoid disturbance (see the recommendations provided in Chapter 6 of Appendix O).

- Implement a flora and fauna management plan (which would contain management and mitigation measures). This plan would detail:
  - The installation of exclusion fencing, signage and other relevant protection measures in particular areas, which would be undertaken under the supervision of an appropriately qualified ecologist as part of pre-construction surveys (see Figure 11.3) in the vicinity of SPS2 (to avoid impacts on the Pink-tailed Legless Lizard; and in the vicinity of the BWPS site and associated access road (to avoid impacts to the Hoary Sunray).
