SITE CONTAMINATION ASSESSMENT

**GOOGONG TOWNSHIP RESIDENTIAL DEVELOPMENT
NEIGHBOURHOOD (NH) 3, NH4 & NH5
OLD COOMA ROAD, GOOGONG**

REPORT NO 14328/2-AA SEPTEMBER 2021

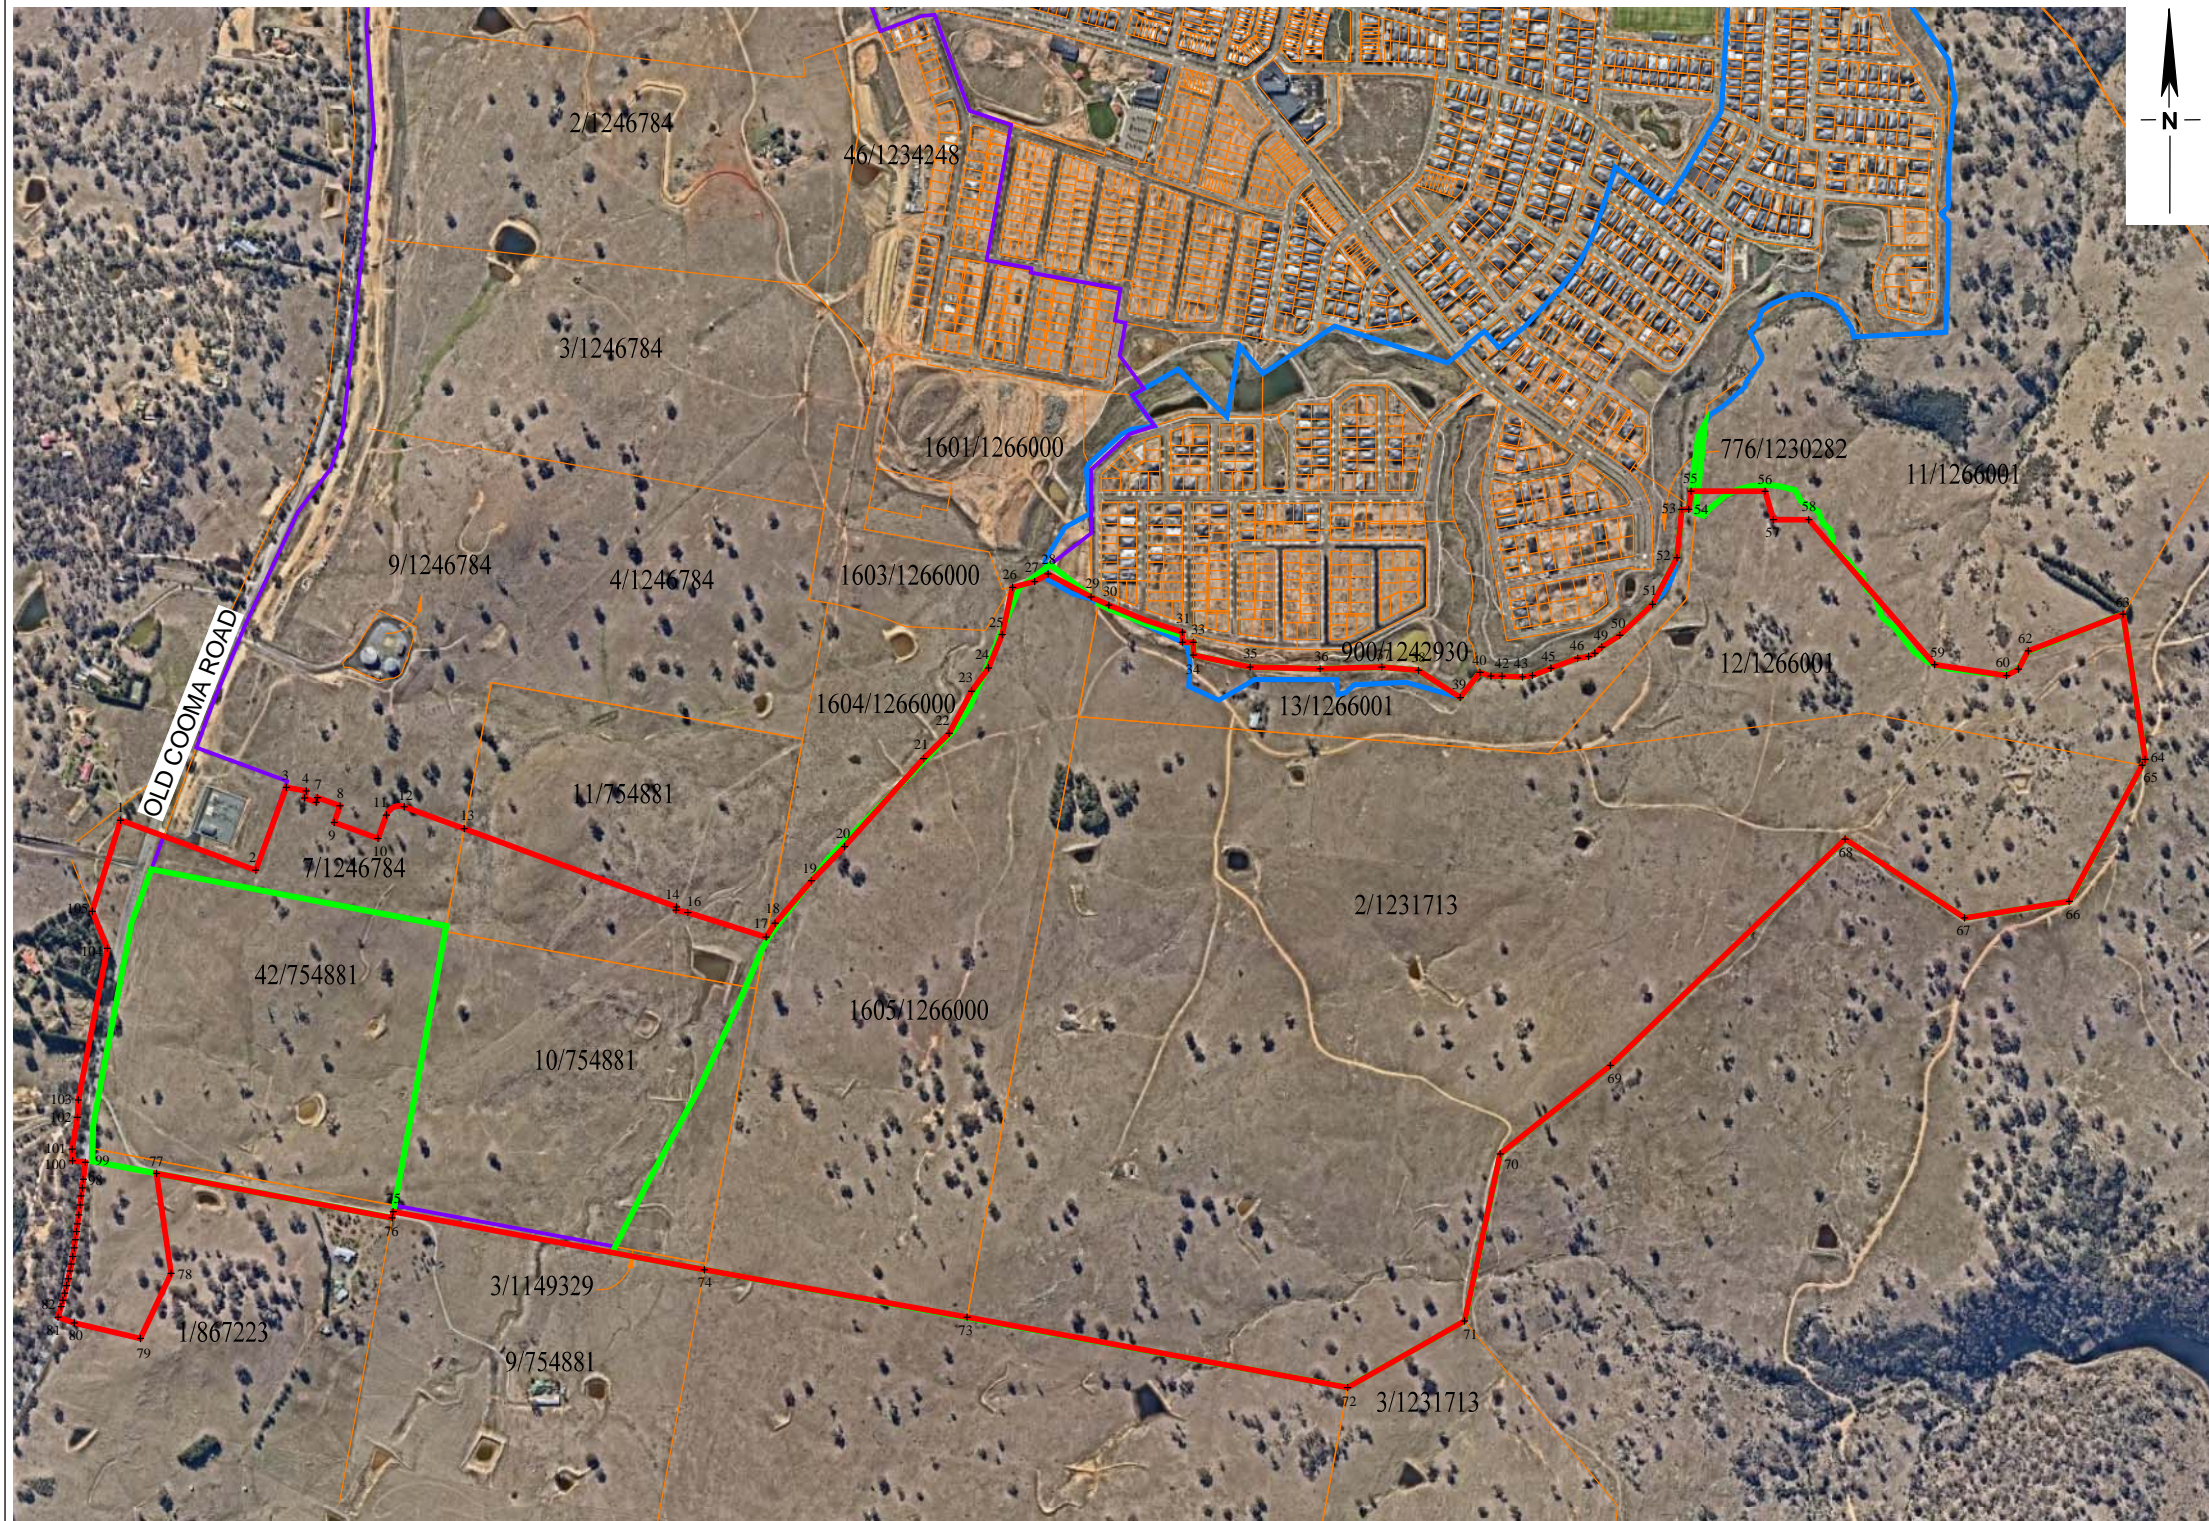
Drawing No: 14328/2-AA1
Job No: 14328/2
Drawn By: MH
Date: 16 June 2021
Checked By: JX

The site, as indicated on Drawing No 14328/2-AA1, is irregular in shape and covers an area of approximately 239 hectares (ha). It should be noted that the site boundary of the SCA Area for NH3 to NH5 (the site) inclusive of the DA extent, as well as additional land to the east and south as shown on the figure in the Project Objective.

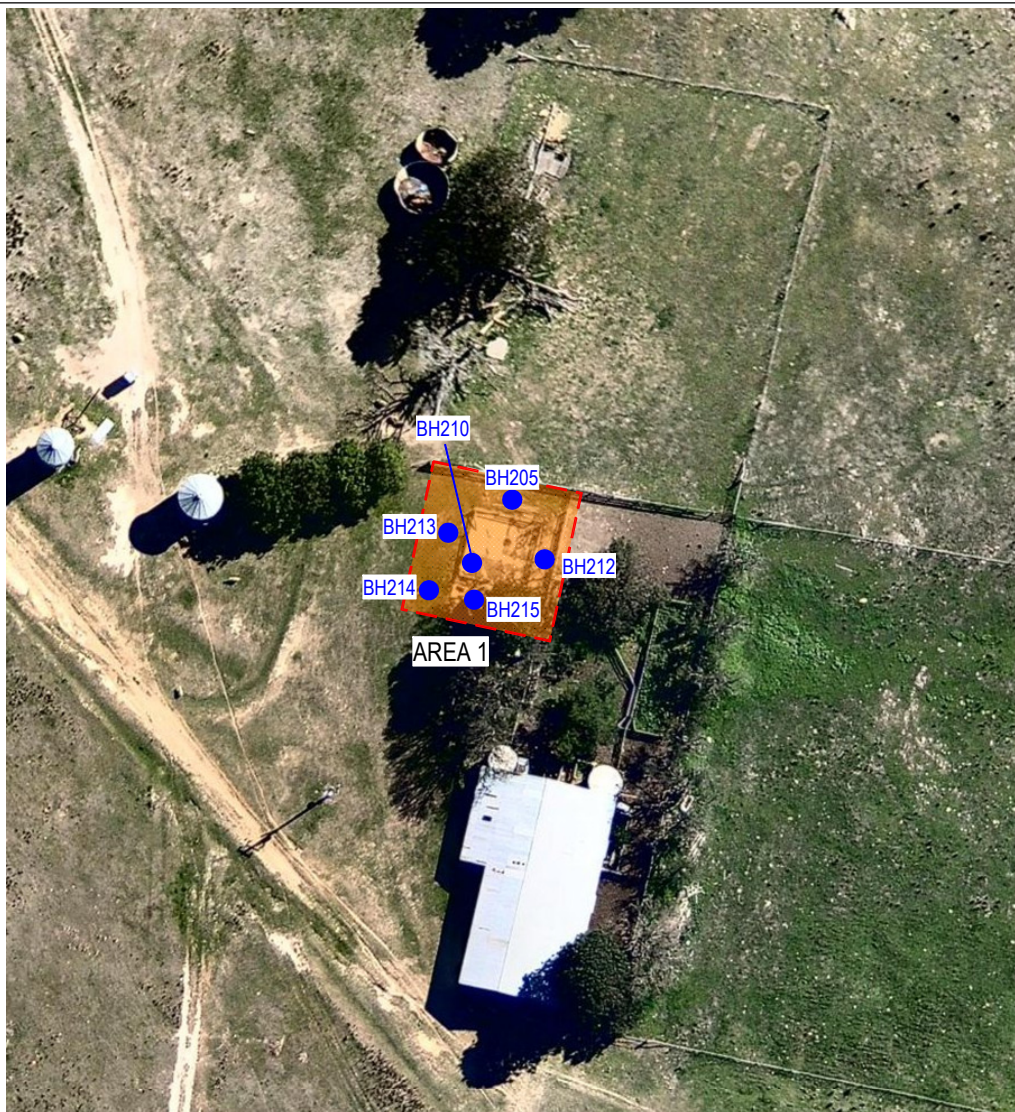
Drawing No: 12675/2-AA6
Job No: 12675/2
Drawn By: MH
Date: 15 May 2014
Checked By: JX

Sample Location	Depth (m)	Contaminant	Concentration (mg/kg)	Assessment Criteria (mg/kg)
BH205	0-0.1	arsenic (As)	370	As = 100 ^a As = 100 ^b
BH210	0.05-0.15	As	190	
BH212	0-0.1	As	390	
BH213	0-0.1	As	460	
BH214	0-0.1	As	400	
BH215	0.3-0.35	As	160

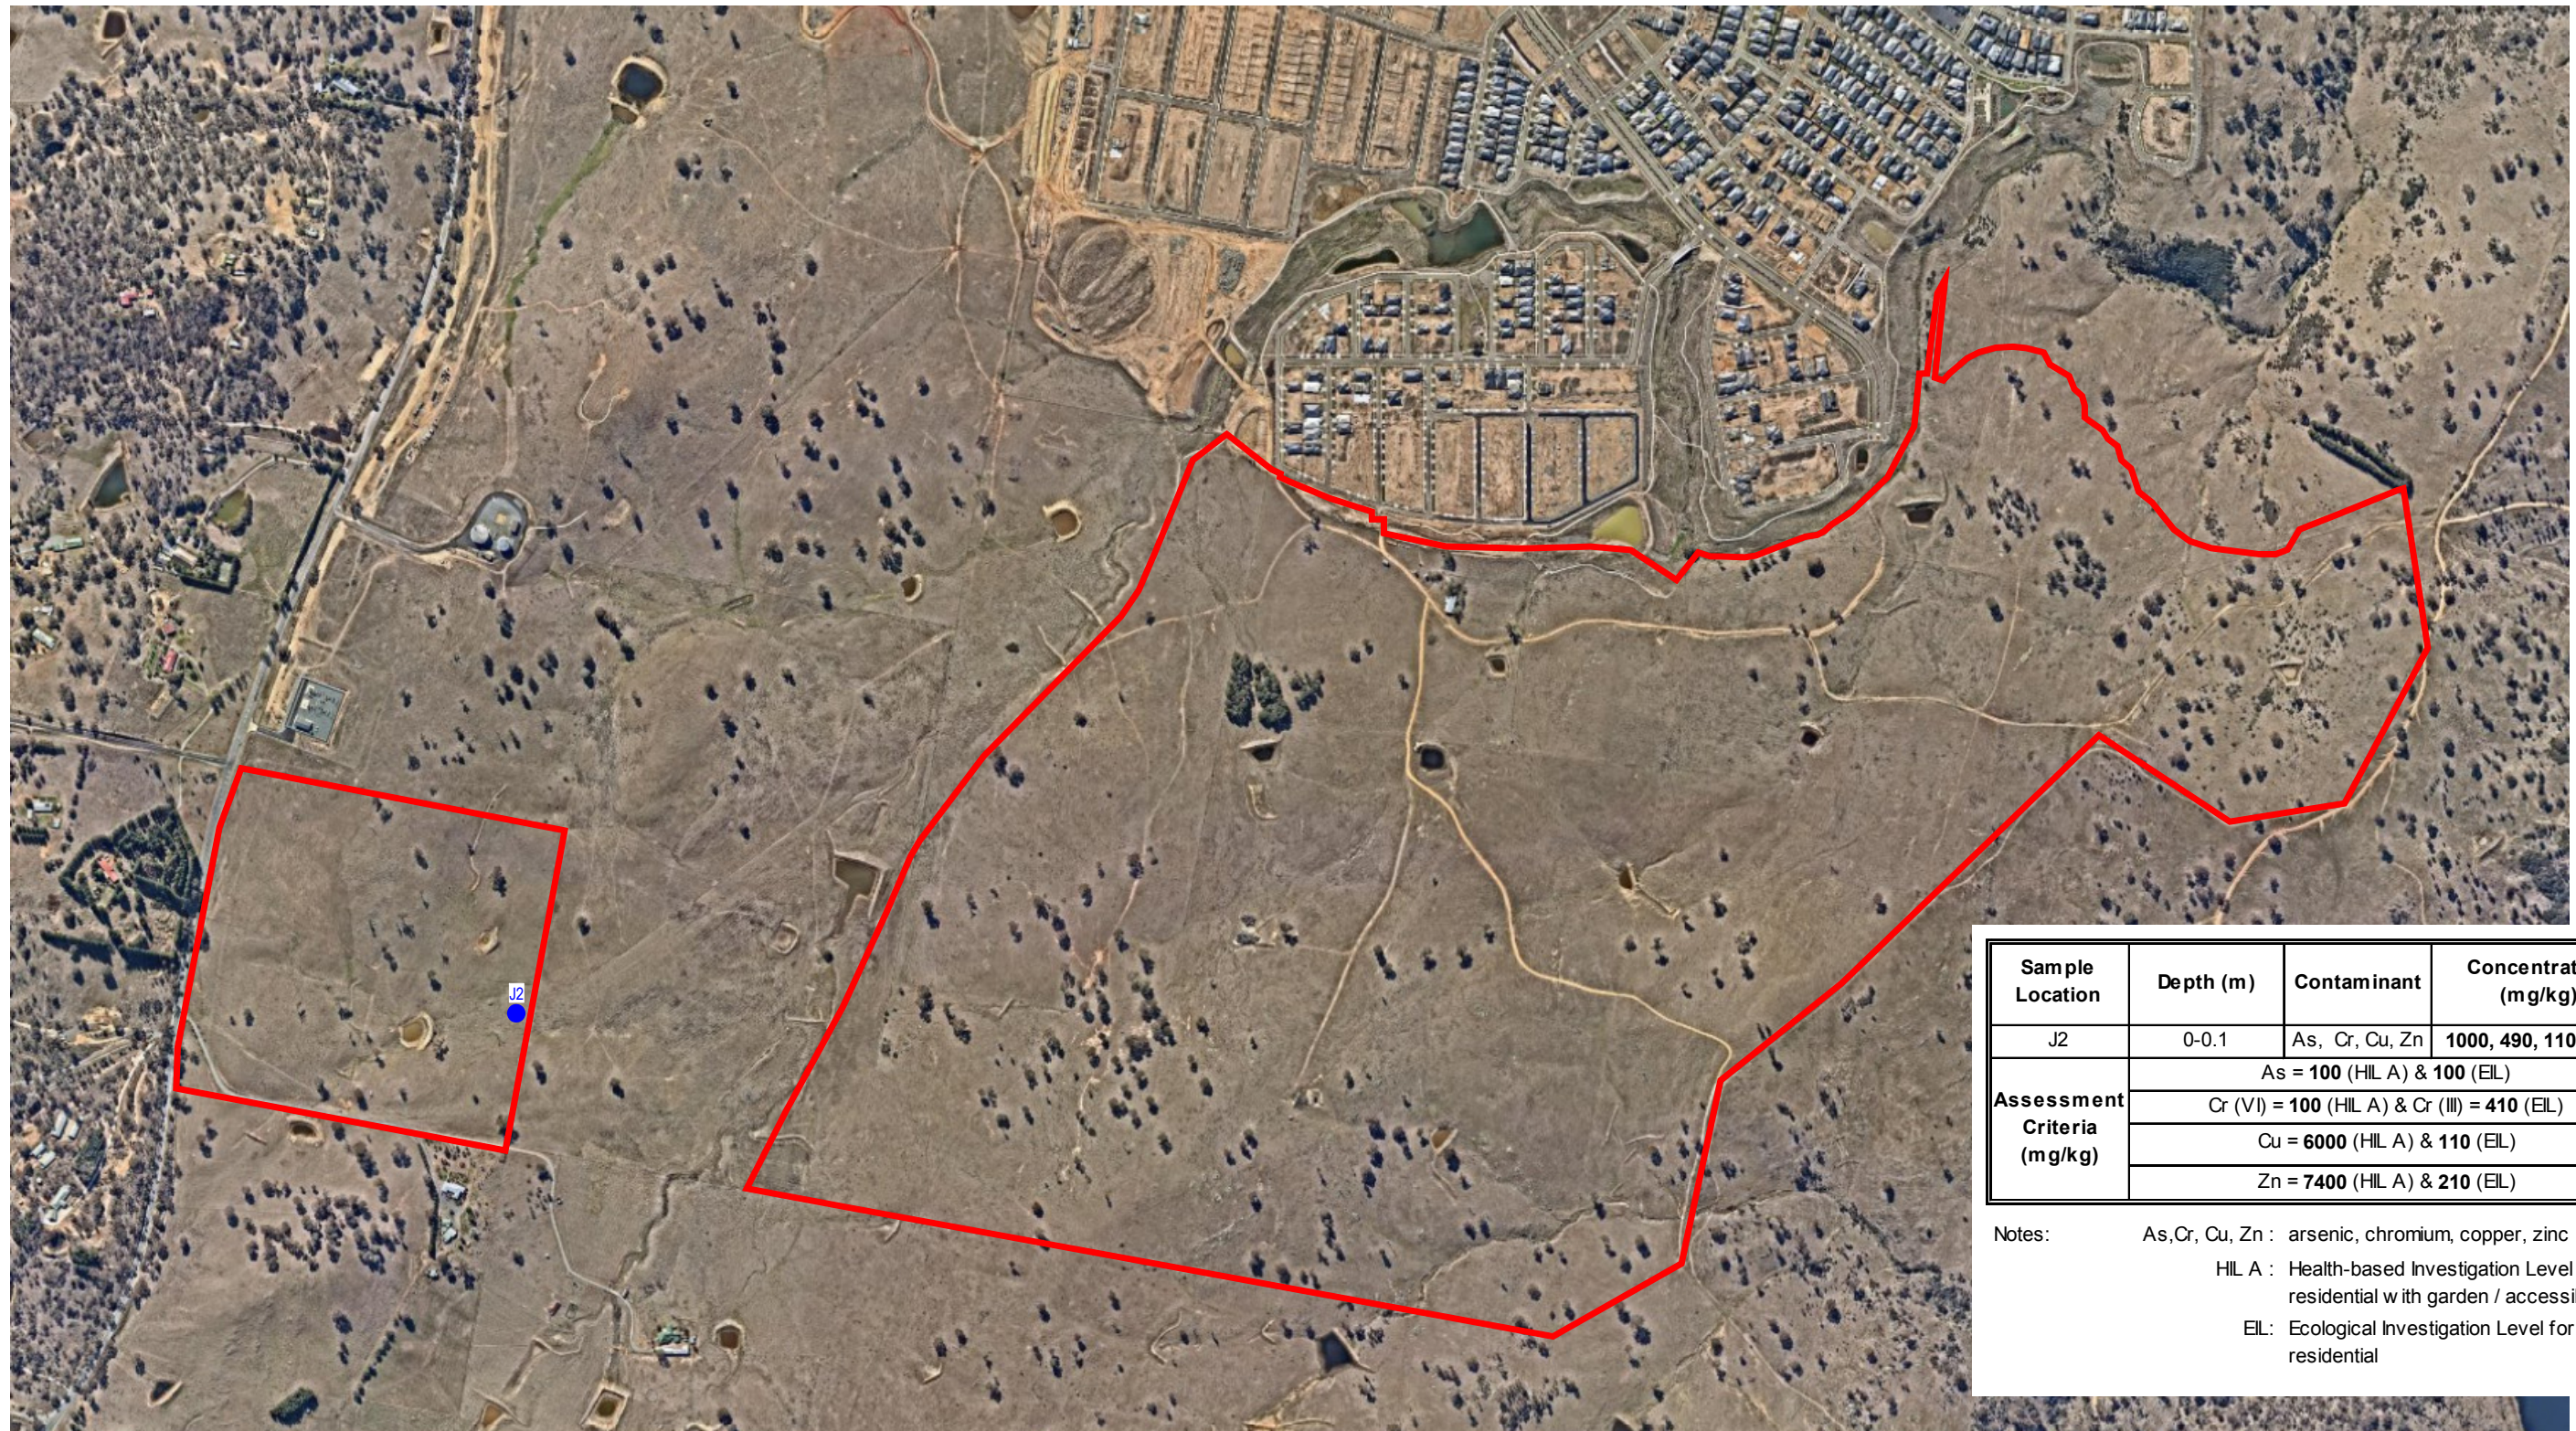
Drawing No: 14328/1-AA4
Job No: 14328/1
Drawn By: MH
Date: 25 June 2019
Checked By: JX

Sample Location	Depth (m)	Contaminant	Concentration (mg/kg)
J2	0-0.1	As, Cr, Cu, Zn	1000, 490, 1100, 790
Assessment Criteria (mg/kg)	As = 100 (HIL A) & 100 (EIL)		
	Cr (VI) = 100 (HIL A) & Cr (III) = 410 (EIL)		
	Cu = 6000 (HIL A) & 110 (EIL)		
	Zn = 7400 (HIL A) & 210 (EIL)

Notes: As,Cr, Cu, Zn : arsenic, chromium, copper, zinc
HIL A : Health-based Investigation Level for residential with garden / accessible soil
EIL: Ecological Investigation Level for urban residential
