Annual Compliance Report

10 June 2018 to 9 June 2019 EPBC 2014/7206
Flagstone West Urban Development Project,
Flagstone, Queensland
Peet Flagstone City Pty Ltd
06 September 2019

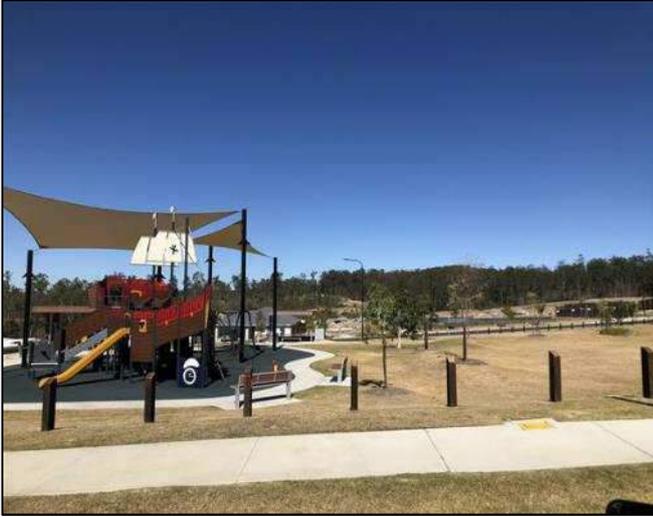
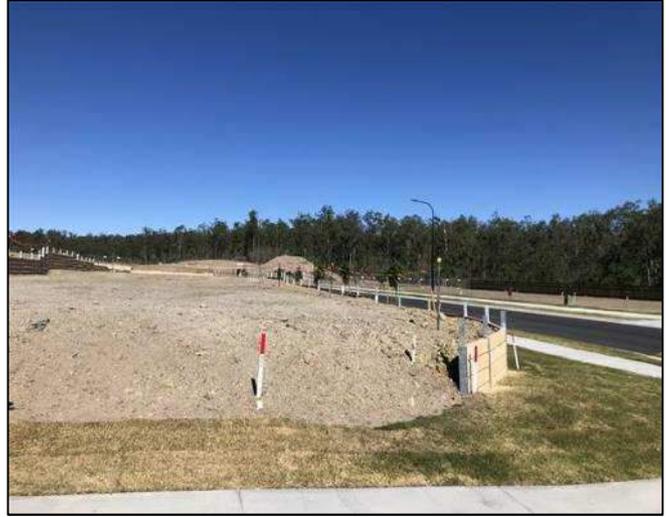
Photo set 1: Continued development within the western extent of the site, including a local park.

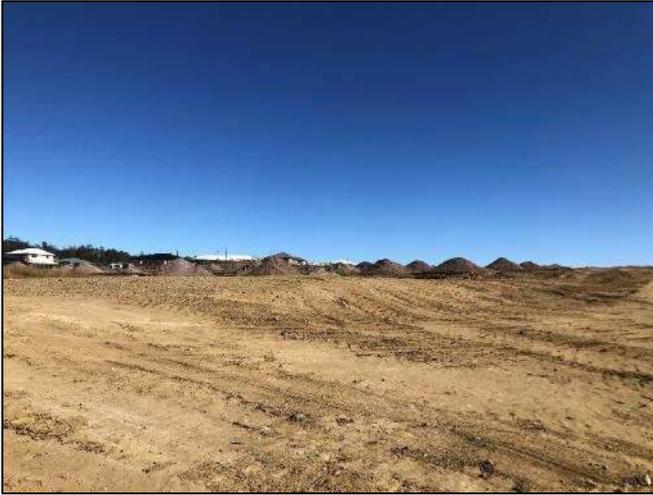
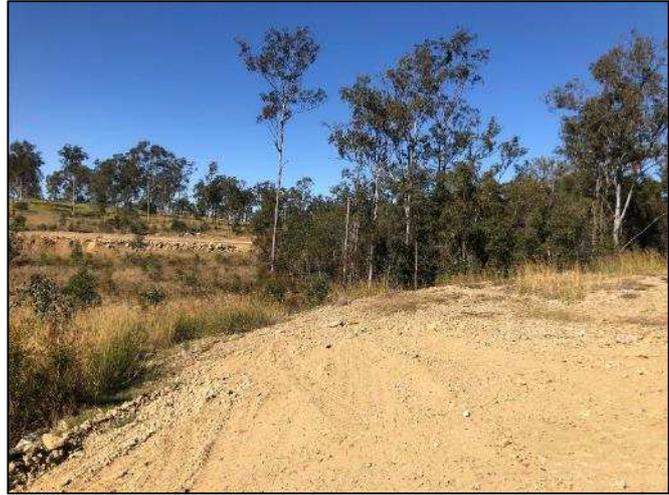
Photo set 2: Continued earthworks within the western extent of context area 1.

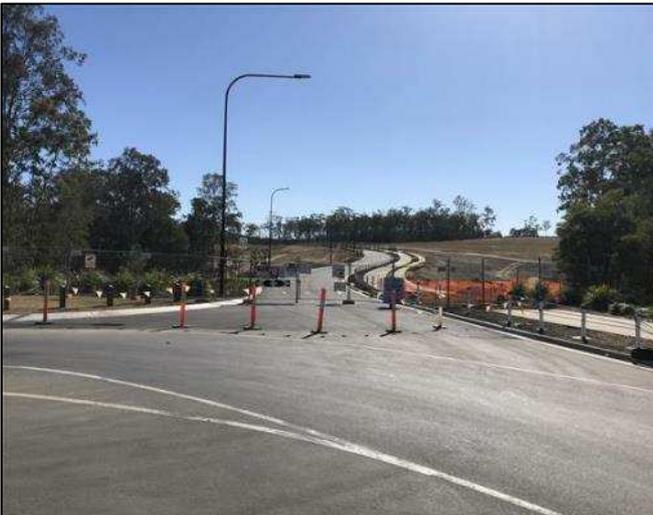
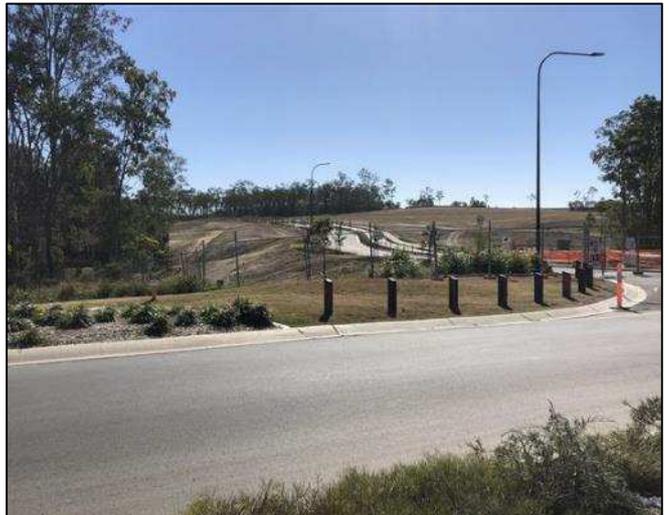
- Continued earthworks and construction activities currently being completed and not accessible to the public at this time.
 - Bridge crossing over Sandy Creek tributary has been completed to join the new development area in the east, and rehabilitation works have commenced in association with the creek. No public access is permitted at this time (refer **Photo set 3**).

Photo set 3: Continued earthworks within the eastern extent of context area 1; bridge crossing established across Sandy Creek.

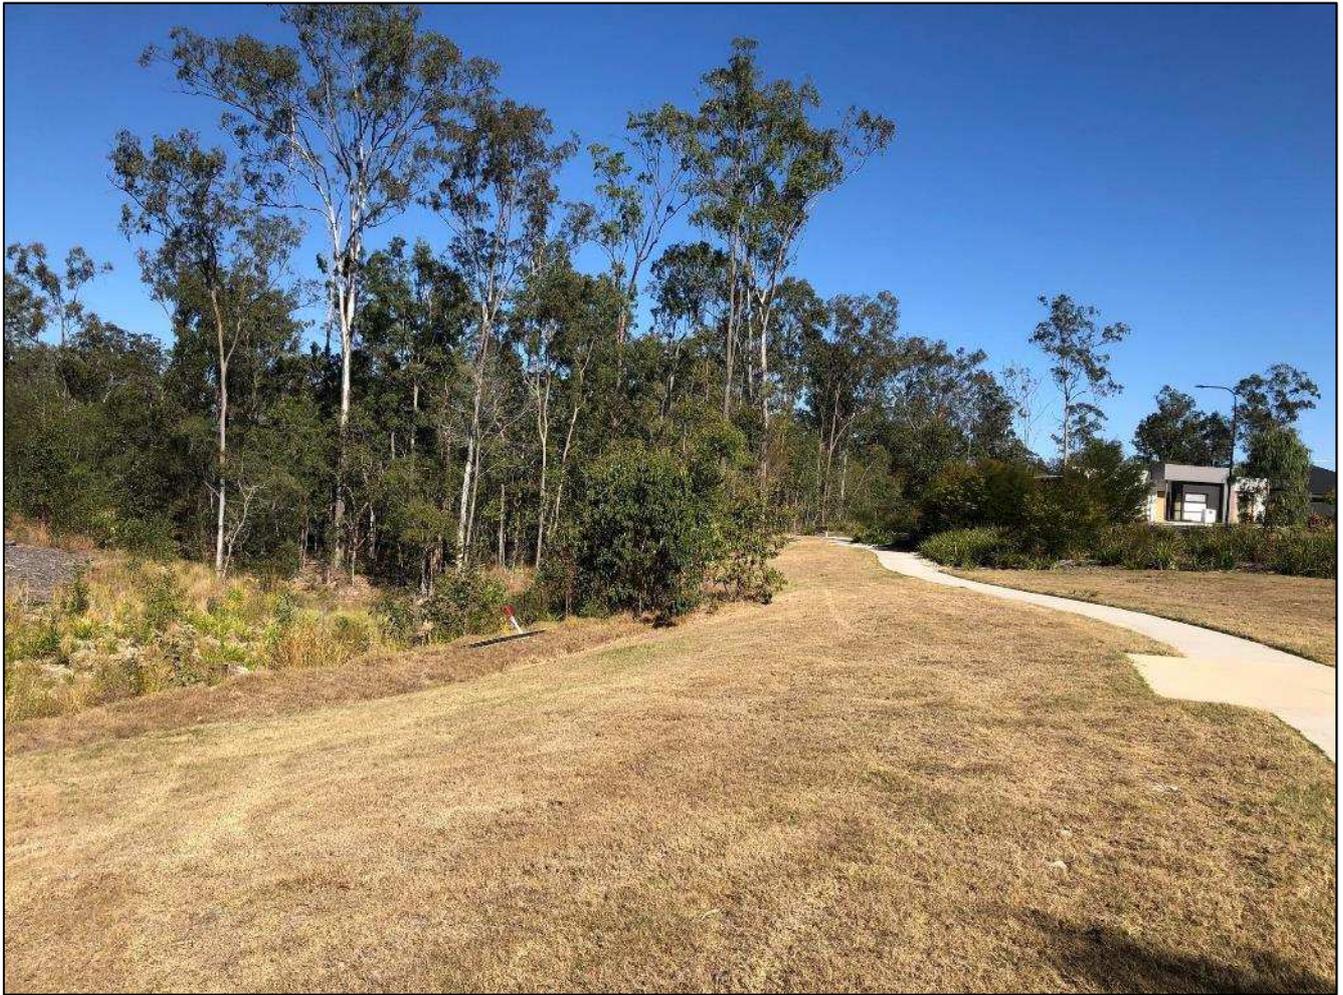
Photo 4: Land parcel setbacks from retained vegetation, with bank rehabilitation works and transition area landscape works.

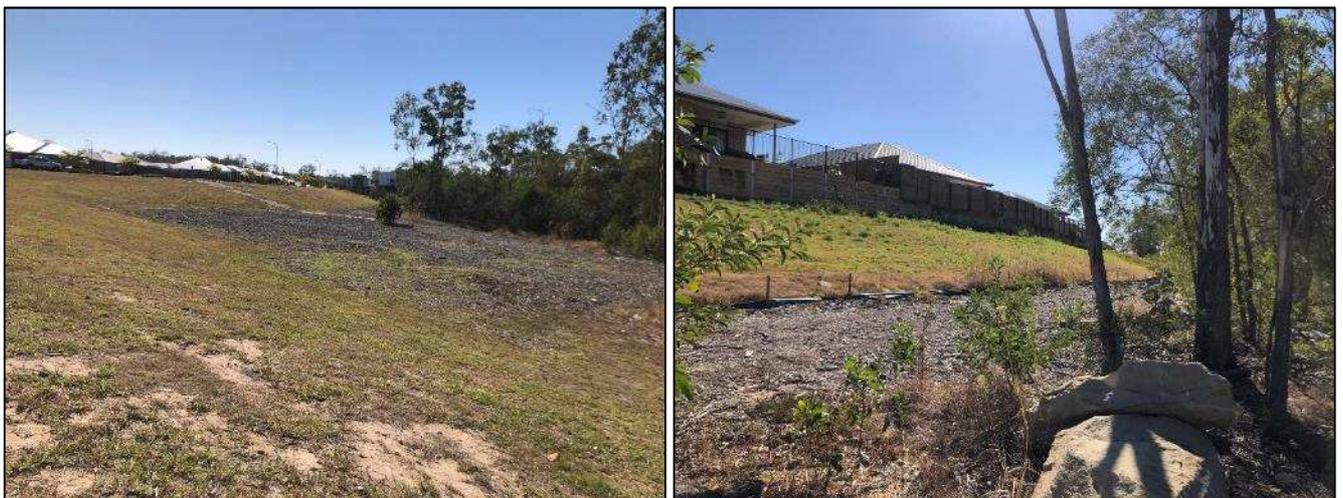
Photo set 5: Transition between retained vegetation associated with the creek and established land parcels.

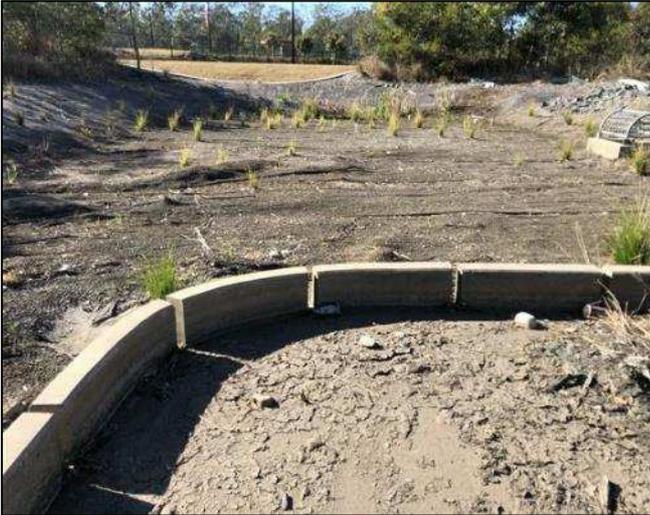
Photo 6: Existing condition of detention basin.

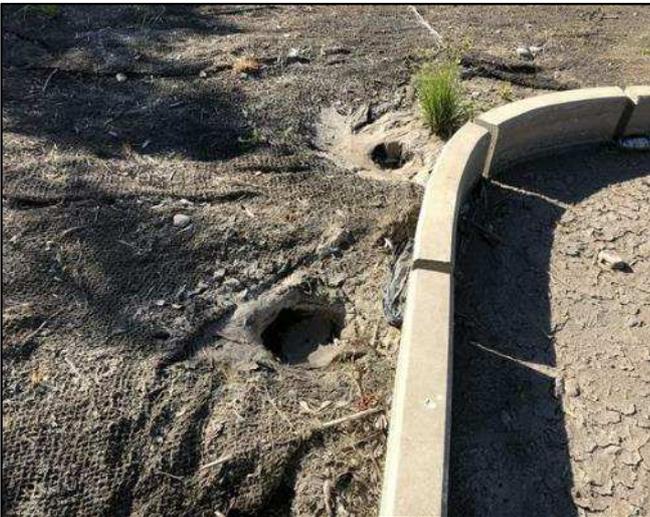
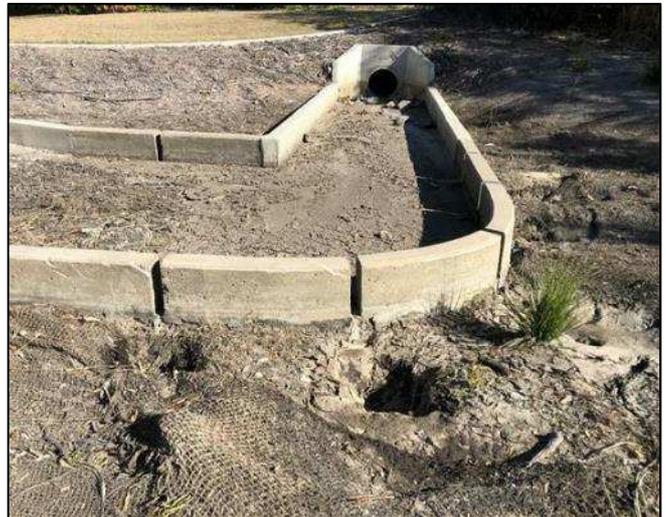
Initial stabilisation works were observed, although some were observed to require maintenance. The sediment basin located adjacent to the dog park established during the previous reporting period contained a small amount of vegetation, where damage was observable to the mesh layer (**Photo 6**). Erosion of dispersive soils beneath the matting has occurred where water has likely become trapped following rainfall events (refer **Photo set 7**).

Photo set 7: Erosion damage to rehabilitation matting within detention basin.

In response to the observed maintenance issues, Peet are liaising with the landscape contractor to rectify the issues.

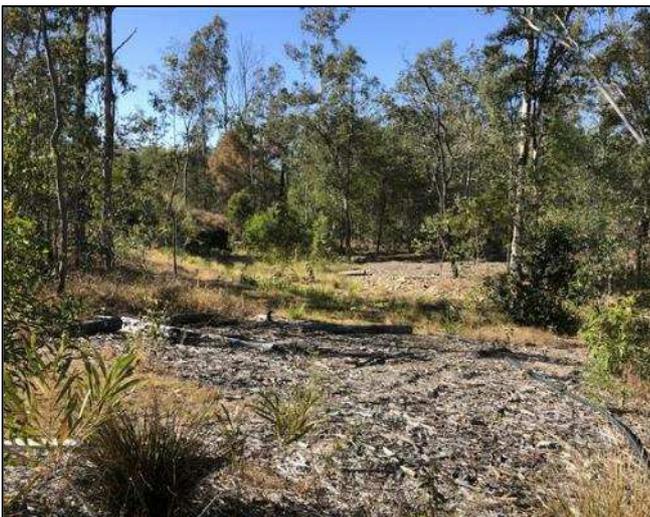
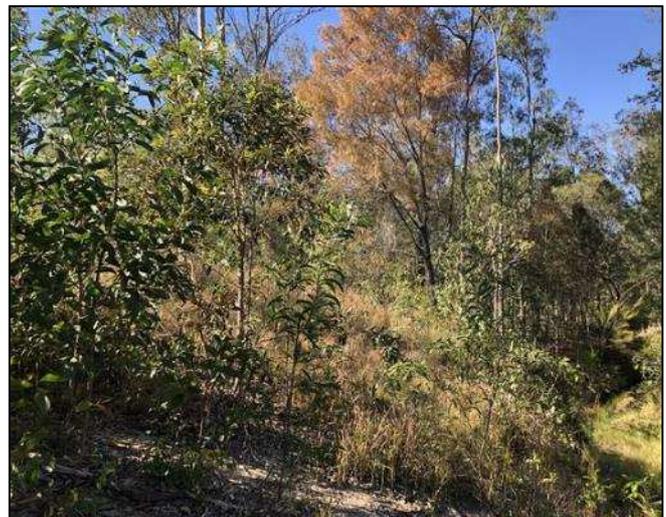
Previously installed logs providing habitat and slowing potential velocity of water flow were observed throughout the creek corridor (refer **Photo set 8**). Natural regeneration of wattle regrowth was also observed along the northern bank of the creek, providing some stability for surface soils during rainfall events and slowing water velocity. Vegetation within Sandy Creek tributary has increased in density since the previous reporting period (**Photo set 9**, **Photo set 10** and **Photo 11**). Some weed removal is required, however, vegetation re-establishment has continued.

Photo set 8: Habitat features (logs) installed during previous reporting period (left); regrowth vegetation along northern edge of creek (right).

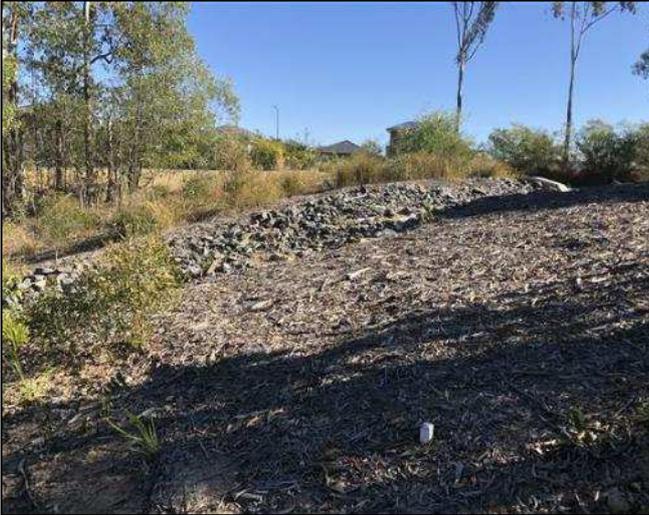
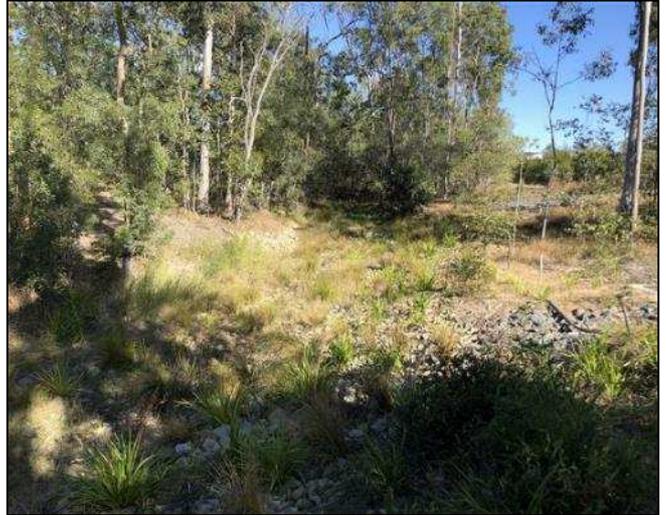
Photo set 9: Rock wall bunding where thick layer of bark has been placed (left); In-stream vegetation present with rocky substrate and surrounded by bushland (right).

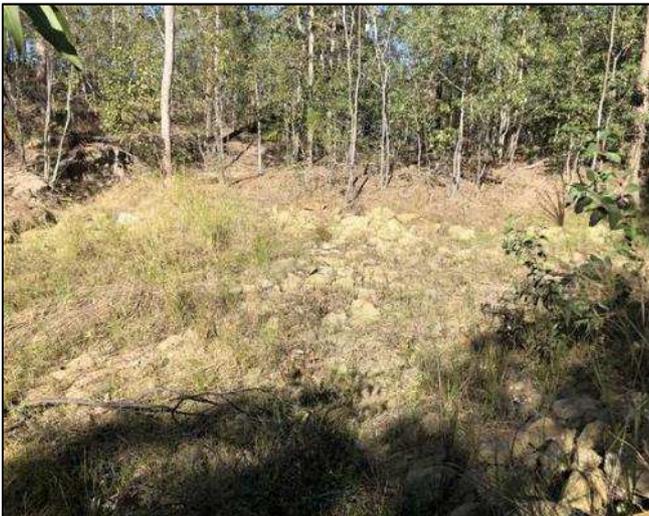
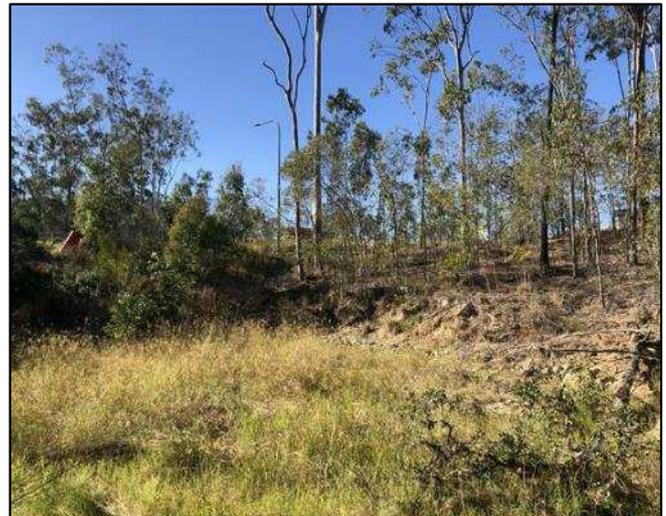
Photo set 10: Installed rock substrate within water holding area adjacent to culvert, and surrounding vegetation characteristics.

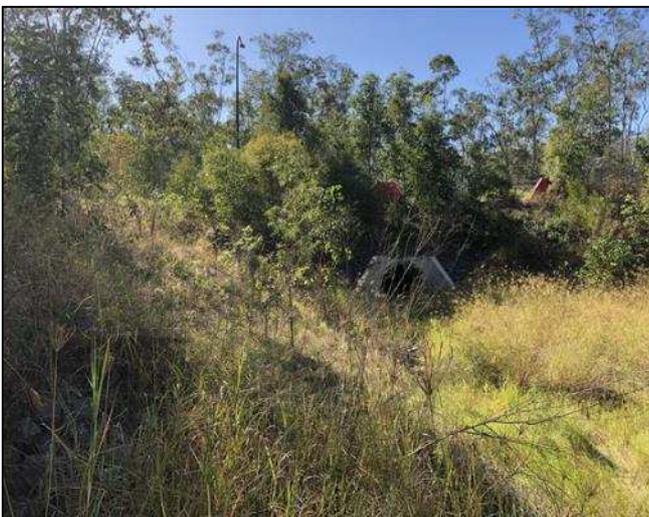
Photo 11: Weed species regrowth within ground layer adjacent to bridge crossing.

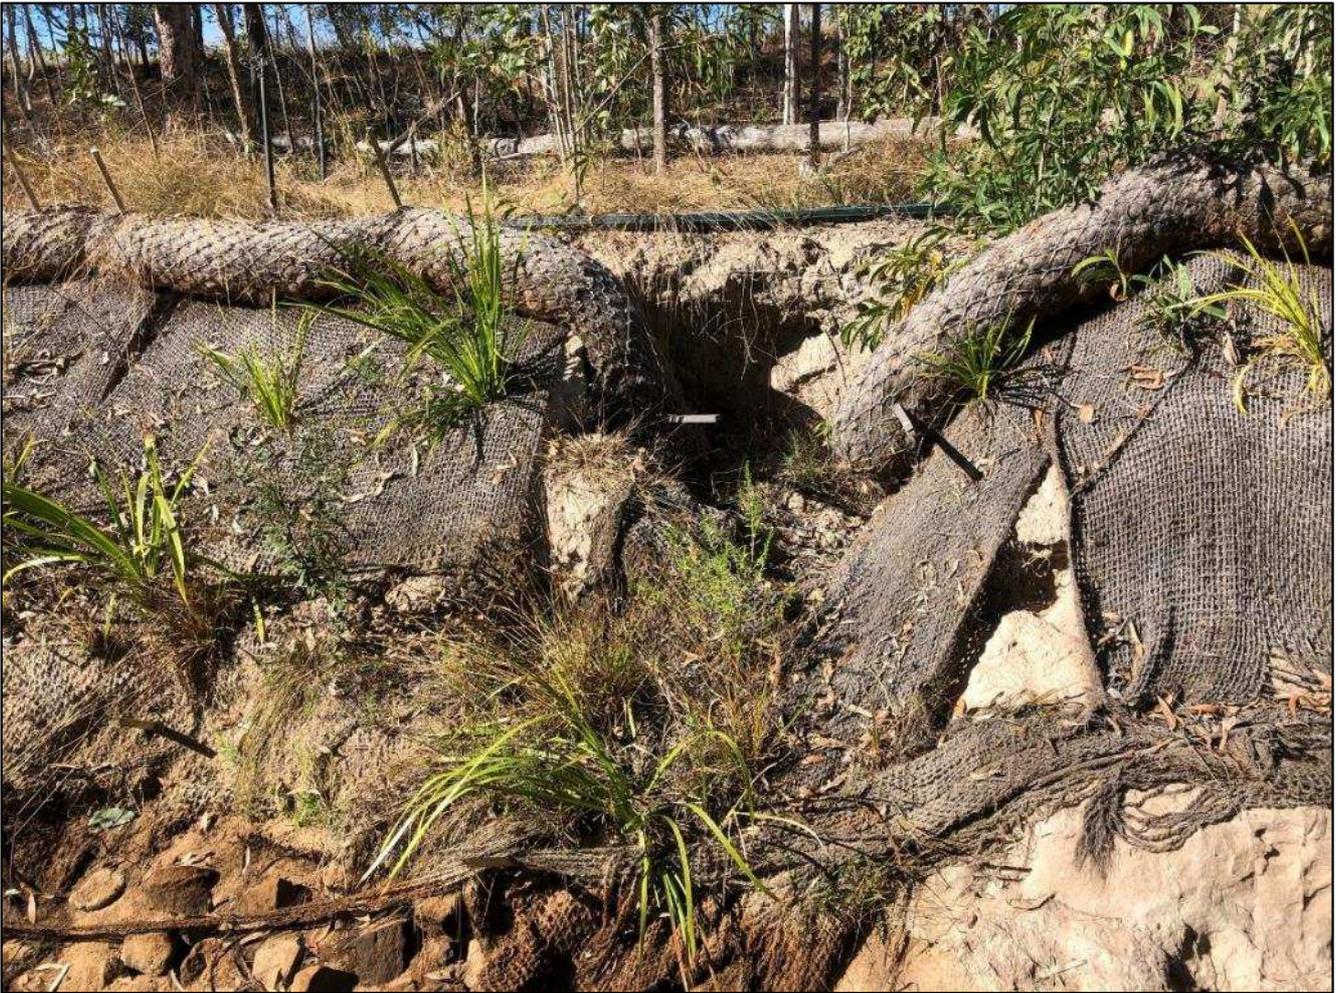
During site inspections, it was noted that in-stream matting to provide bank stabilisation particularly within creek bends requires maintenance. It is anticipated that following high rainfall events, water flow has broken through the matting and slowly eroded the dispersive soils (**Photo 12**). This was observed in a minimal number of isolated areas and damage is considered negligible at this stage. Further, some sediment build-up was noted within drainage entry/exit points (**Photo set 13**).

Photo 12: Matting requires attention in sections along Sandy Creek tributary.

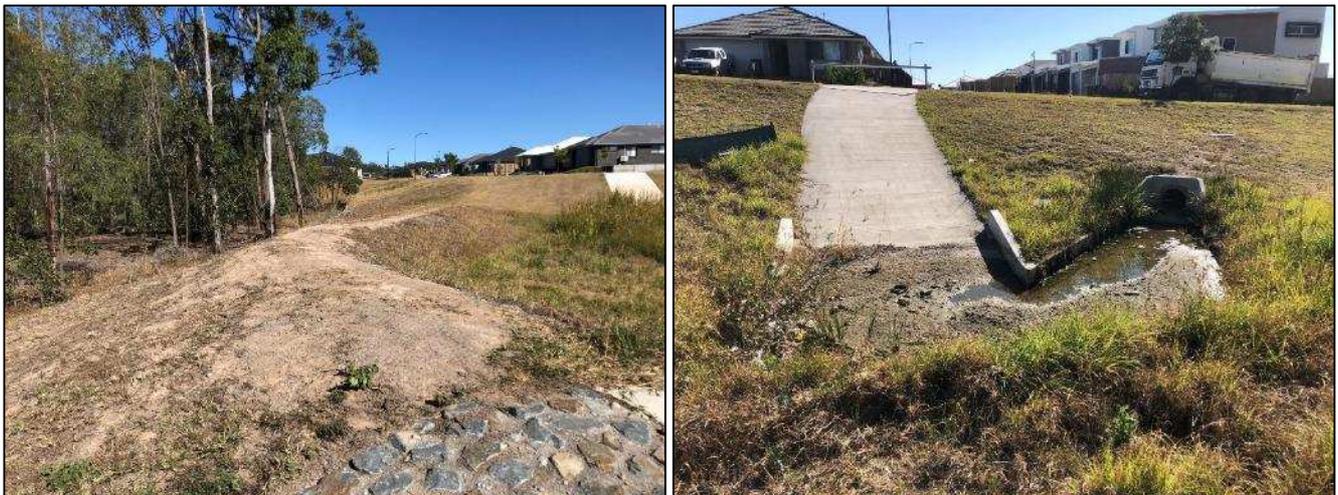
Photo set 13: Bund (left) and sediment build-up within drainage area north of Sandy Creek tributary (right).

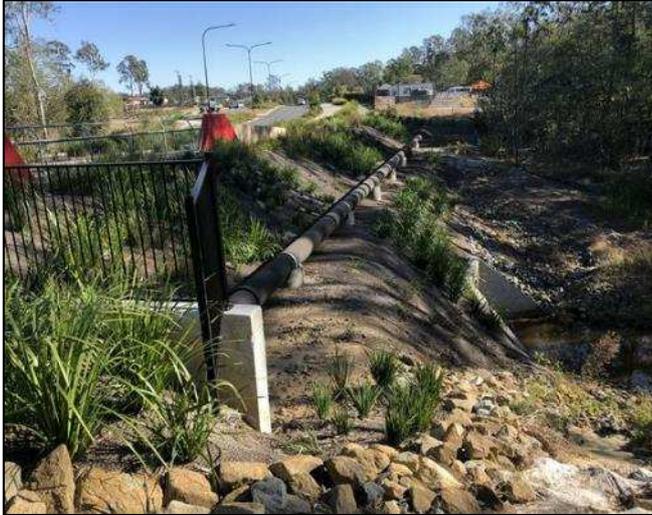
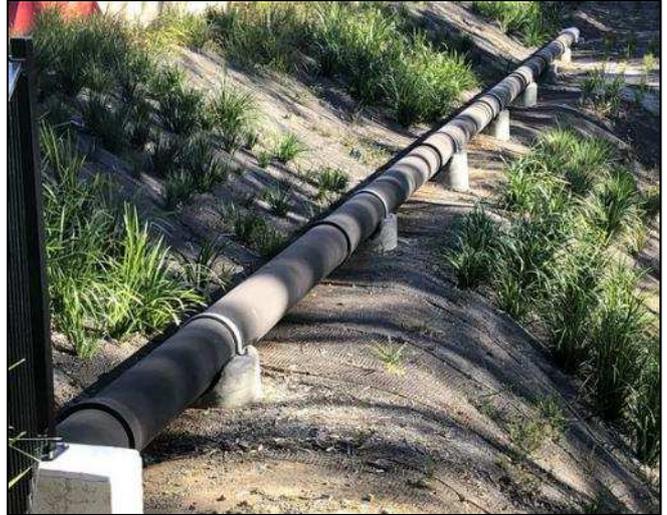
- Revegetation and bank stabilisation works are evident on the eastern side of the bridge on Flagstonian Drive situated at the entrance to the estate. This has included planting of Lomandra species and installation of rocks where run-off is anticipated to occur and within the gully line (refer **Photo set 14** and **Photo 15**). No specific evidence (e.g. scats or tracks) of fauna utilising the culverts beneath the bridge was noted during the brief inspection. However, it is assumed that fauna usage occurs throughout the site due to the observed presence of larger mammals during field survey. Mammals observed were a single European Hare (*Lepus europaeus*) and Eastern Grey Kangaroo (*Macropus giganteus*). In addition, a number of bird species were noted utilising vegetation associated with the creek.

Photo set 14: Rehabilitation works on eastern side of bridge crossing.

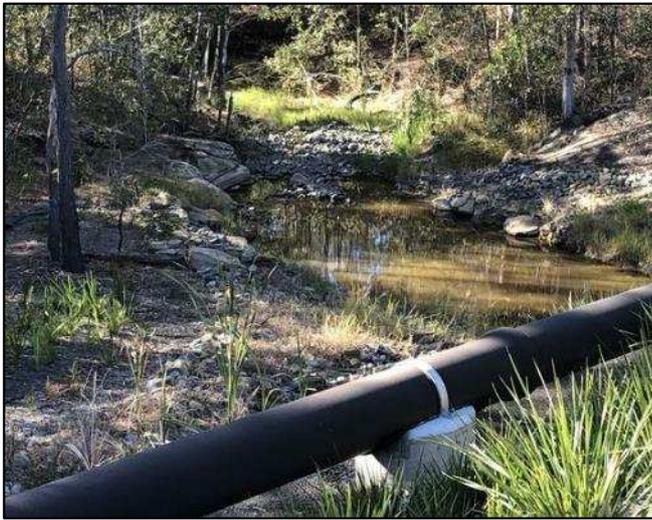
Photo 15: Bank revegetation and installation of larger rock substrate providing habitat features.

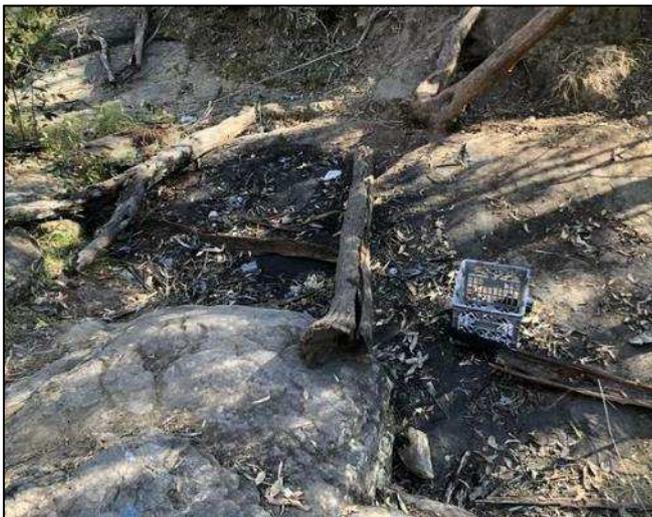
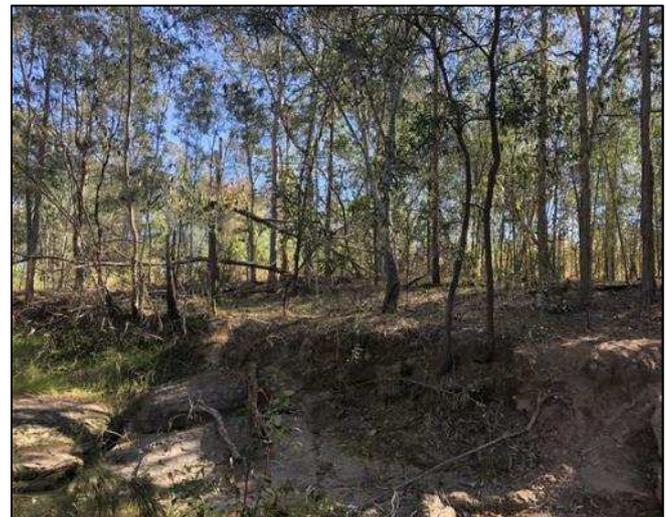
- Continued evidence of rehabilitation works along both the southern and northern banks of the creek was noted during site visit. The section of the creek immediately to the west of the bridge was observed to have highly eroded areas along the creek line and banks. Scattered rubbish items were also observed in-stream (refer **Photo set 16**). Regrowth vegetation is sparse proximal to the bridge.

Photo set 16: Deposited rubbish proximal to bridge crossing (left); eroded banks from high flows (right).

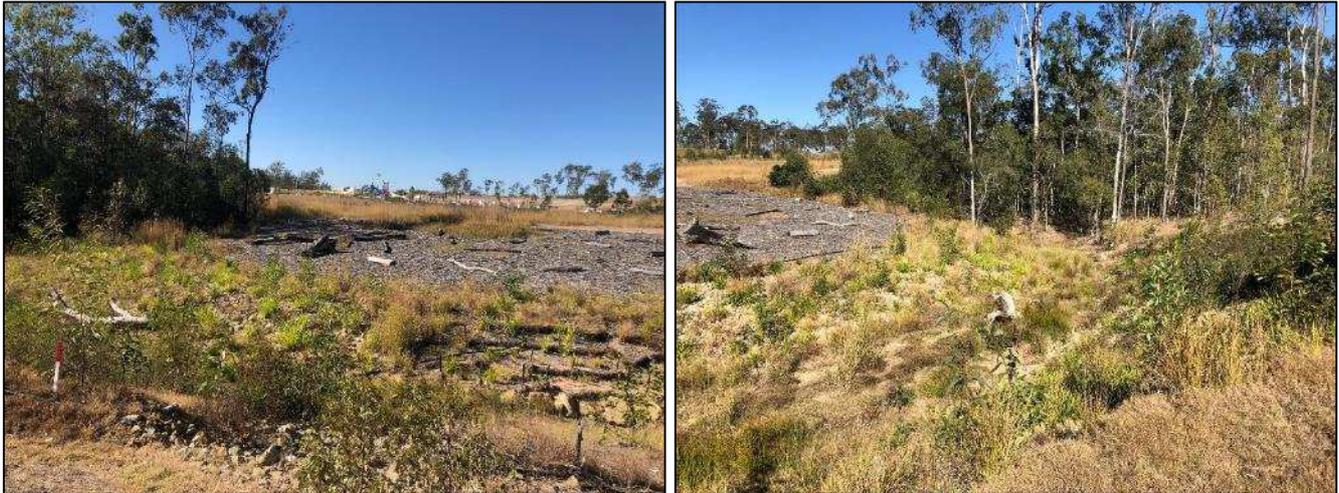
- Rehabilitation efforts further downstream were observed to have become well-established. The density of instream vegetation (*i.e.*, Lomandra species) was noted and a more natural state was reflected (refer **Photos 17-19**).

Photo set 17: Bank stabilisation works and in-stream rehabilitation and stabilisation works.

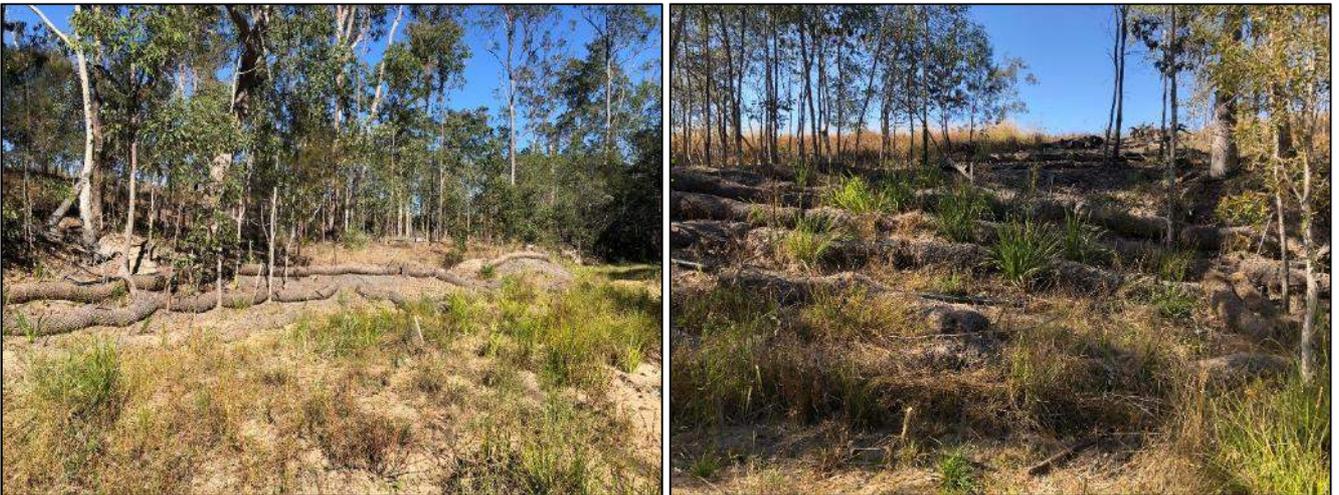
Photo set 18: Bank stabilisation efforts.

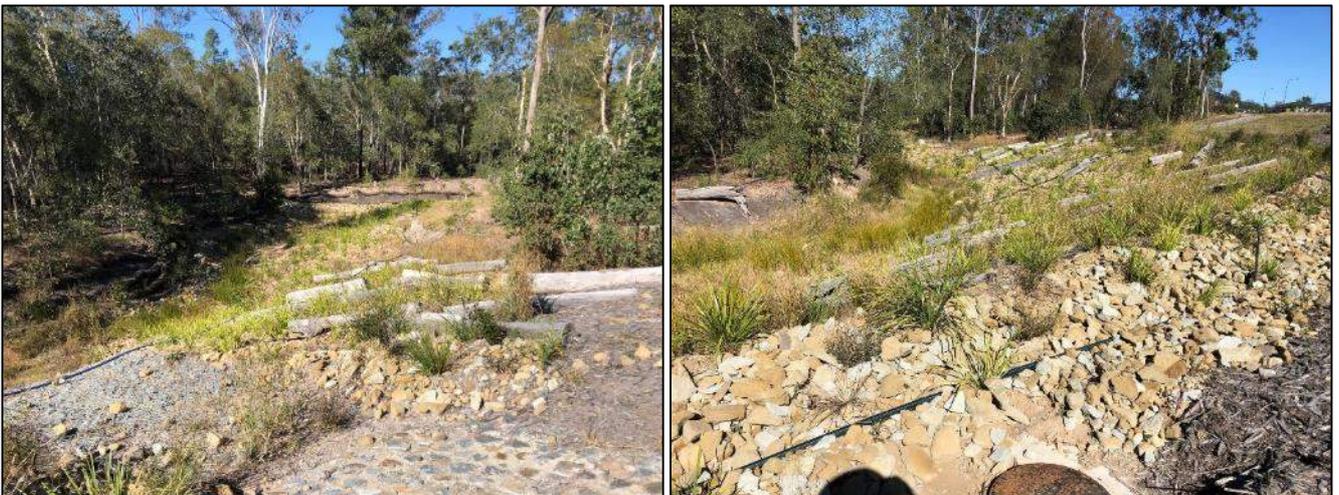
Photo set 19: Rehabilitation works along creek.

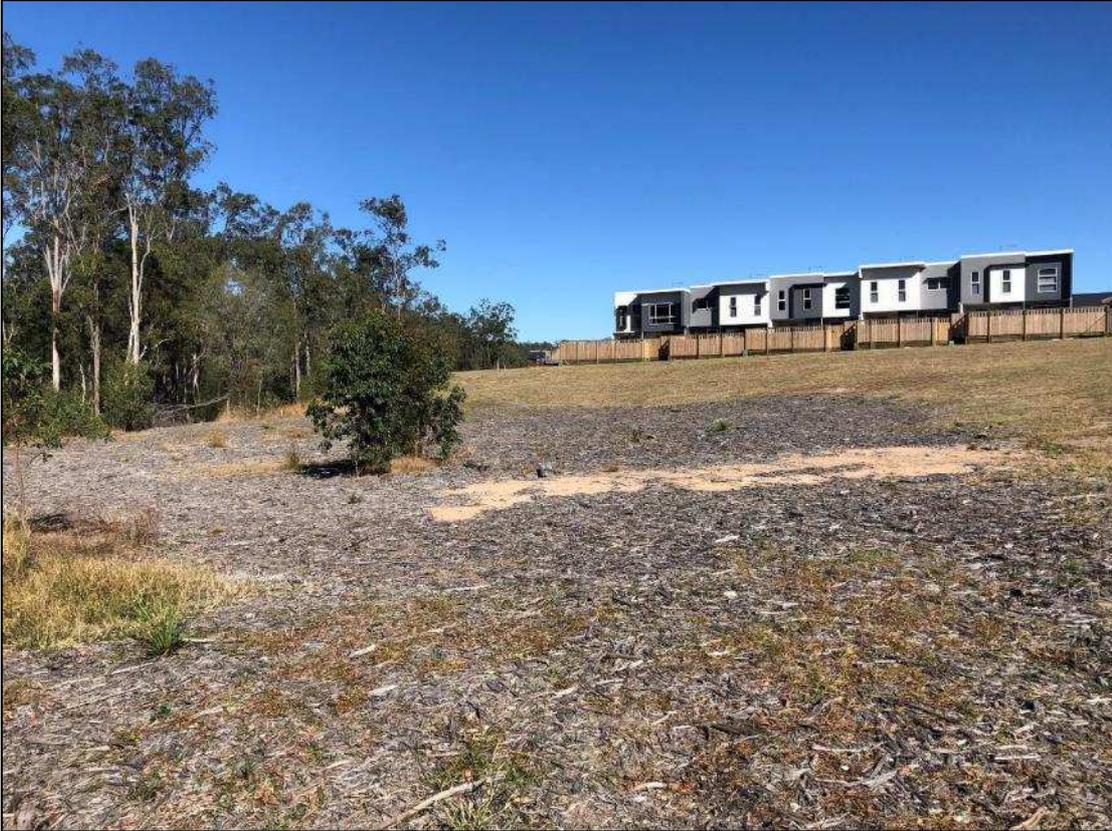
- Areas within the transition zone between the riparian vegetation and adjacent residential dwellings along the northern creek line was observed to be dominated by mulch. Minimal evidence of natural regeneration was noted, and was potentially attributable to the density of mulch laid reducing the capacity for vegetation shoots to re-establish (refer **Photo 20** and **Photo 21**).

Photo 20: Natural vegetation regeneration absent, bark layered quite thickly where Nut Grass and similar flora were observed to be present.

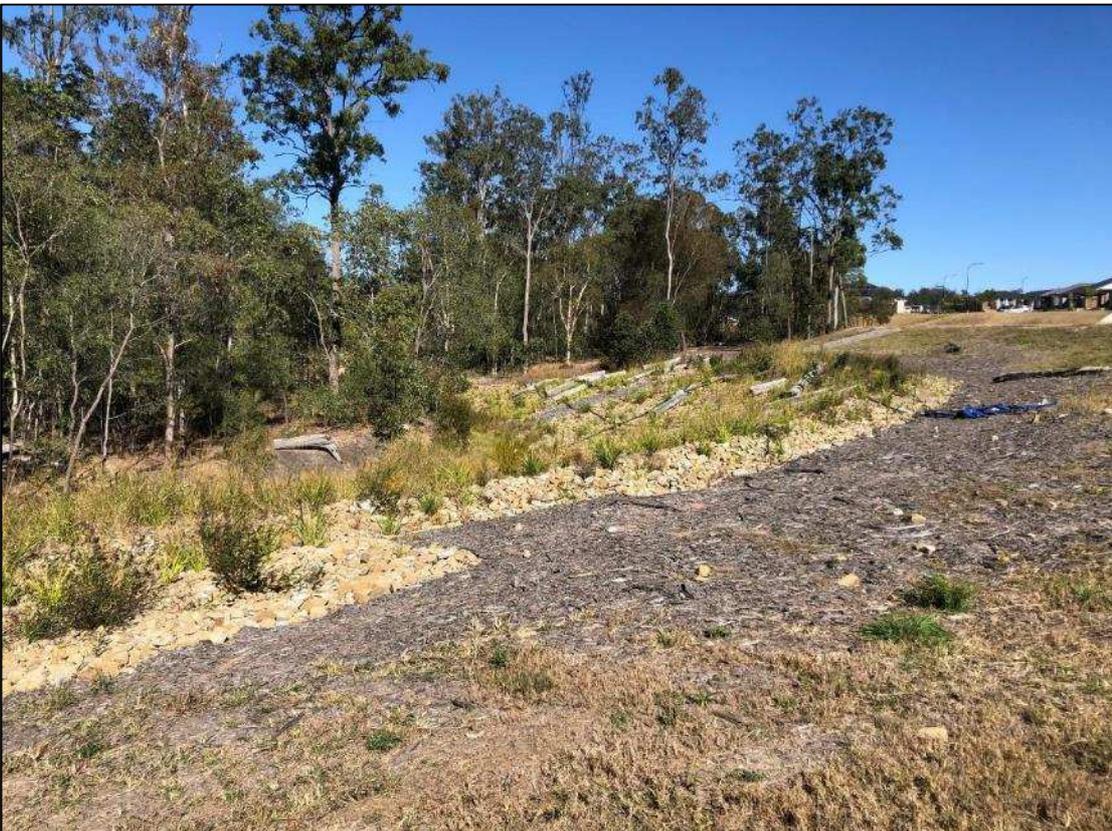
Photo 21: Bank rehabilitation and stabilisation works.

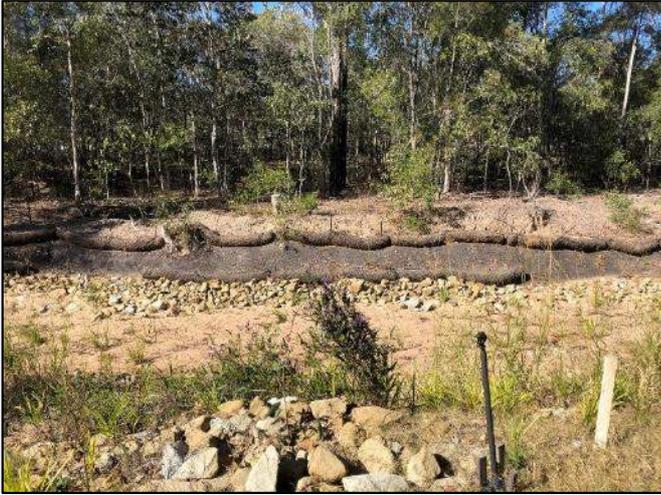
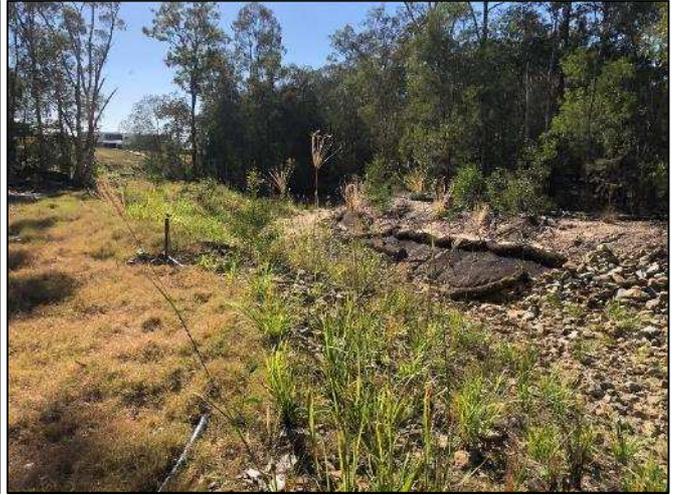
- Bank stabilisation and rehabilitation efforts were mostly observed to be in good condition (**Photo set 22**). Sections within Sandy Creek tributary were observed to have some sediment build-up, which will require attention during the following reporting period (**Photo set 23**).

Photo set 22: Bank stabilisation and rehabilitation works.

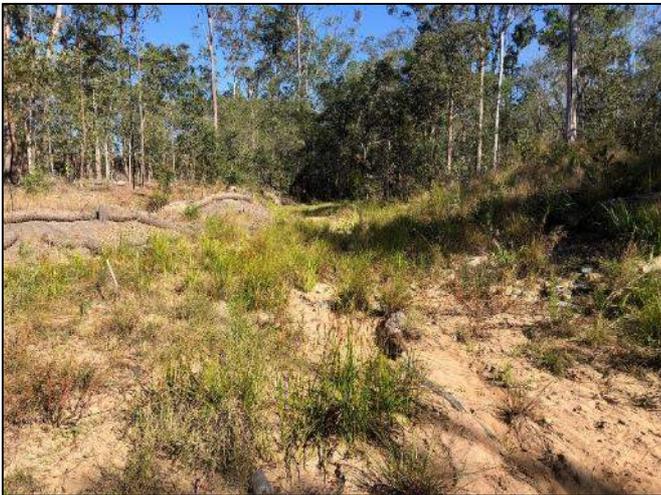
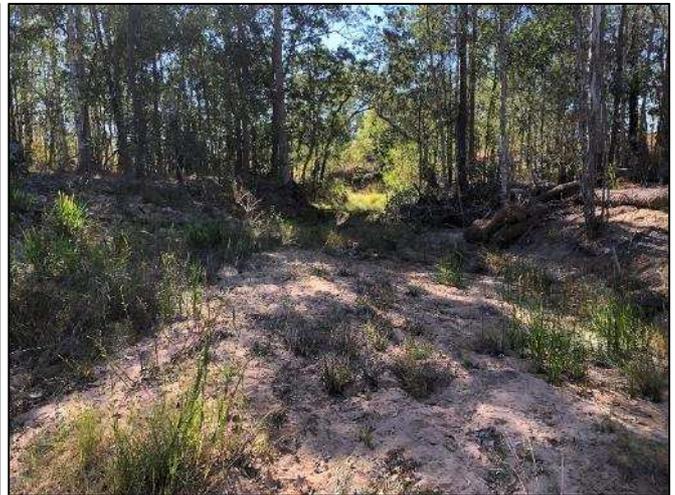
Photo set 23: Sediment build-up in-stream.

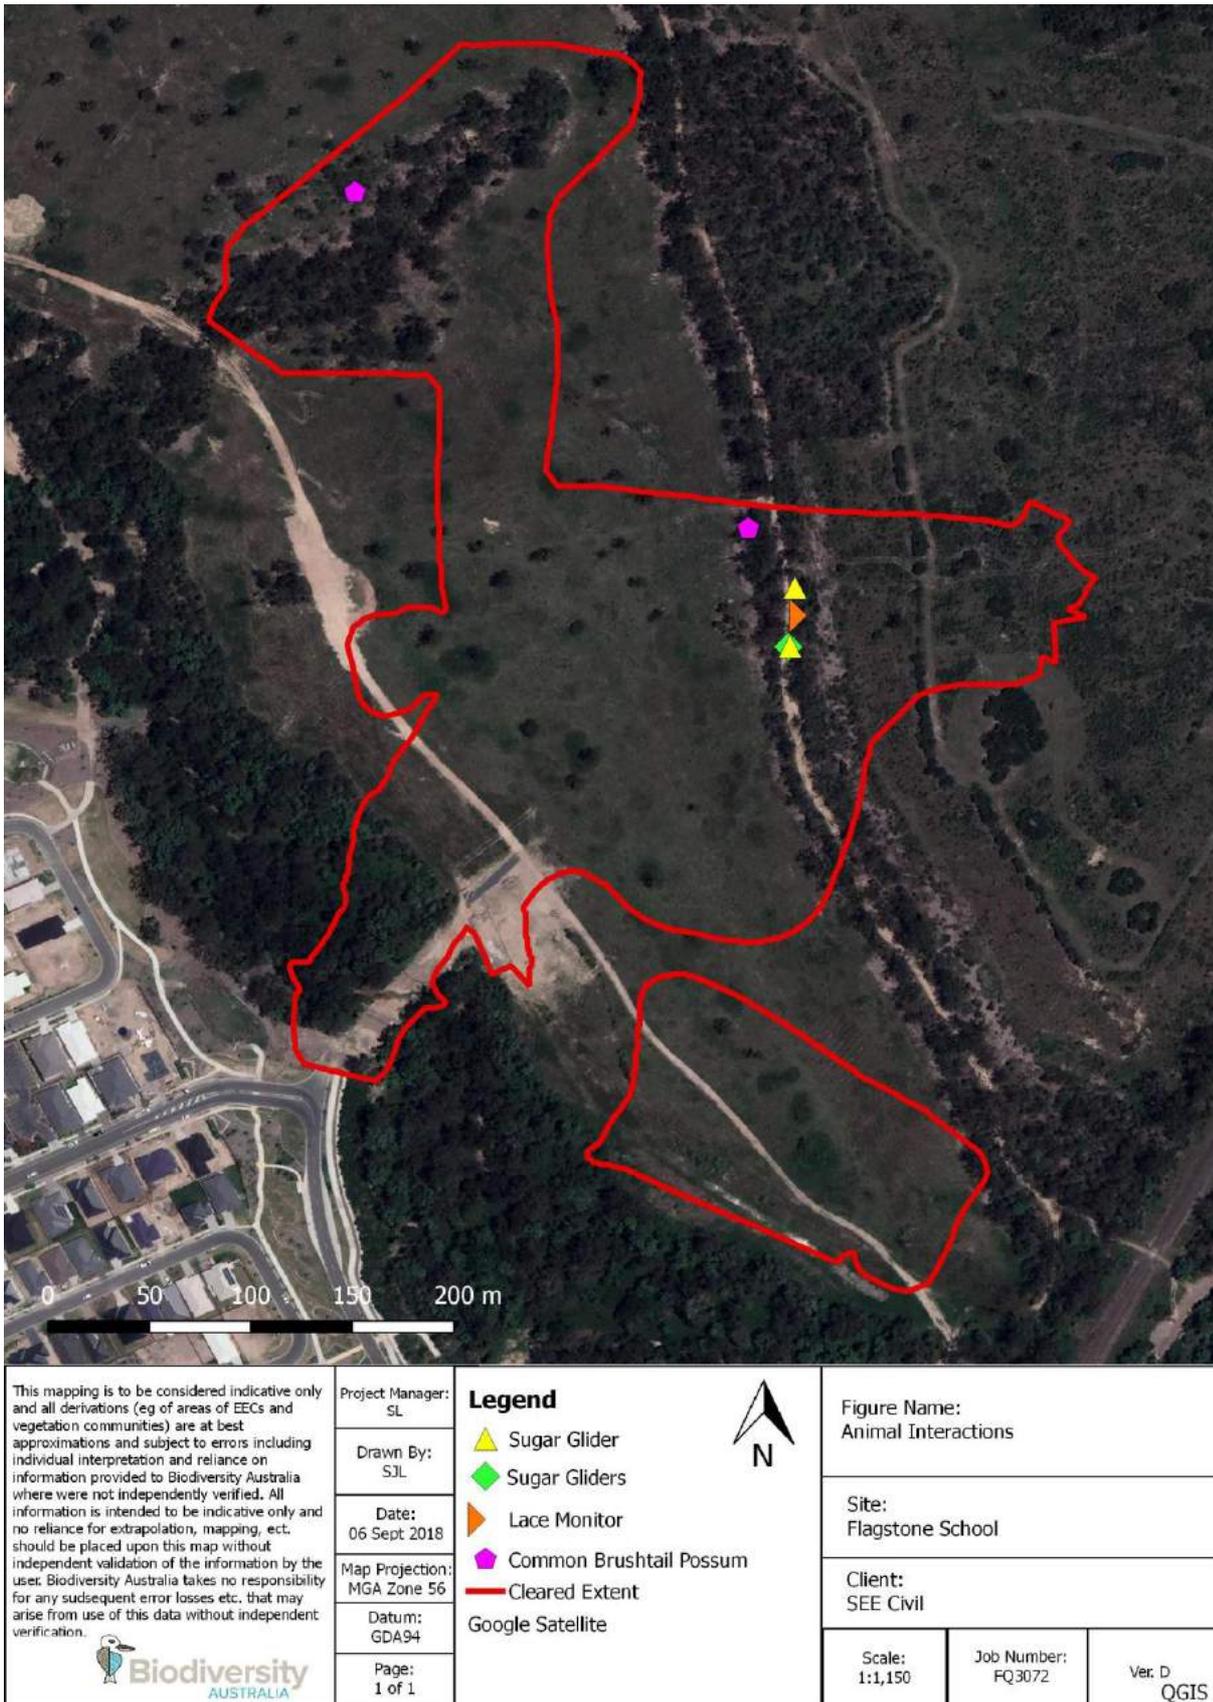
Figure 1: Animal interactions recorded at Flagstone School

Fauna interactions and the approximate area cleared of vegetation is illustrated in Figure 1, below:
