Brisbane Office
Job No: DL16/220
Ref No: 11122
Author: L. Slater

16th November, 2016

**RE: LEVEL ONE COMPLIANCE REPORT FOR
BULK EARTHWORKS FILLING OPERATIONS
FLAGSTONE CITY STAGE 1D,
JIMBOOMBA**

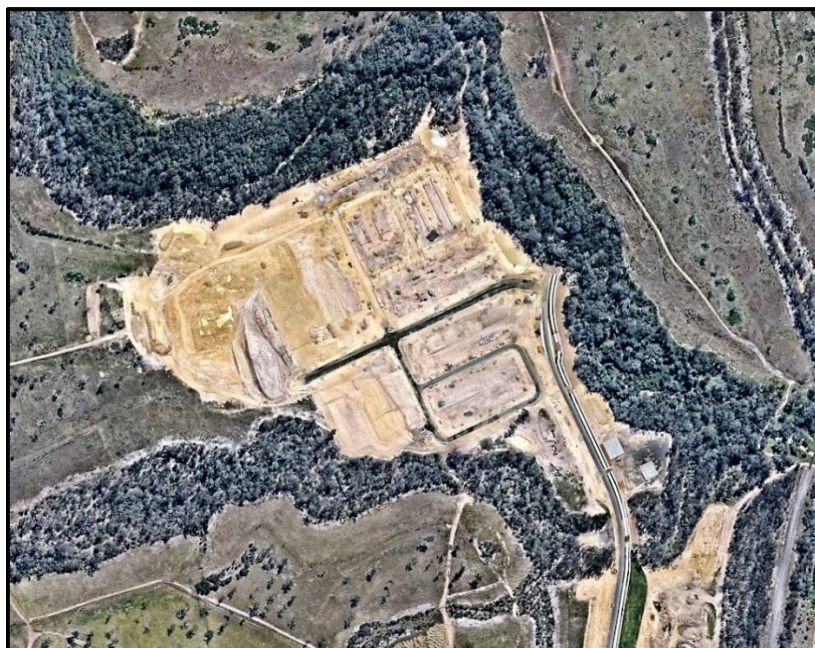
Picture 1: Aerial View of the Site (Image Source: Nearmap.com)

The Site is bounded by future residential developments to the North and to the East, and undeveloped land to the South and West.

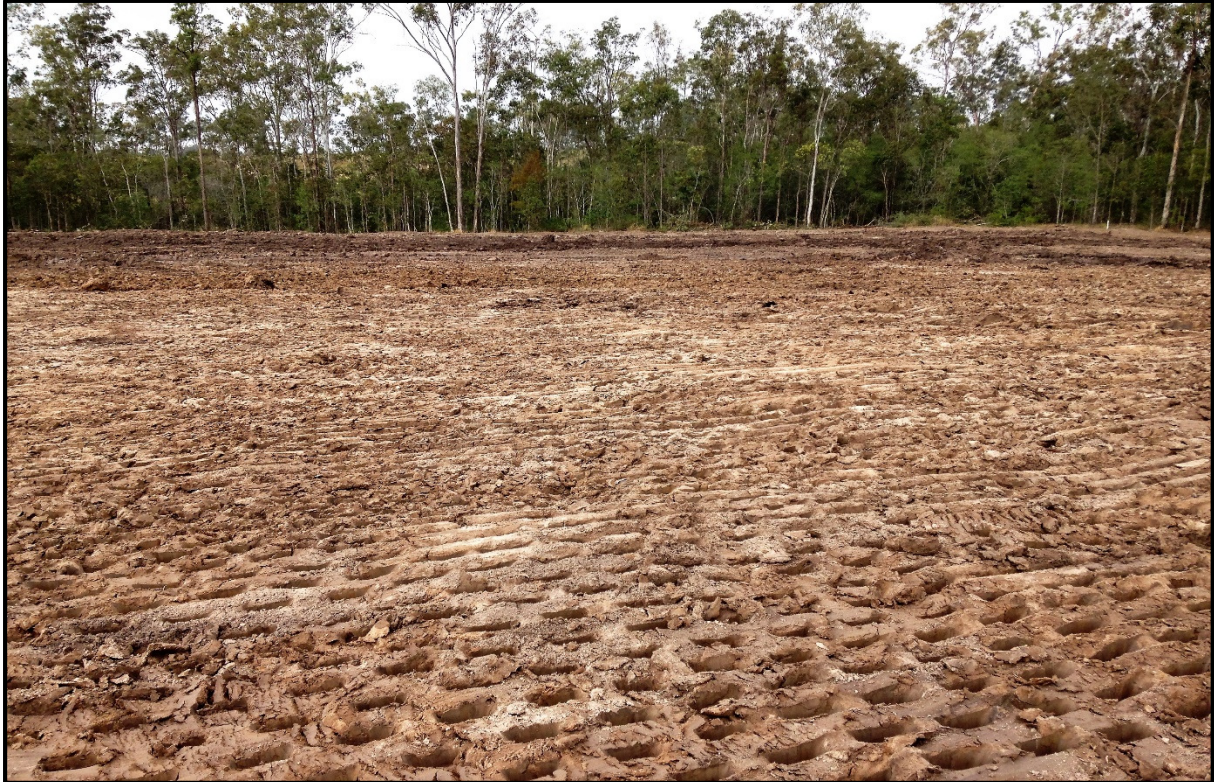
Picture 2: View of the Stripped Surface Prior to Filling Operations

The fill areas at The Site were observed to be stripped and cleared of all visible organic matter, deleterious, loose and unsuitable materials to depths exposing competent ground.

- Sandy Clay (CI-CH) Very stiff to hard, medium to high plasticity, fine to medium grained sand, grey brown mottled red and moist.

- Walk over assessments confirming that the competent ground was exposed.
- Proof roll testing using large sized truck carrying out multiple passes confirming no movement of the exposed natural foundation and existing fill.

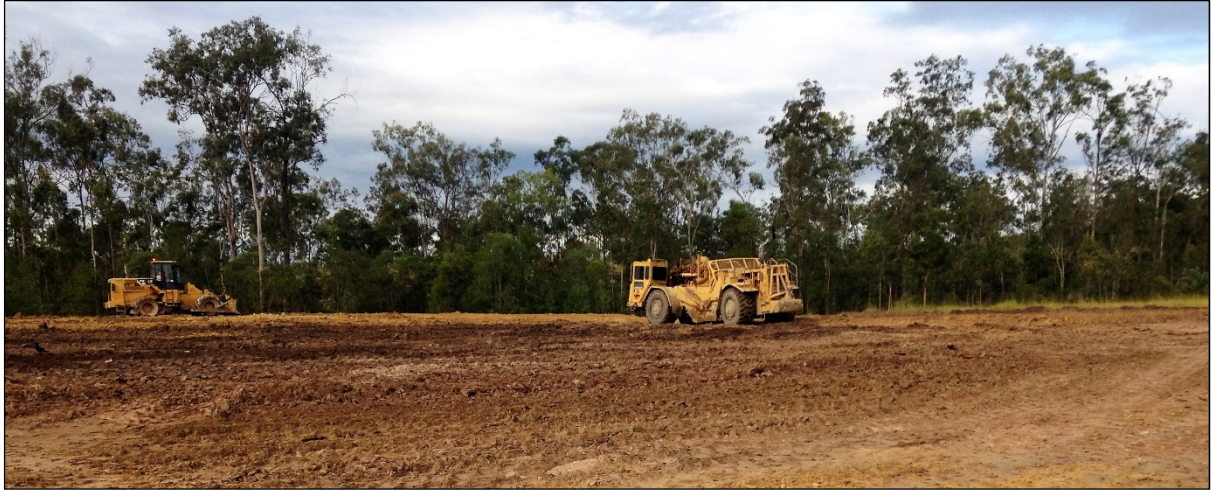
Picture 3: View of the Site During Construction

- Sandy Clay (CI), low to medium plasticity, fine to coarse grained sand, grey orange brown.

Placement of the fill materials was carried out in layers appropriate for the above plant and compacted using the above plant carrying out multiple passes.

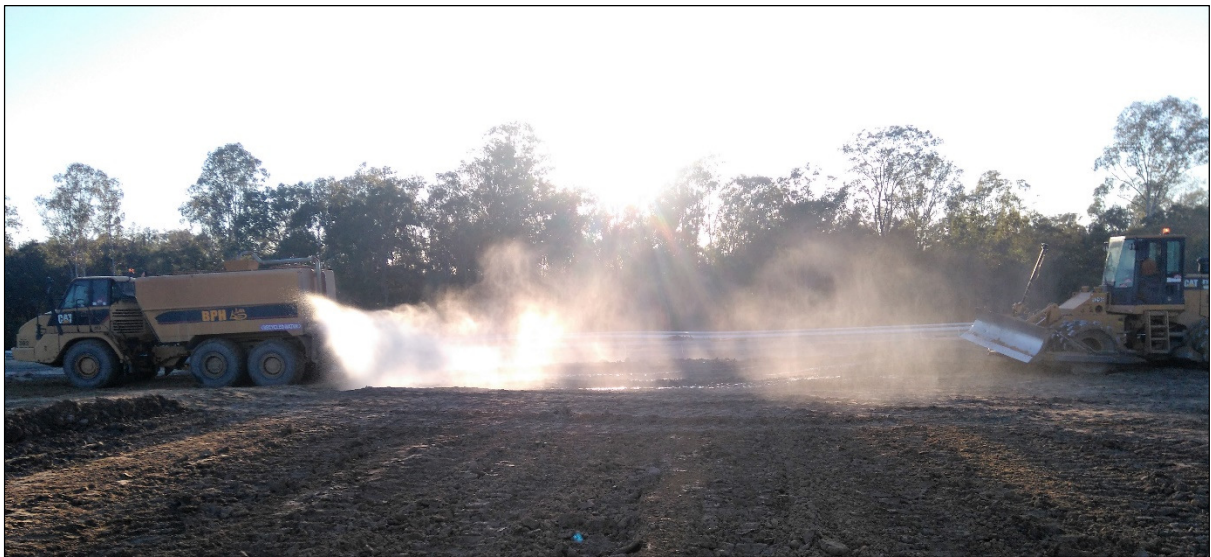
Picture 4: View of the Site During Construction

Our representative observed the filling process as described above and was assessed to be consistent for the entire thickness of fill.
