# Annual Compliance Report

10 June 2019 to 9 June 2020 EPBC 2014/7206  
Flagstone West Urban Development Project,  
Flagstone, Queensland  
Peet Flagstone City Pty Ltd  
09 September 2020

Document: Annual Compliance Report 10 June 2019 to 9 June 2020 EPBC 2014/7206, prepared by Saunders Havill Group for Peet Flagstone City Pty Ltd, dated 09 September 2020.

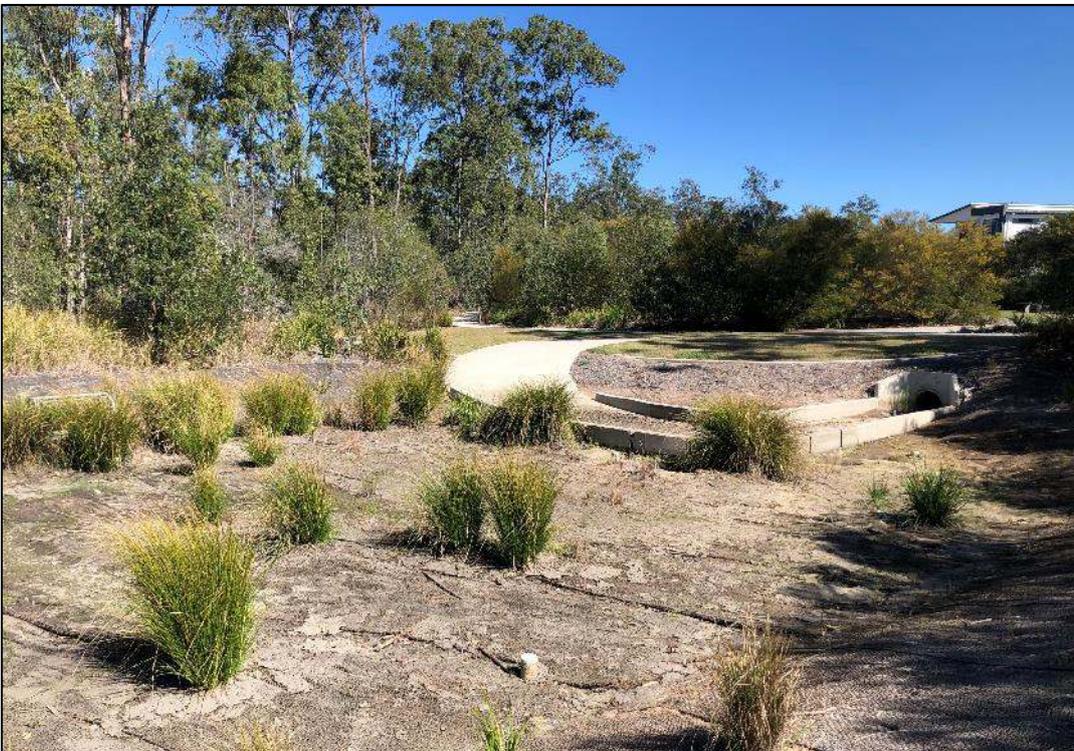
**Photo 1: Detention basin adjacent to dog park in south-eastern extent.**

Stabilisation works observed during the site visit associated with the last reporting period were observed, where the majority are well established with some maintenance required. Detention basins previously established along the interface between residential development and the tributary branching from Sandy Creek were inspected. A small amount of litter and sediment deposition was observed within the detention basins, and re-establishment of flora species incorporated to assist in water filtration and mitigation of flow velocity was continued to be observed (refer **Photo 1** and **Photo 2**).

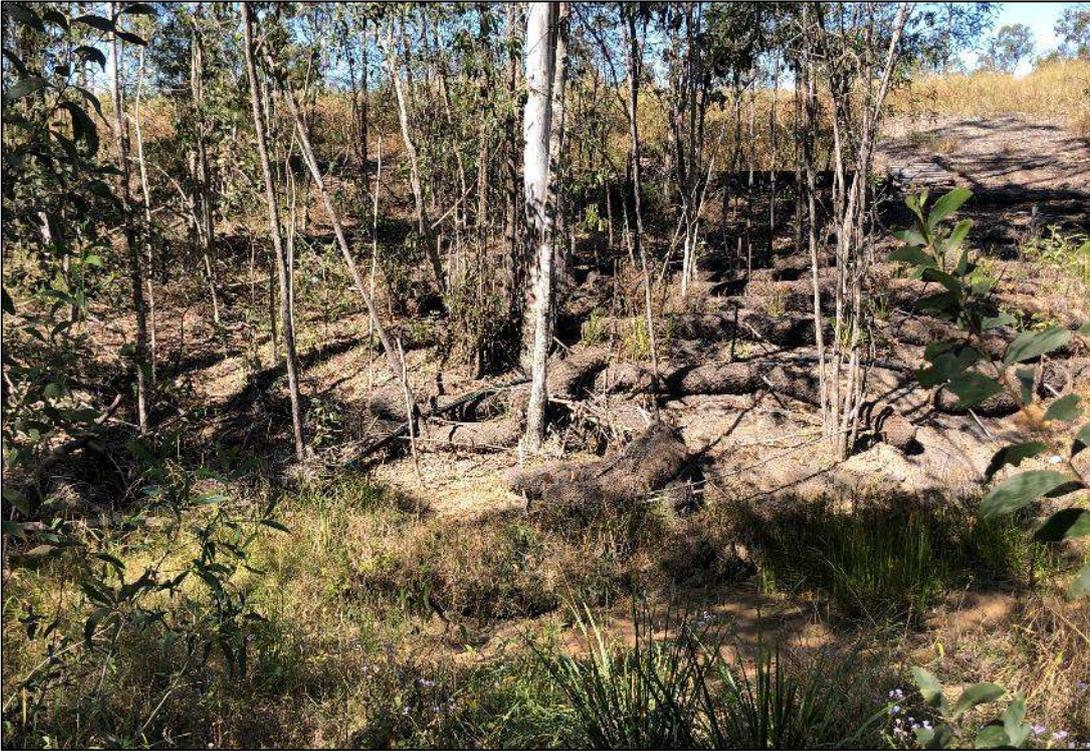
**Photo 3: Bank stabilisation requiring minor maintenance.**

During site inspections, it was noted that in-stream matting to provide bank stabilisation particularly within creek bends requires maintenance. It is anticipated that following high rainfall events, water flow has broken through the matting and slowly eroded the dispersive soils (refer **Photo 3**). This was observed in a minimal number of isolated areas and damage is considered negligible at this stage.

In response to the observed maintenance issues, Peet are liaising with the landscape contractor to rectify the issues.

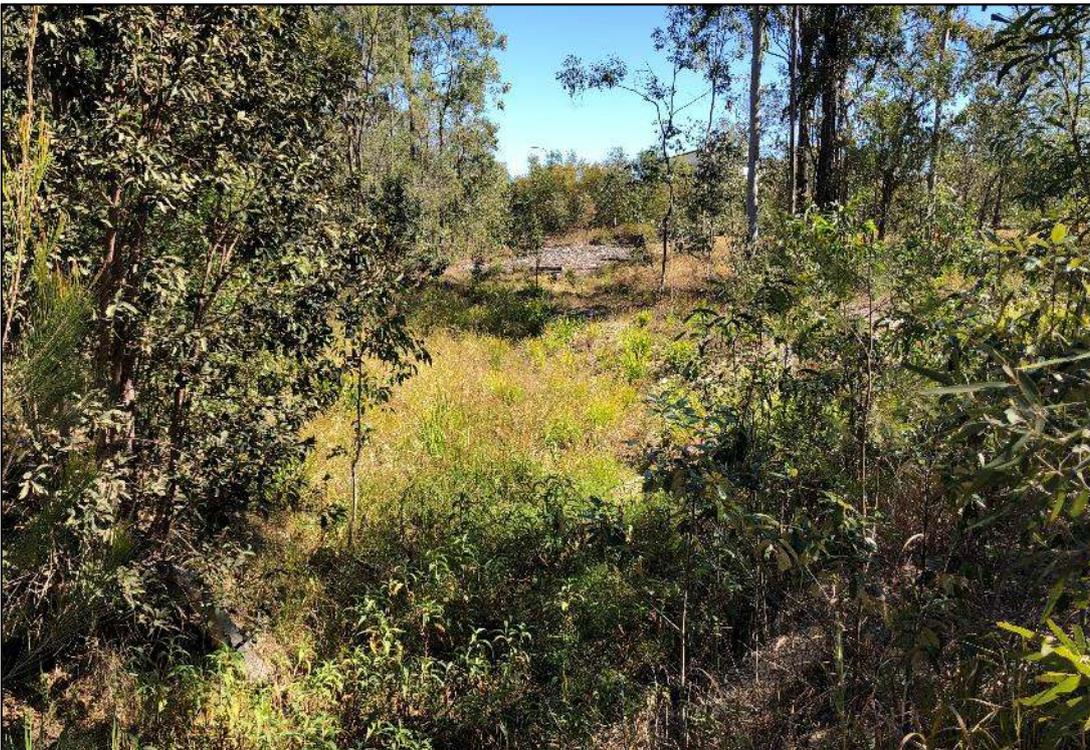
**Photo 4: Natural regeneration along the tributary.**

Previously installed logs providing habitat and slowing potential velocity of water flow were continued to be observed throughout the creek corridor. Natural regenerating wattle regrowth along the northern bank was observed to be more established compared to the previous inspection (refer **Photo 4**). In addition, flora within the ground layer such as *Lomandra* spp. and grasses were observed to have re-established, providing enhanced stability for surface soils during rainfall events and slowing water velocity. Some weed removal is required, however, vegetation re-establishment has continued.

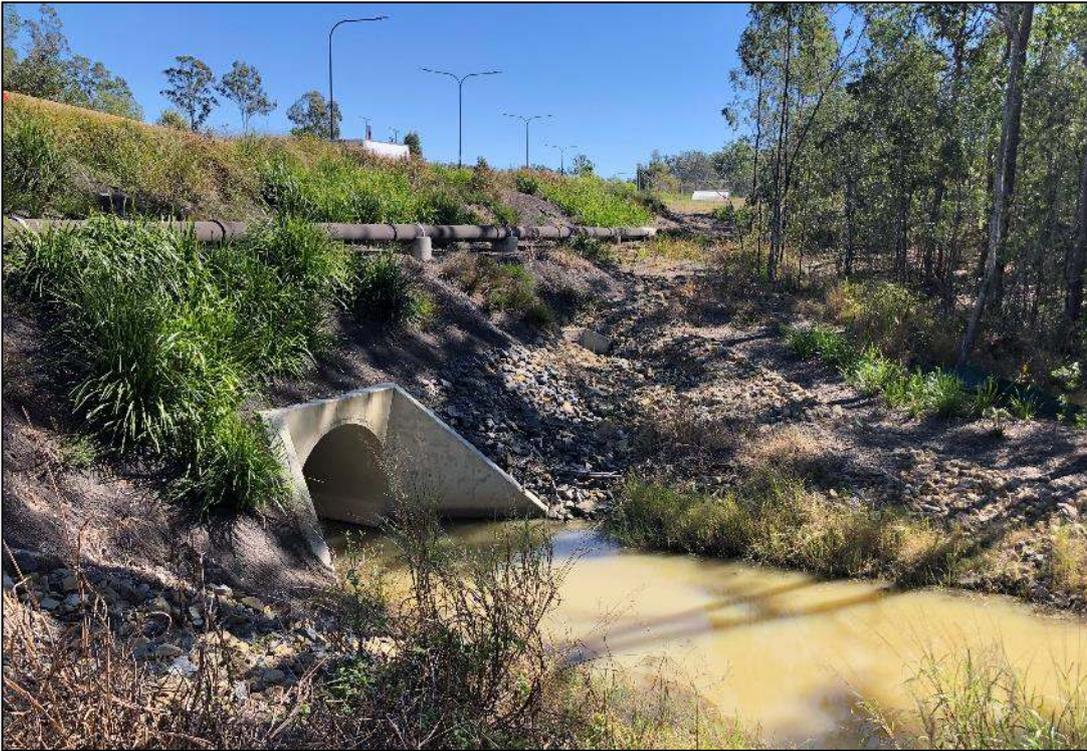
**Photo 5:        Rehabilitated area on the eastern side of Flagstonian Drive bridge crossing.**

- Maintenance of revegetation and bank stabilisation works implemented during the previous reporting period on the eastern side of the bridge on Flagstonian Drive situated at the entrance to the estate was observed. Previously planted *Lomandra* species are now well established and stabilisation of the bank and into the gully line was recorded (refer **Photo 5**). The western side of the bridge was observed to have a build-up of sediment deposition that was covered in grass species.

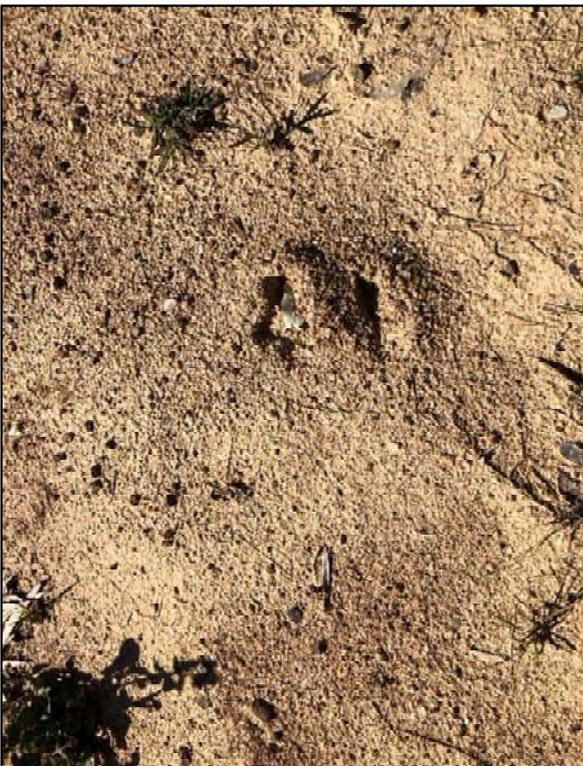
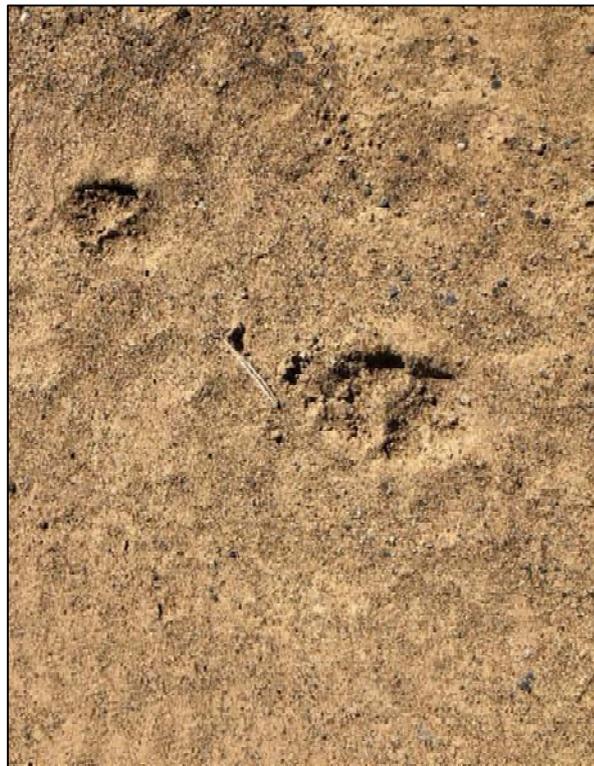
**Photo set 6:        Example of fauna tracks on-site in the waterway corridors.**

- Evidence of rehabilitation associated with the bridge crossing connecting Flagstonian Drive to the future residential area to the north-east of Sandy Creek. Evidence of fauna utilising the culverts beneath the bridge was noted during the brief inspection. This was in the form of tracks adjacent to and within the culverts (refer **Photo set 6**). Tracks observed are from Fox, Dog, species within the *Macropus* genus, and unidentifiable bird species.

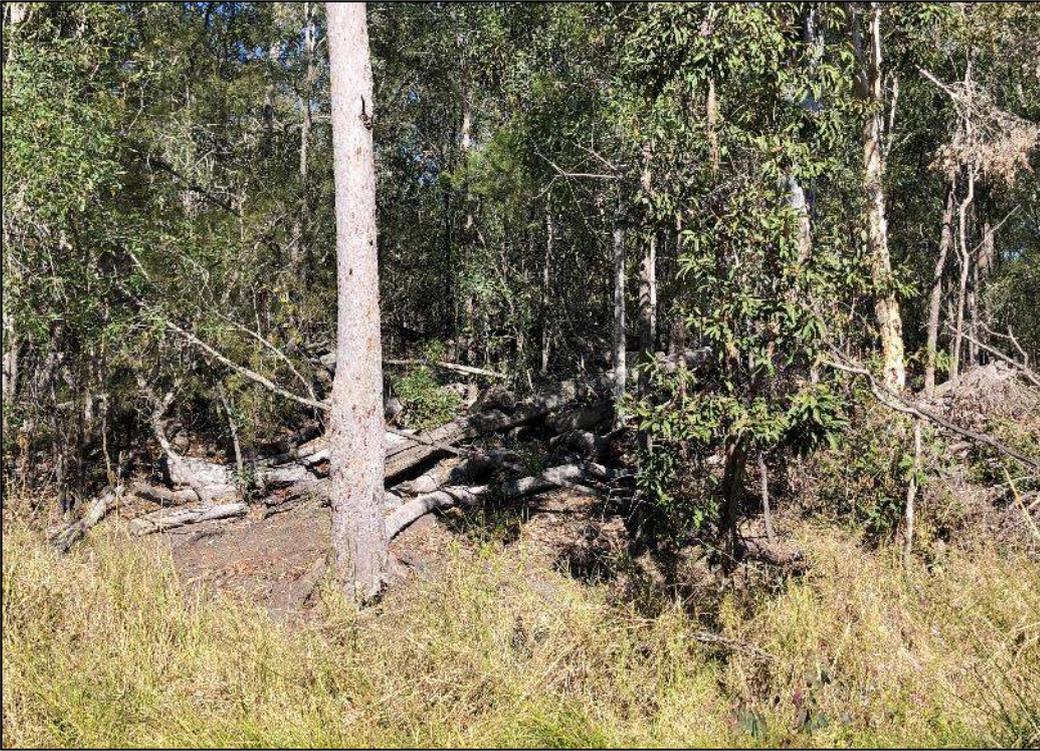
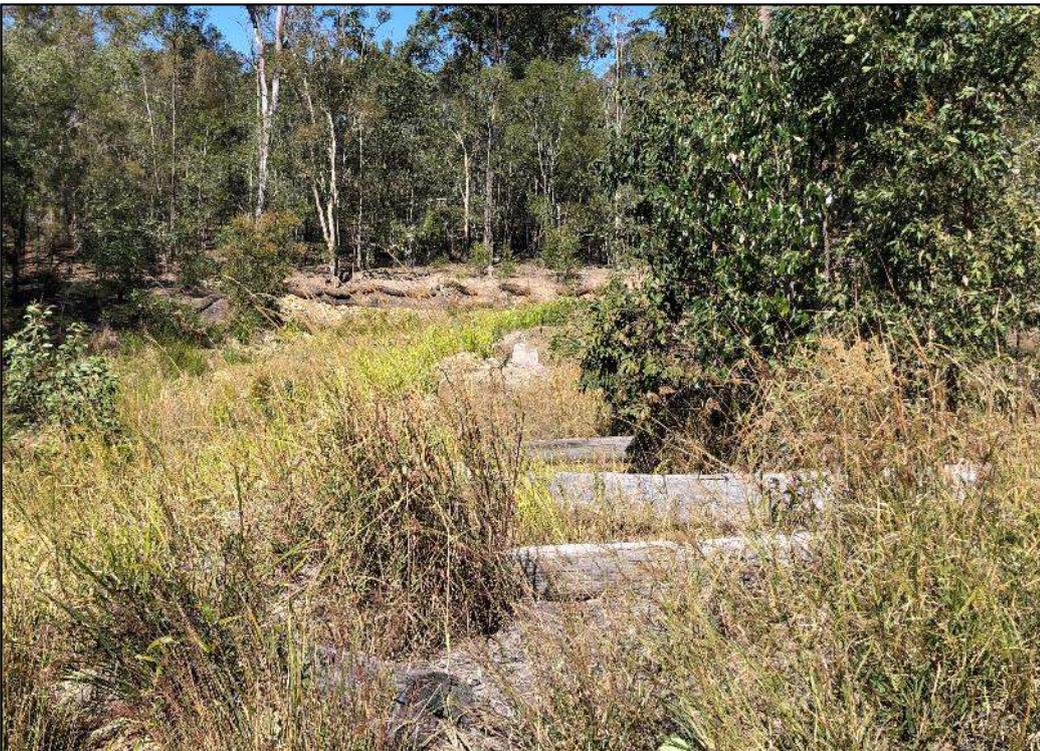
**Photo set 7: Example of log placement across the tributary corridor.**

- Pre-existing fauna management measures were continued to be observed along and abutting the banks of the tributary creek – consisting largely of the placement of logs and small piles of previously felled trees (refer **Photo set 7**). This area was identified as functioning fauna habitat, where shelter and protection from weather and potential predators was abundant.

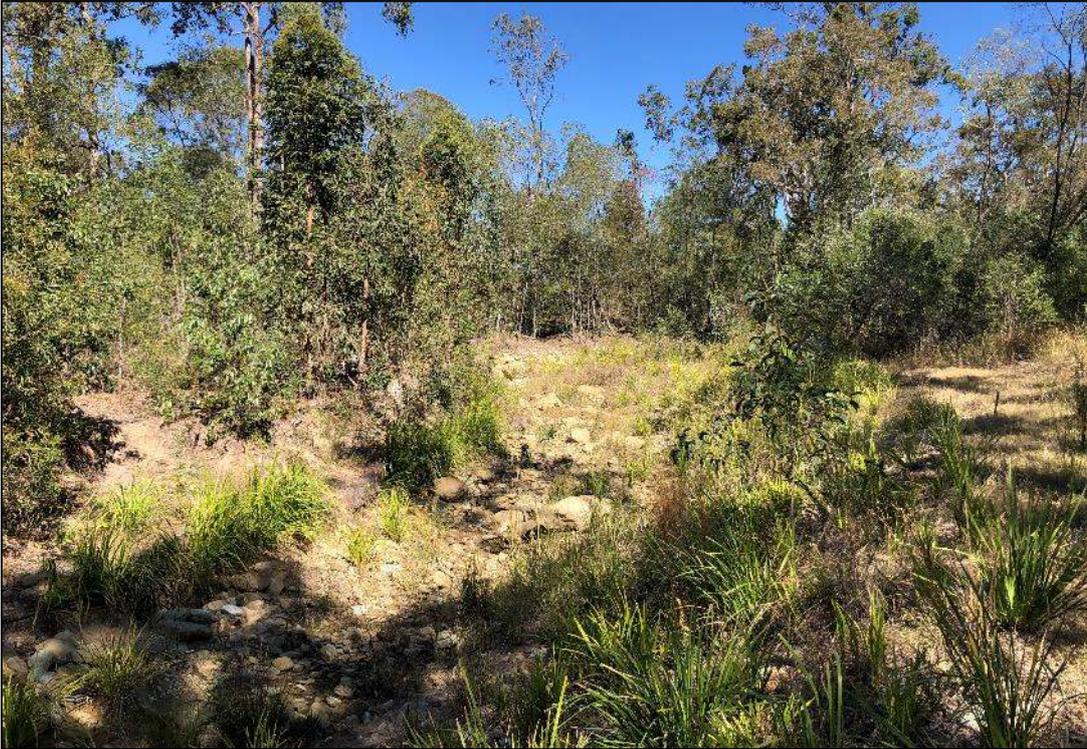
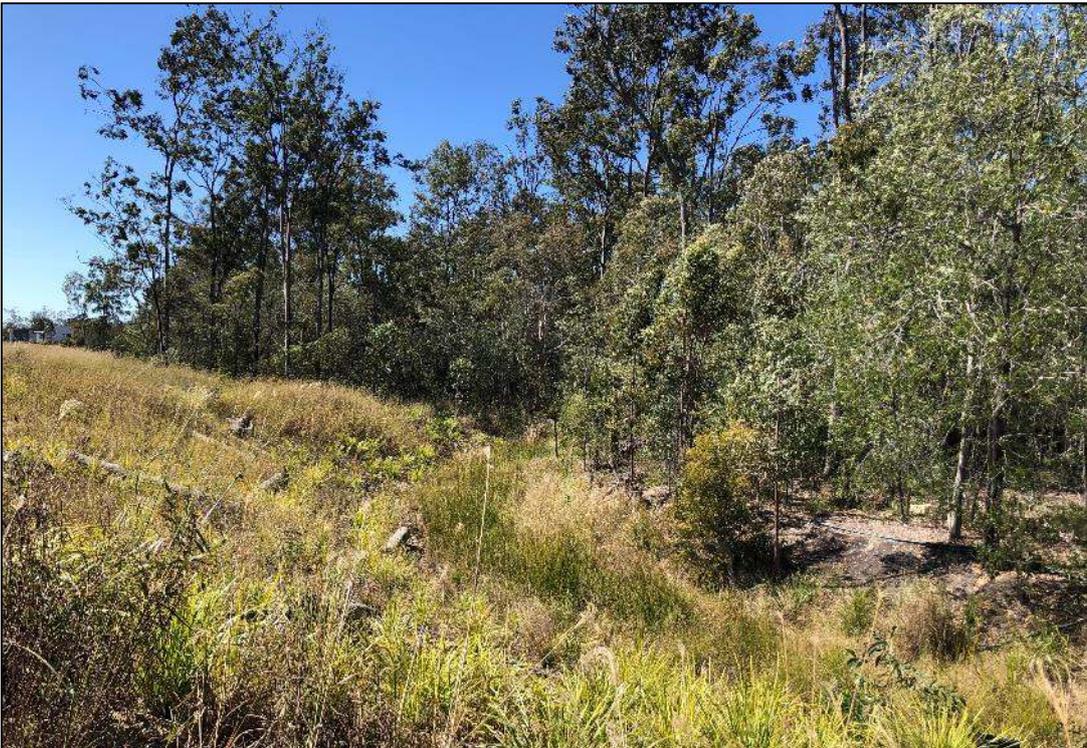
**Photo set 8: Re-established instream vegetation density.**

- Continued evidence of rehabilitation works along both the southern and northern banks of the tributary was noted during site visit. New rehabilitation efforts further upstream were observed to have become well-established. The density of instream vegetation (*i.e.*, *Lomandra* species) was noted and a more natural state was reflected (refer **Photo set 8**). Overall, bank stabilisation and rehabilitation efforts were mostly observed to be in good condition.

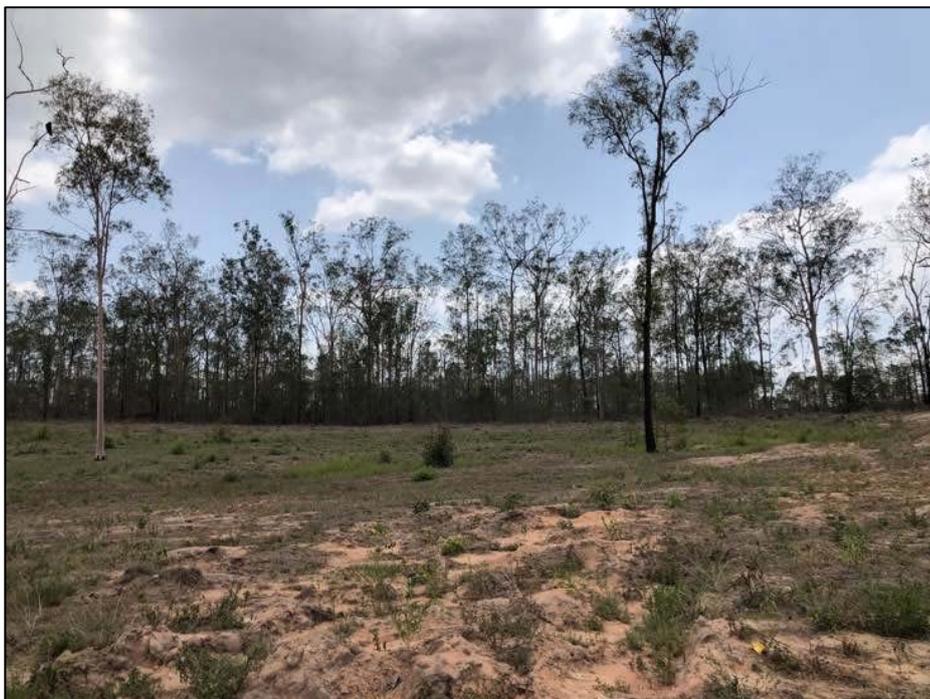
Vegetation on site is a mix of open and closed eucalypt woodland (**Photo Plate 1 and Photo Plate 2**). The canopy is generally sparse, approximately 50-100 years of age. Canopy species included Grey Ironbark (*Eucalyptus siderophloia*), Narrow-leaved Ironbark (*E. crebra*), Spotted Gum (*Corymbia Citriodora* subsp. *Variegata*), Gum-topped Box (*E. moluccana*), Moreton Bay Ash (*C. tessellaris*), Pink Bloodwood (*C. intermedia*), and Smooth-barked Apple (*Angophora leiocarpa*).

**Photo Plate 1: Vegetation composition within an area of the clearing site extent**

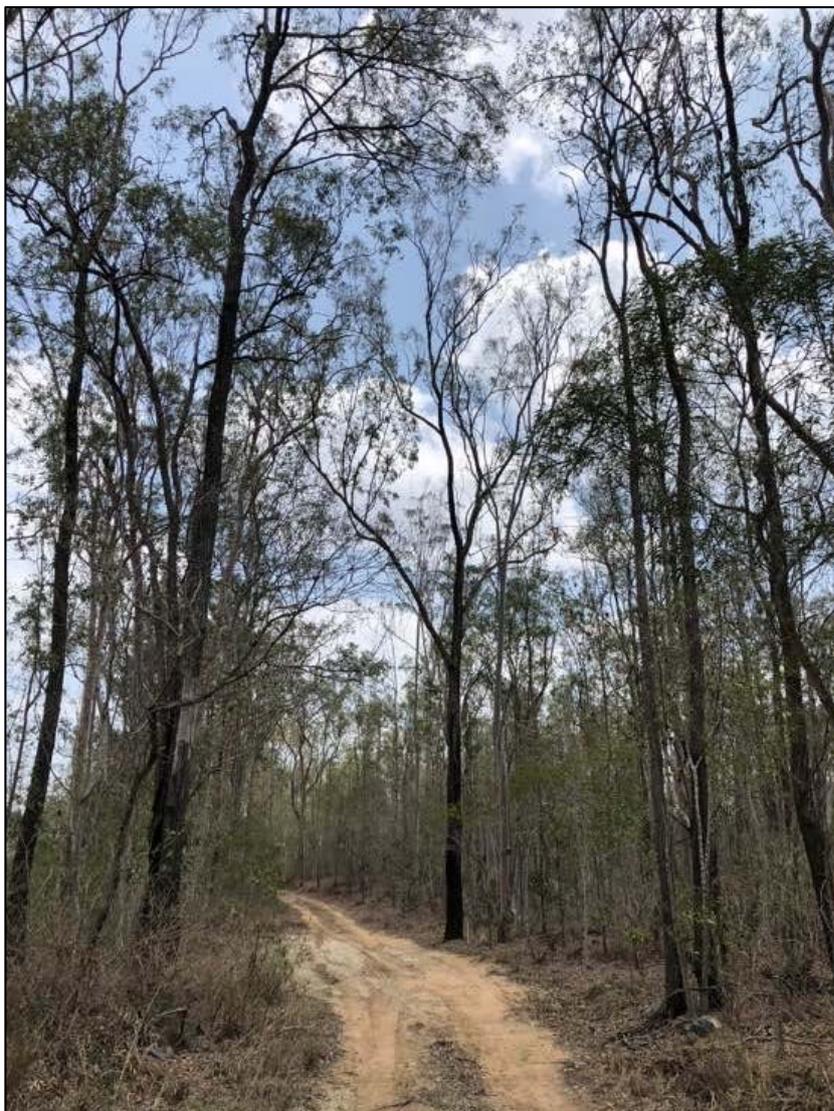
The density of the midstory varied significantly across the site, ranging from very sparse to dense. Species observed in the midstory included Hickory Wattle (*Acacia implexa*), Soap Tree (*Alphitonia excelsa*), Swamp Box (*Lophostemon suaveolens*), Black Wattle (*Acacia leiocalyx*), Black She-oak (*Allocasuarina littoralis*), Weeping Bottlebrush (*Callistemon viminalis*) and canopy recruits. Patches of Lantana (*Lantana camera*) are present throughout the site.

Photo Plate 2. Vegetation composition showing a denser midstory and native grass cover

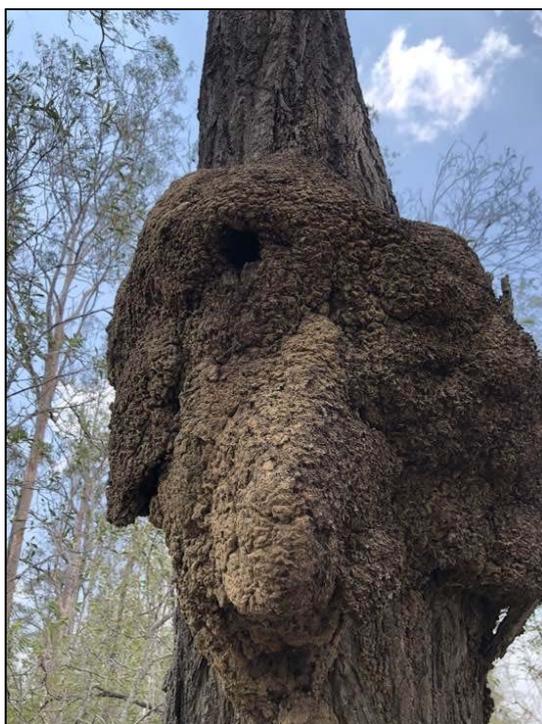
**Photo Plate 3:** Arboreal termitaria recorded on site showing obvious excavation on site

Twelve arboreal termitaria are present within the surveyed area, some featuring excavations (**Photo Plate 3**). Active termitaria support obvious excavated tunnel entrances, which open into a larger chamber inside the mound. Arboreal termitaria are commonly used as nesting sites for Forest Kingfishers (*Todiramphus macleayii*), Sacred Kingfishers (*T. sanctus*), and Laughing Kookaburras (*Dacelo novaeguineae*) or as shelter sites for gliders (*Petaurus* spp.), possums and some reptiles.

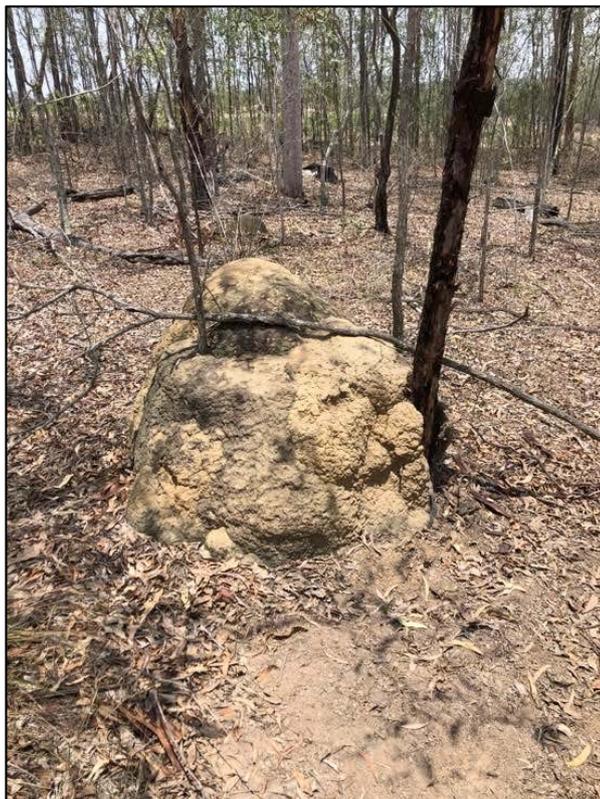
**Photo Plate 4: Terrestrial termitaria present on site**

A high density of terrestrial termitaria are also present on site (**Photo Plate 4**). These features provide foraging for variety of species like the Short-beaked Echidna (*Tachyglossus aculeatus*) and nesting opportunities for many species within the Varanidae family. Lace Monitors (*Varanus varius*) lay clutches of eggs within the protection of a hole dug into a termite nest; the termites seal up the hole, camouflaging the Monitor's clutch (Cogger 2014).

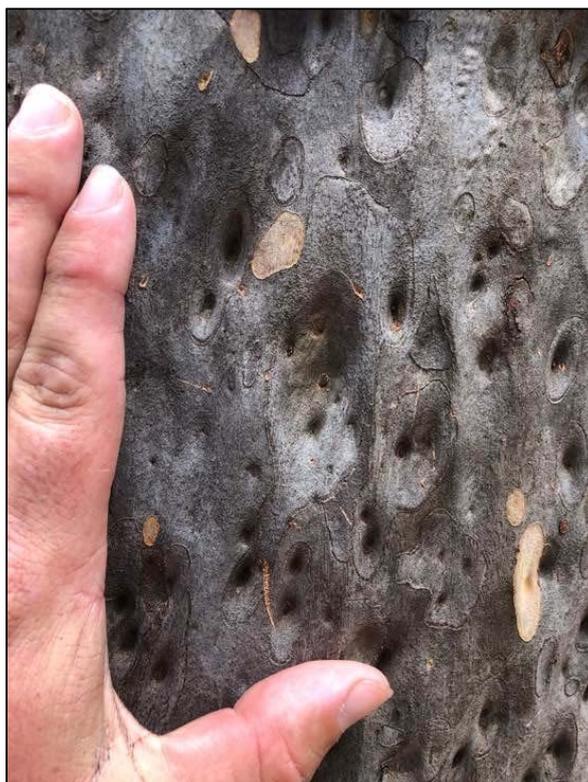
**Photo Plate 5: Arboreal fauna scratch marks noted on a Corymbia**

A selection of trees were noted to have scratch marks on their trunks, indicating that there has been substantial arboreal fauna activity in the area, most likely being species of monitors and/or nocturnal mammals such as possums and gliders (**Photo Plate 5**).

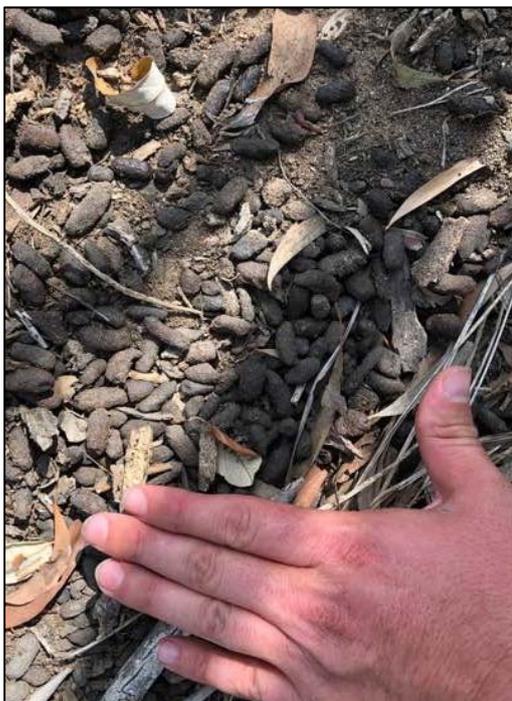
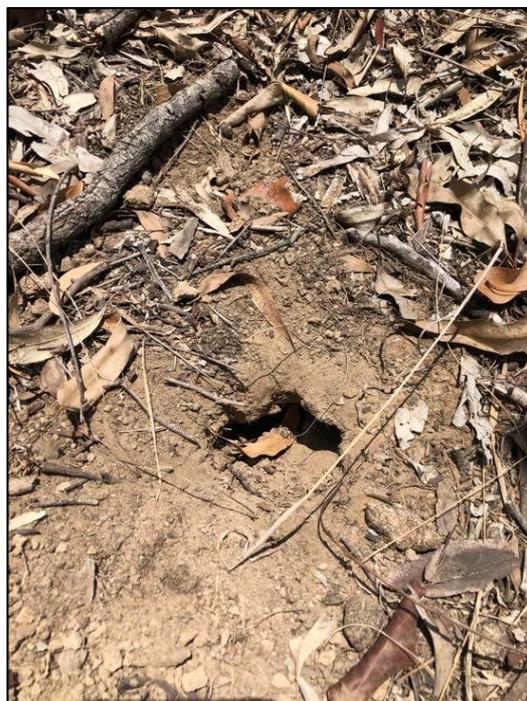
Photo Plate 6: Brushtail Possum scat (left) and suspected Bandicoot dig (right) recorded on site

Scats, tracks and other evidence of faunal presence were noted within the extent of the site (**Photo Plate 6**). A number of small mammal diggings were observed in soft soil, however it is difficult to distinguish diggings as belonging to native species such as echidnas or bandicoots, or introduced species such as hares. Macropod tracks and scats were also noted in several areas, suggesting grazing and/or thoroughfare by macropod species including Eastern Grey Kangaroos, which were directly observed on site.

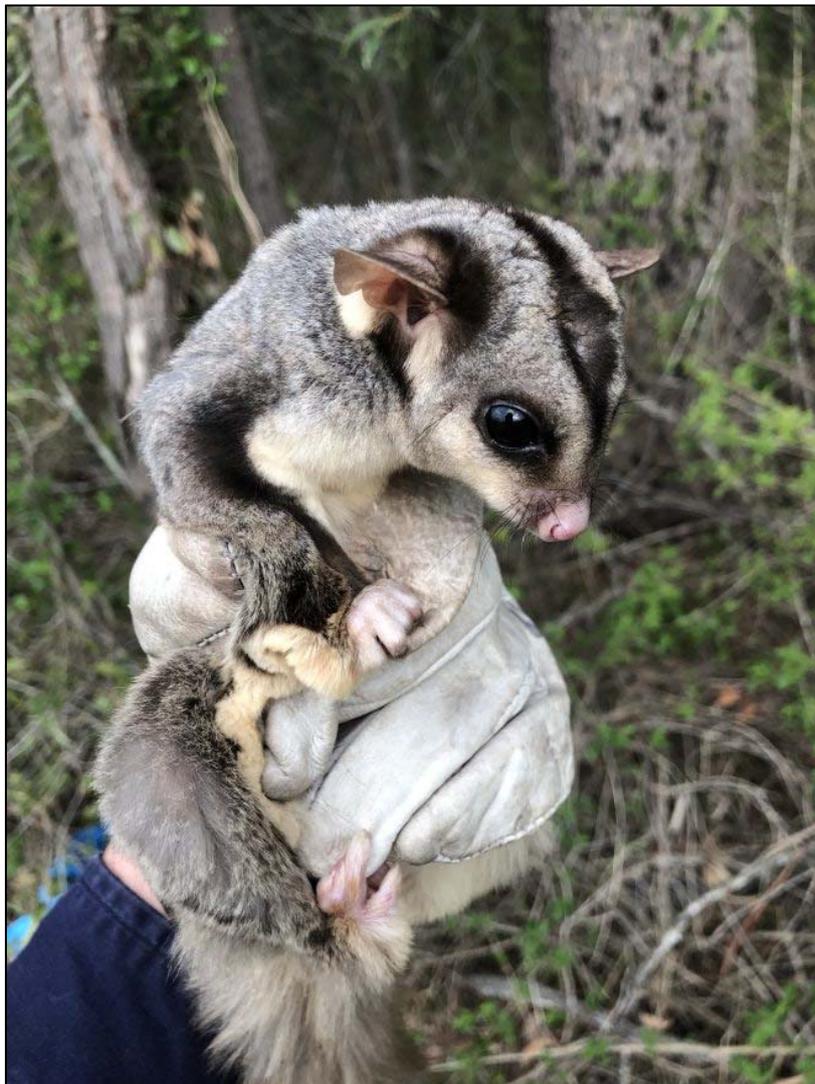
All juvenile animals were captured in good health and transferred to a wildlife carer to be raised. Those with mortal injuries were humanely euthanised in the field as per the Biodiversity Australia Euthanasia Policy, developed in accordance with relevant legislative requirements.

Photo Plate 1: Photo Plate 1: Squirrel Glider, captured and released into adjacent habitat
