Annual Compliance Report

10 June 2021 to 9 June 2022 EPBC 2014/7206
Flagstone West Urban Development Project,
Flagstone, Queensland
PEET Flagstone City Pty Ltd
5 September 2022

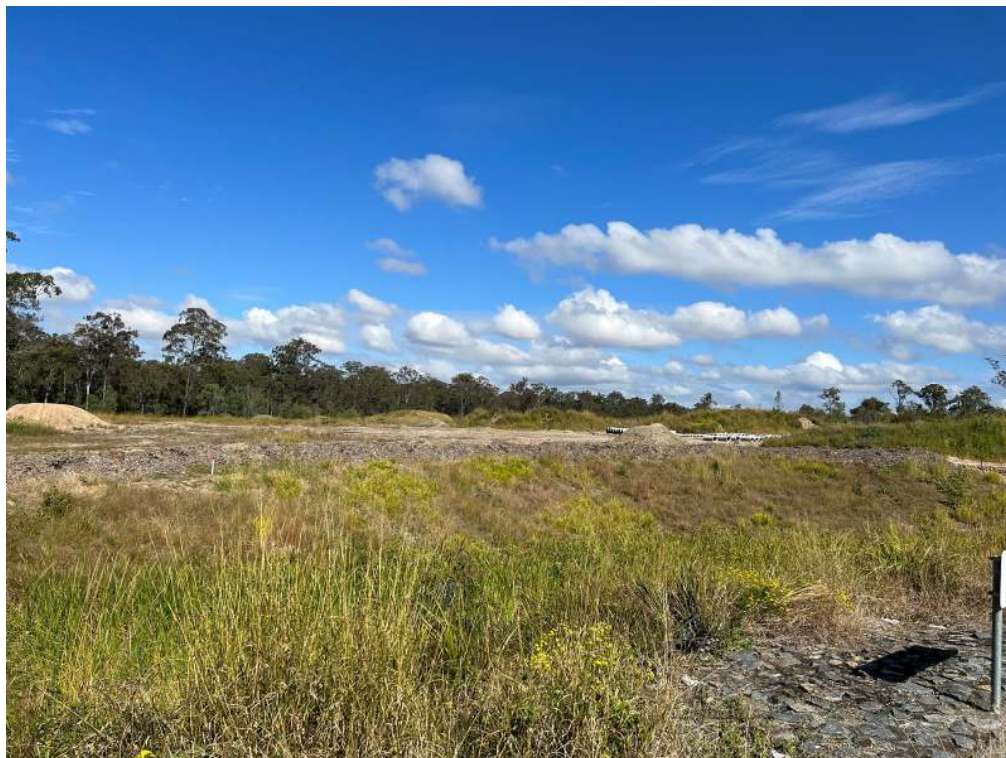
Photo 1: Earthworks completed south-east of the interstate rail.

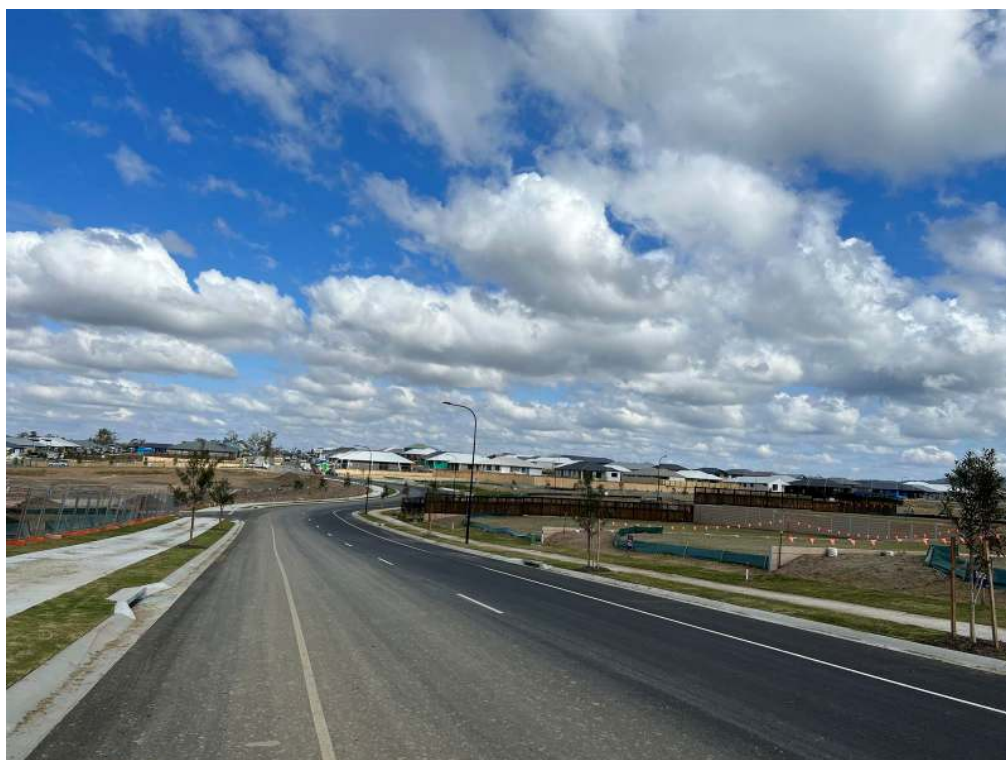
Photo 2: Progress of construction in the north-east, including road network and landscaping – Aspire release.

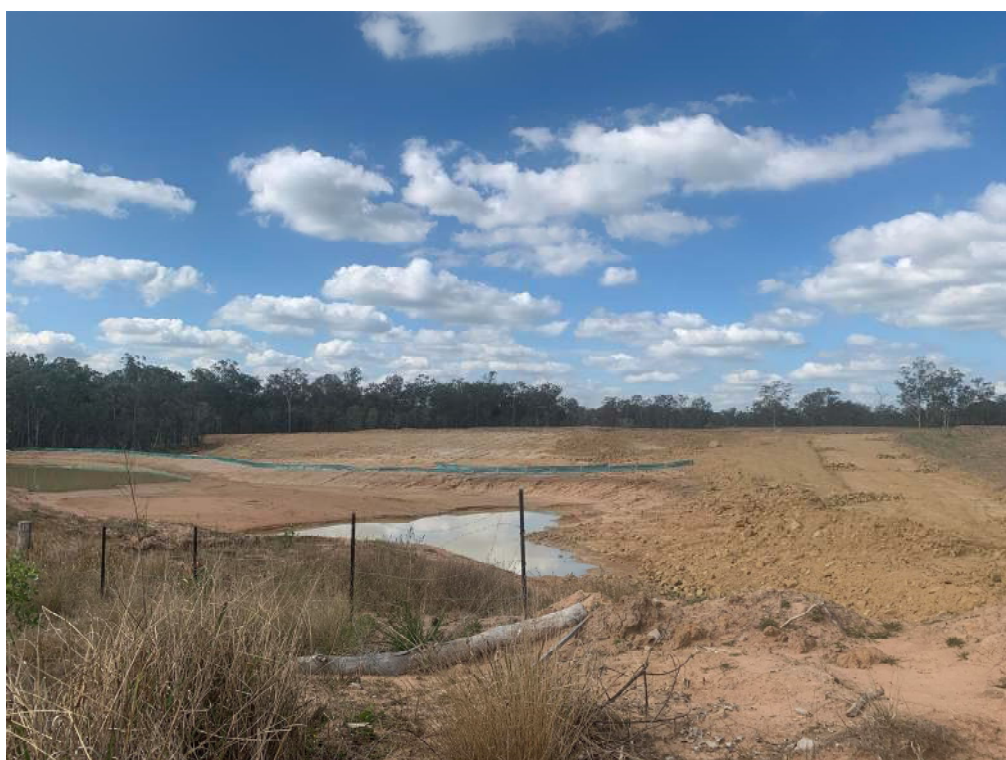
Photo 4: Ongoing construction to the north of Aspire release – northern limits of earthworks extent.

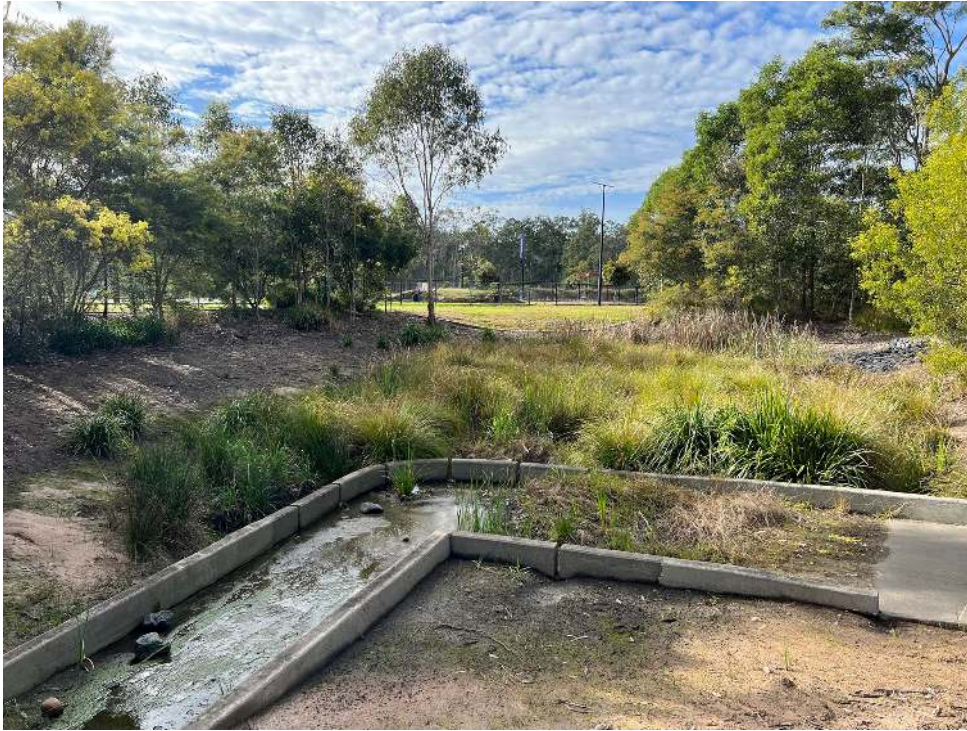
Detention basins previously established along the interface between residential development and the tributary branching from Sandy Creek were inspected. Small amounts of sediment deposition were observed within multiple detention basins. The level of sediment observed is not considered to compromise the function of the detention basins, being aligned with natural variations (refer to **Photo 5**). It is notable that many of the detention basins have now become established, with native flora present and increasing to support the function of the basins in providing enhanced water quality and filtration services (refer to **Photo 10**). Overall, basins appeared to be in good condition, where minimal amounts of sediment deposition were observed.

Photo 5: Detention basin adjacent to dog park in south-eastern extent – flora within basin is in good condition and has become well-established.

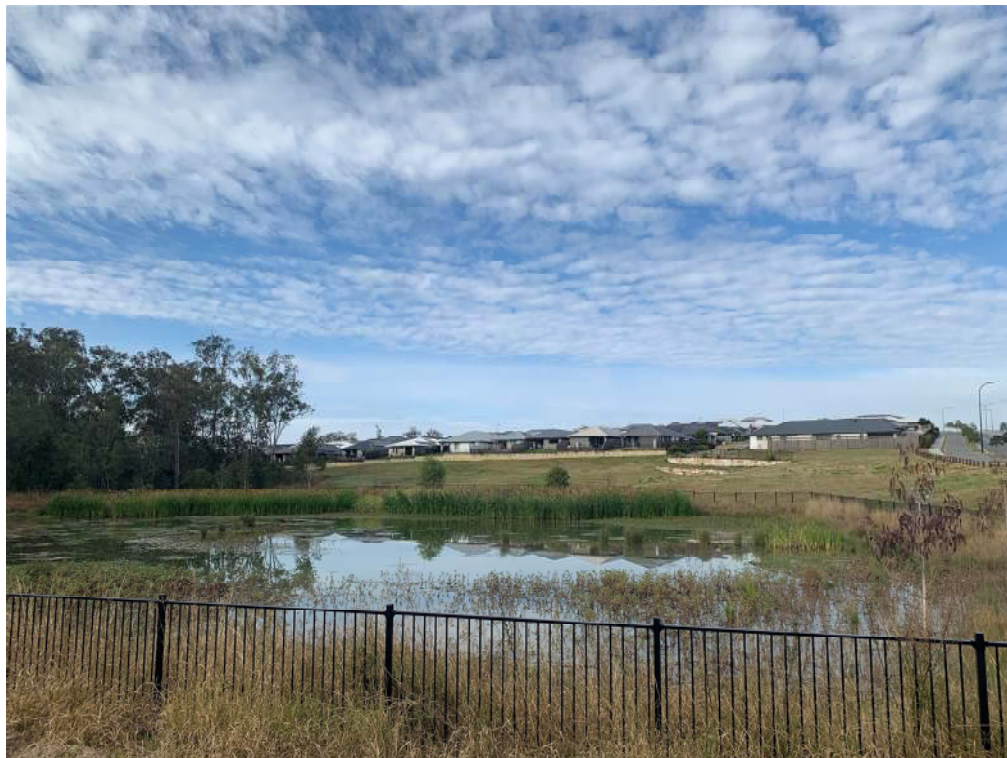
Photo 6: Detention basin along the northern boundary of established estate.

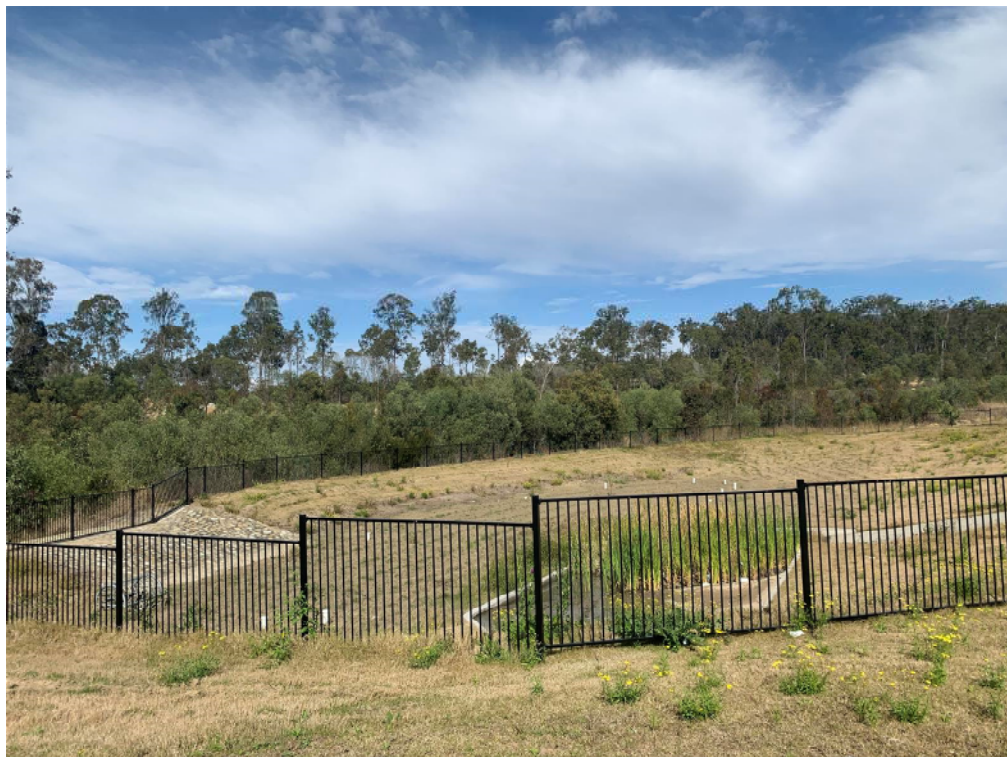
Photo 7: Detention basin in south-west created during the last reporting period.

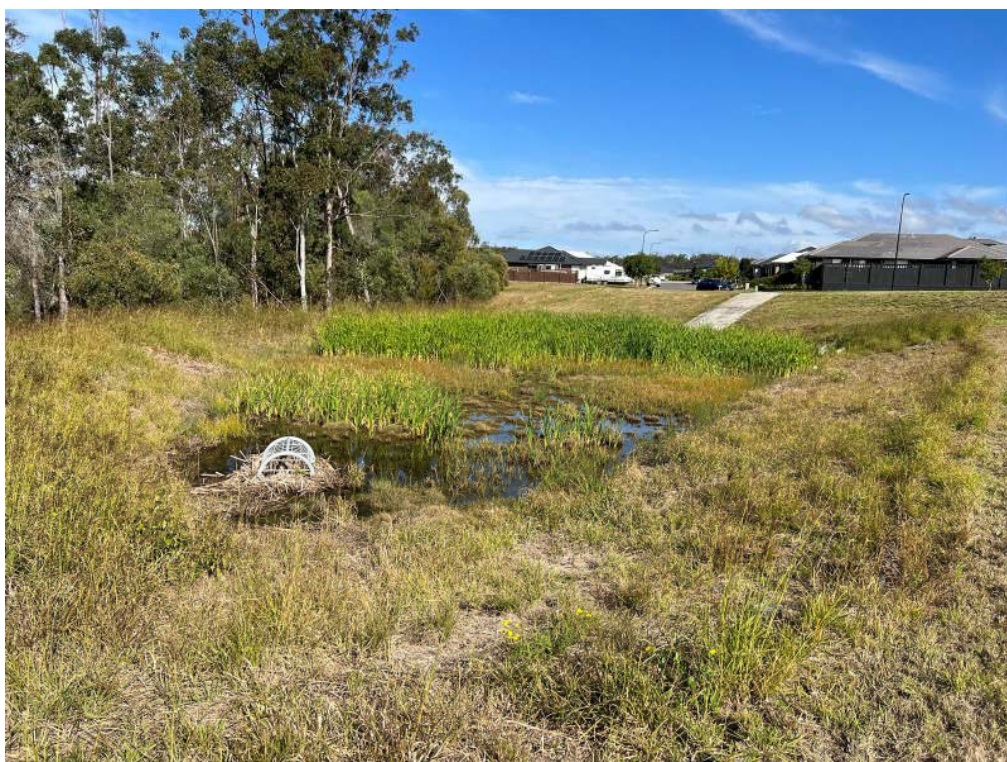
Photo 8: Established detention basin in south-west.

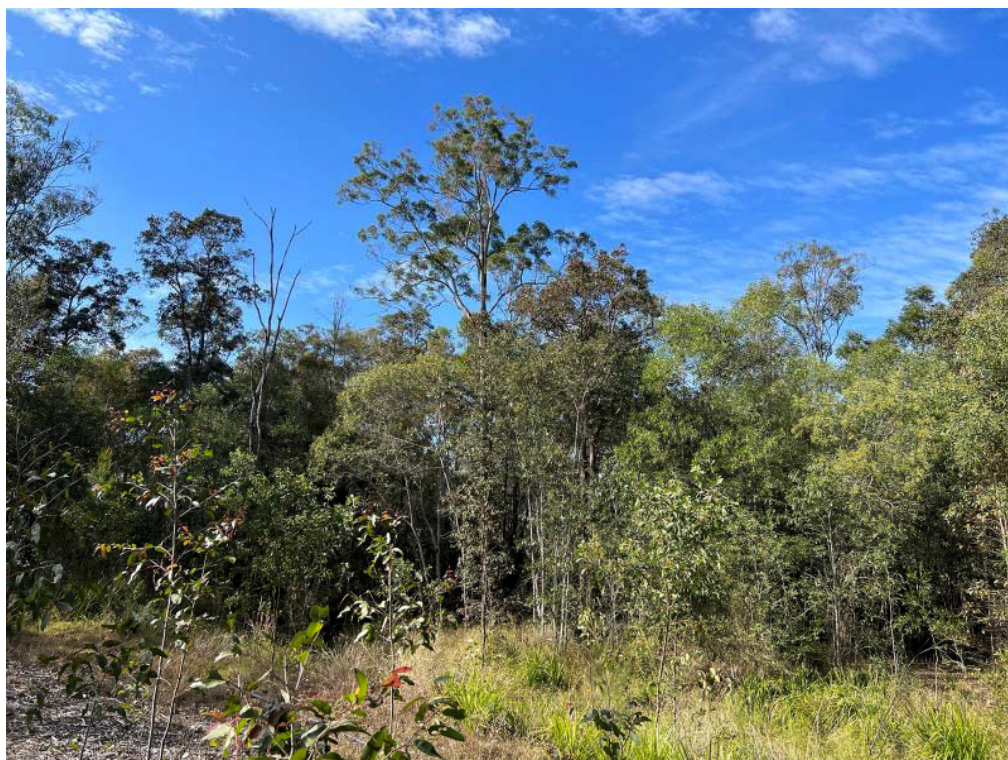
Previously established rehabilitation works continued to be observed along both the southern and northern banks of the tributary branching from Sandy Creek during site visit. Rushes and sedges have become well-established throughout the tributary centreline and riparian area, with grasses dominant on the outer edges, away from the channel (refer **Photo 9**, **Photo 10** and **Photo 11**). Further, regrowth *Acacia* species were observed to be regenerating throughout the riparian zone of the tributary.

Photo 9: Continued regeneration within the tributary – rushes and sedges established within the creek corridor, with grasses dominant away from the channel and regrowth Acacia species present.

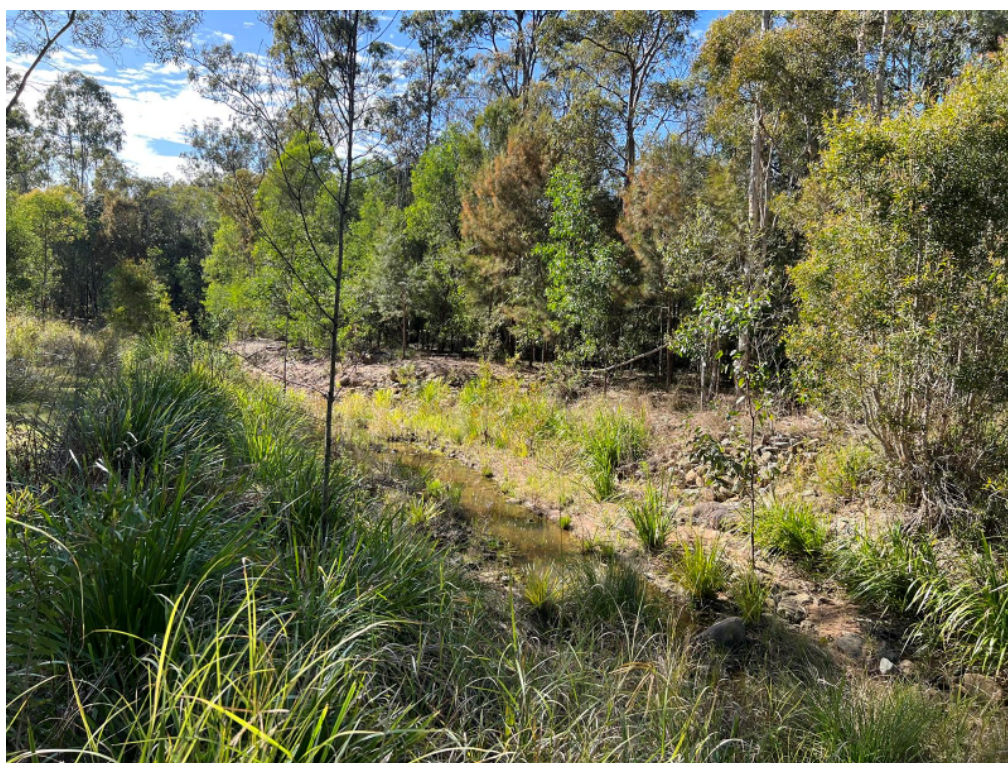
Photo 10: Continued presence of *Lomandra* sp. as part of filtration and stability.

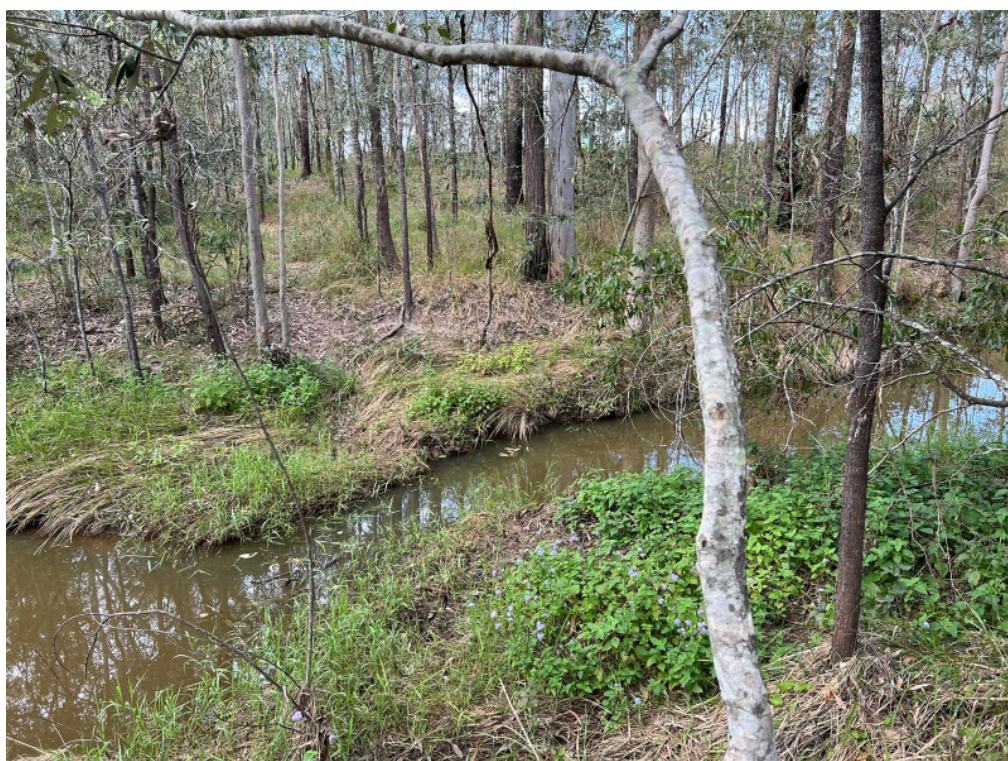
There has been a slight increase in weed presence since the last reporting period. Species including Lantana (*Lantana camara*) and Blue-Billy Goat Weed (*Ageratum houstonianum*) were observed to be present at varying densities within the tributary creek channel (refer **Photo 12**). Corky Passionflower (*Passiflora suberosa*) and Red Natal Grass (*Melinis repens*) were also observed at select locations along the riparian corridor. Weed species present will be managed by PEET as part of usual management efforts. The levels of weed encroachment in this reporting period has likely been influenced by the increased levels of rainfall (i.e., effects of a La Nina) experienced during the first half of 2022. It is also noted minor flood debris were present in sections along the tributary. Overall, rehabilitation efforts were mostly observed to be in good condition, where native flora and bank stabilisation measures were continued to be observed and in good condition.

Photo 12: Tributary channel with low levels of Blue Billy Goat Weed presence.

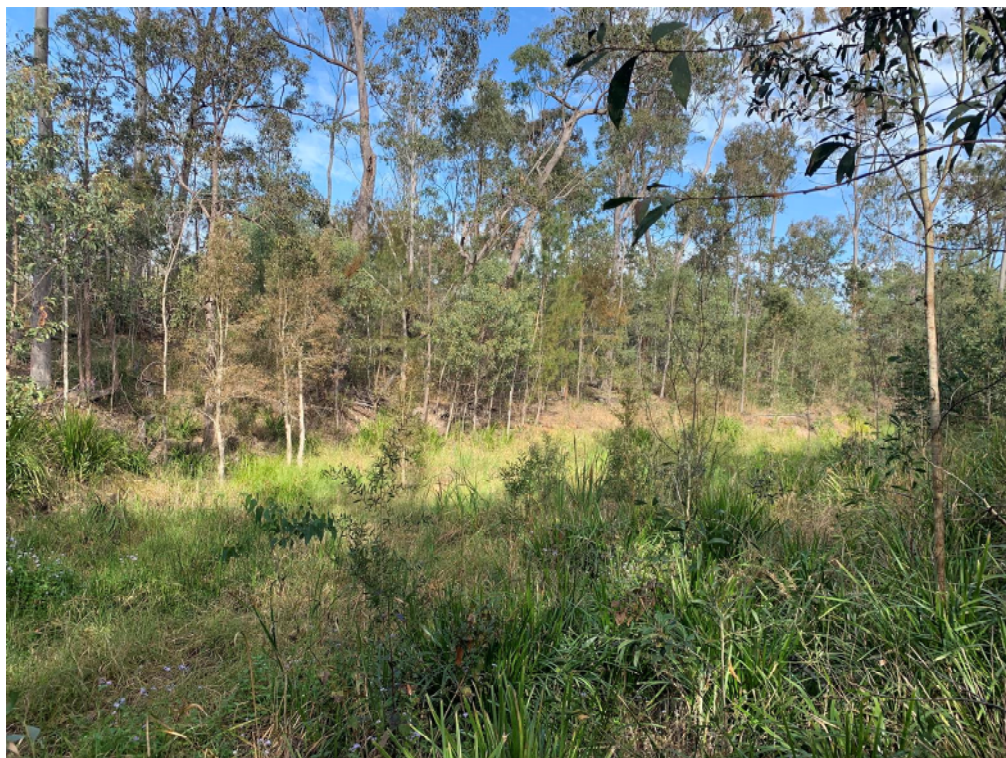
The previously installed bank stabilisation mechanisms along the tributary were observed to be present. Several of the coir logs have decomposed overtime. It is noted that the vegetation along the tributary banks associated with the coir log locations has become increasingly established to provide bank stability. Rocks placed as bank stabilisation mechanisms in the previous reporting period continued to be observed and have continued to stabilise locations of the bank that would likely have eroded during increased rainfall events if they were not present (refer **Photo 10**). No newly eroded locations along the channel were observed, where in-stream flora has become reflective of a natural state (**Photo 13**).

Photo 13: Continued regeneration along the tributary centreline with some emergence of weed species.

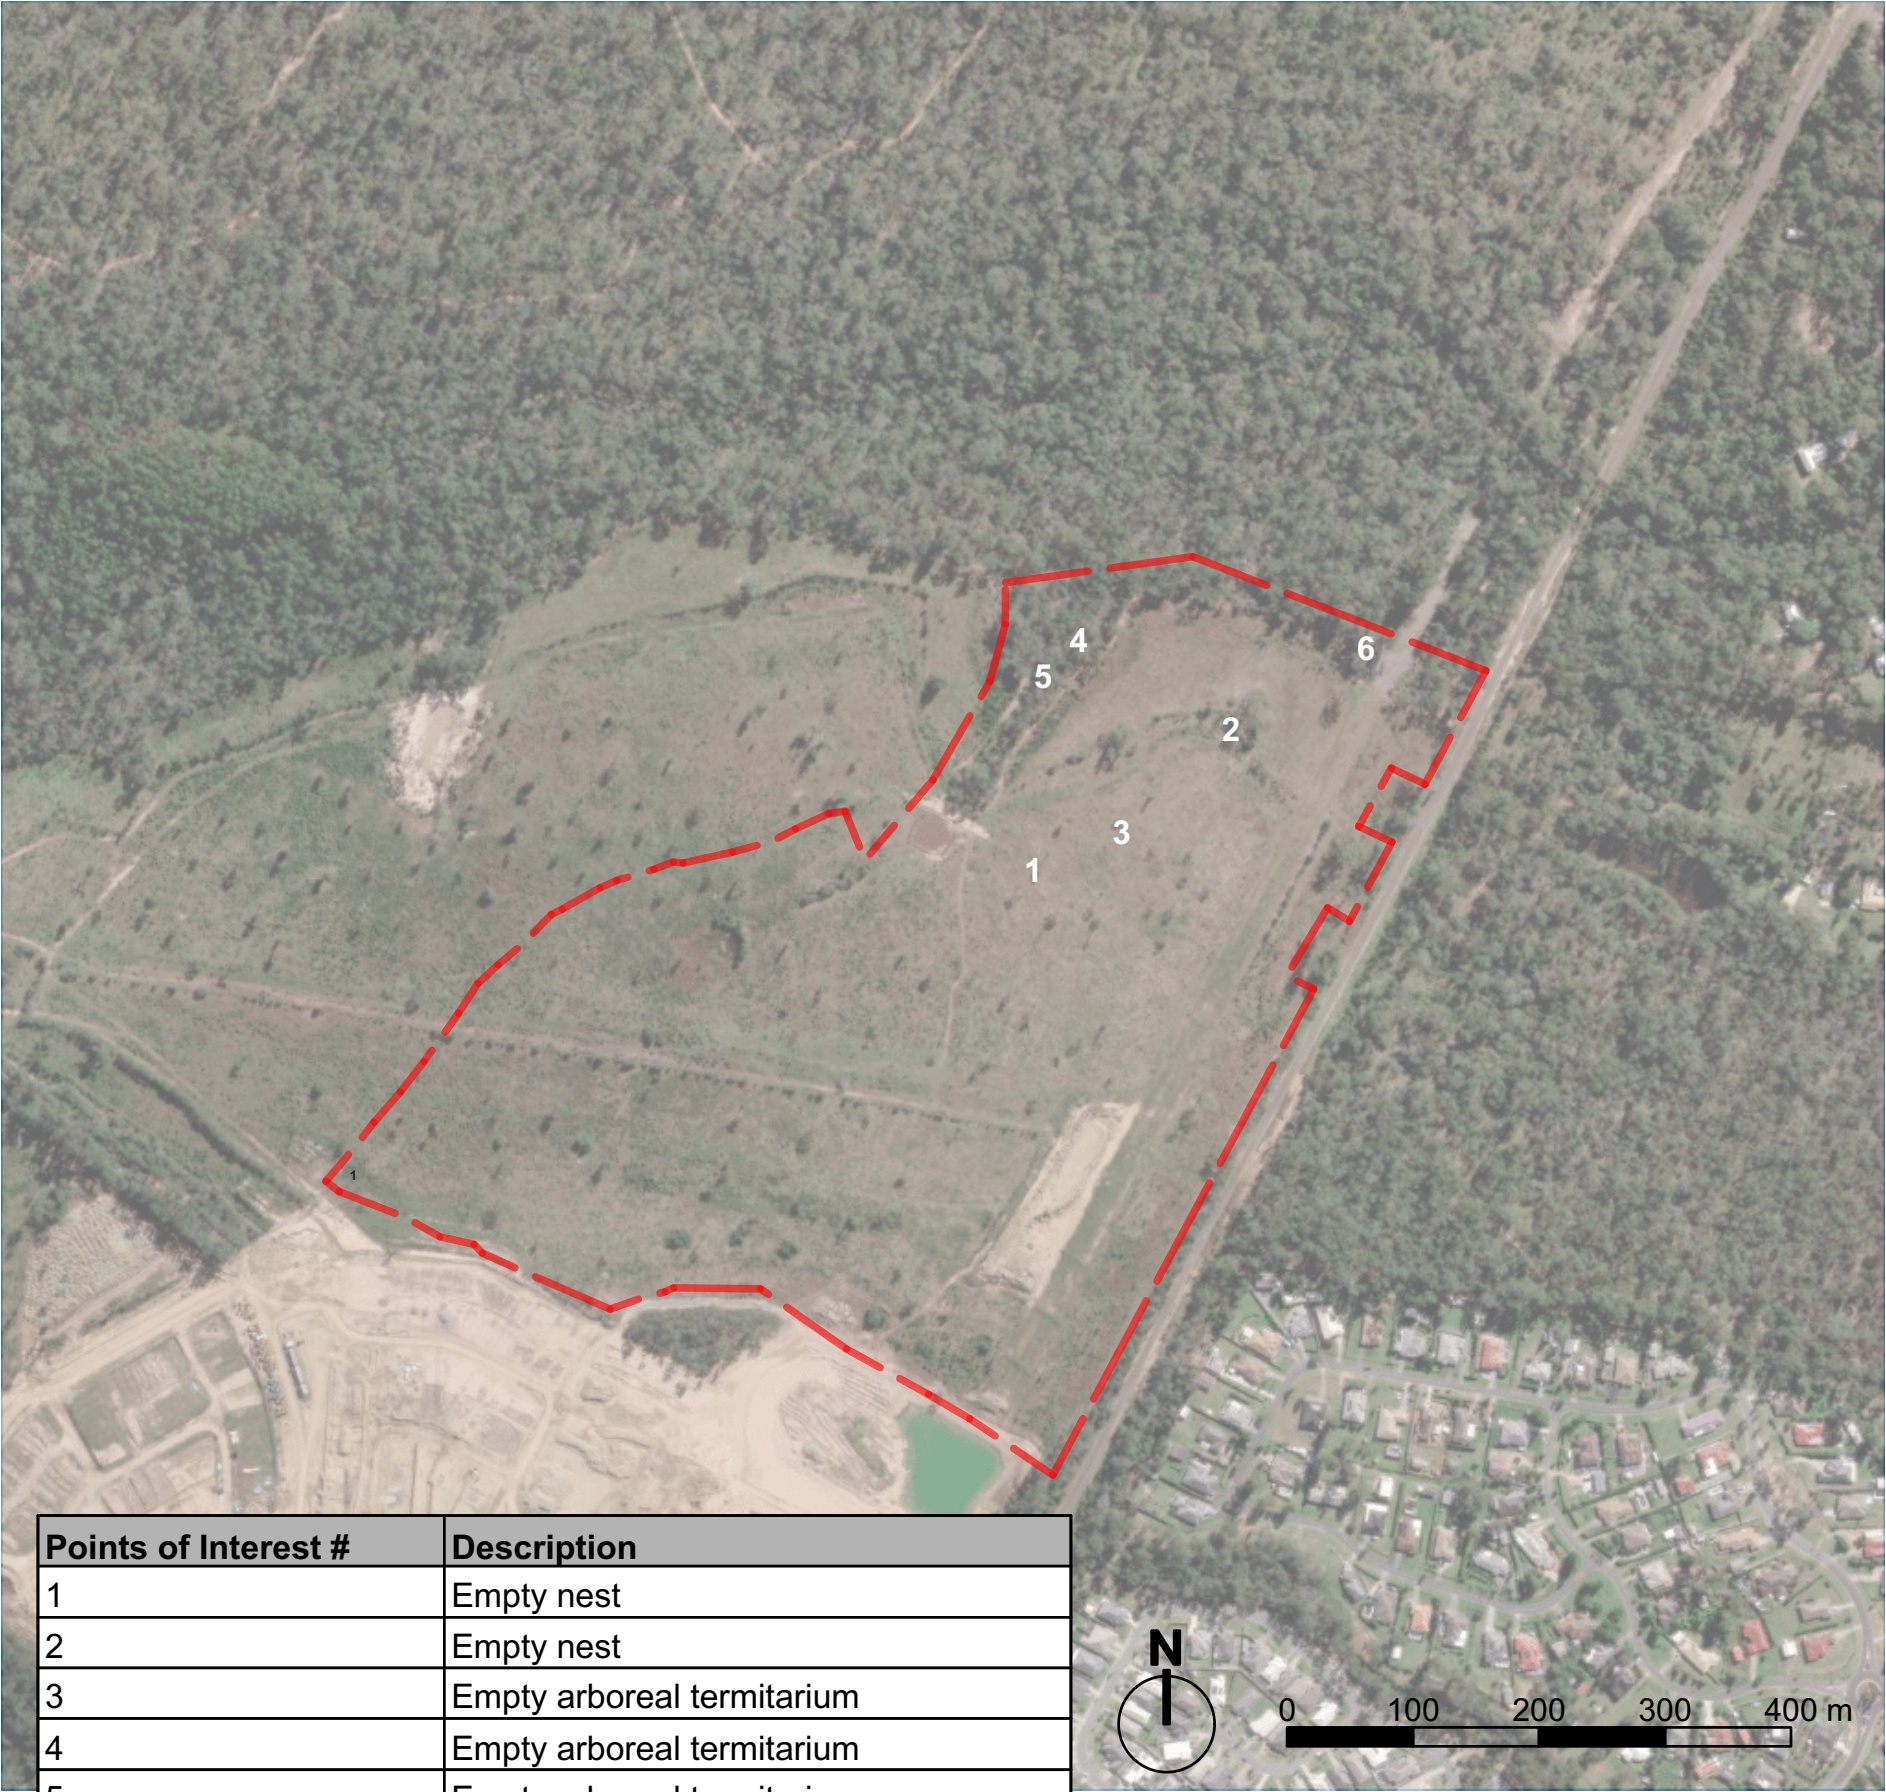
Attachment 1 – Map

Points of Interest #	Description
1	Empty nest
2	Empty nest
3	Empty arboreal termitarium
4	Empty arboreal termitarium
5	Empty arboreal termitarium
6	Empty arboreal termitarium

Because the arboreal termitaria would become viable habitat sites within one or two years, replacing the four destroyed arboreal termitaria by installing four nestboxes suitable for a Forest Kingfisher or similar hollow-dwelling birds is recommended. No fauna was harmed during clearing and clearing proceeded in accordance with the V&FMP.

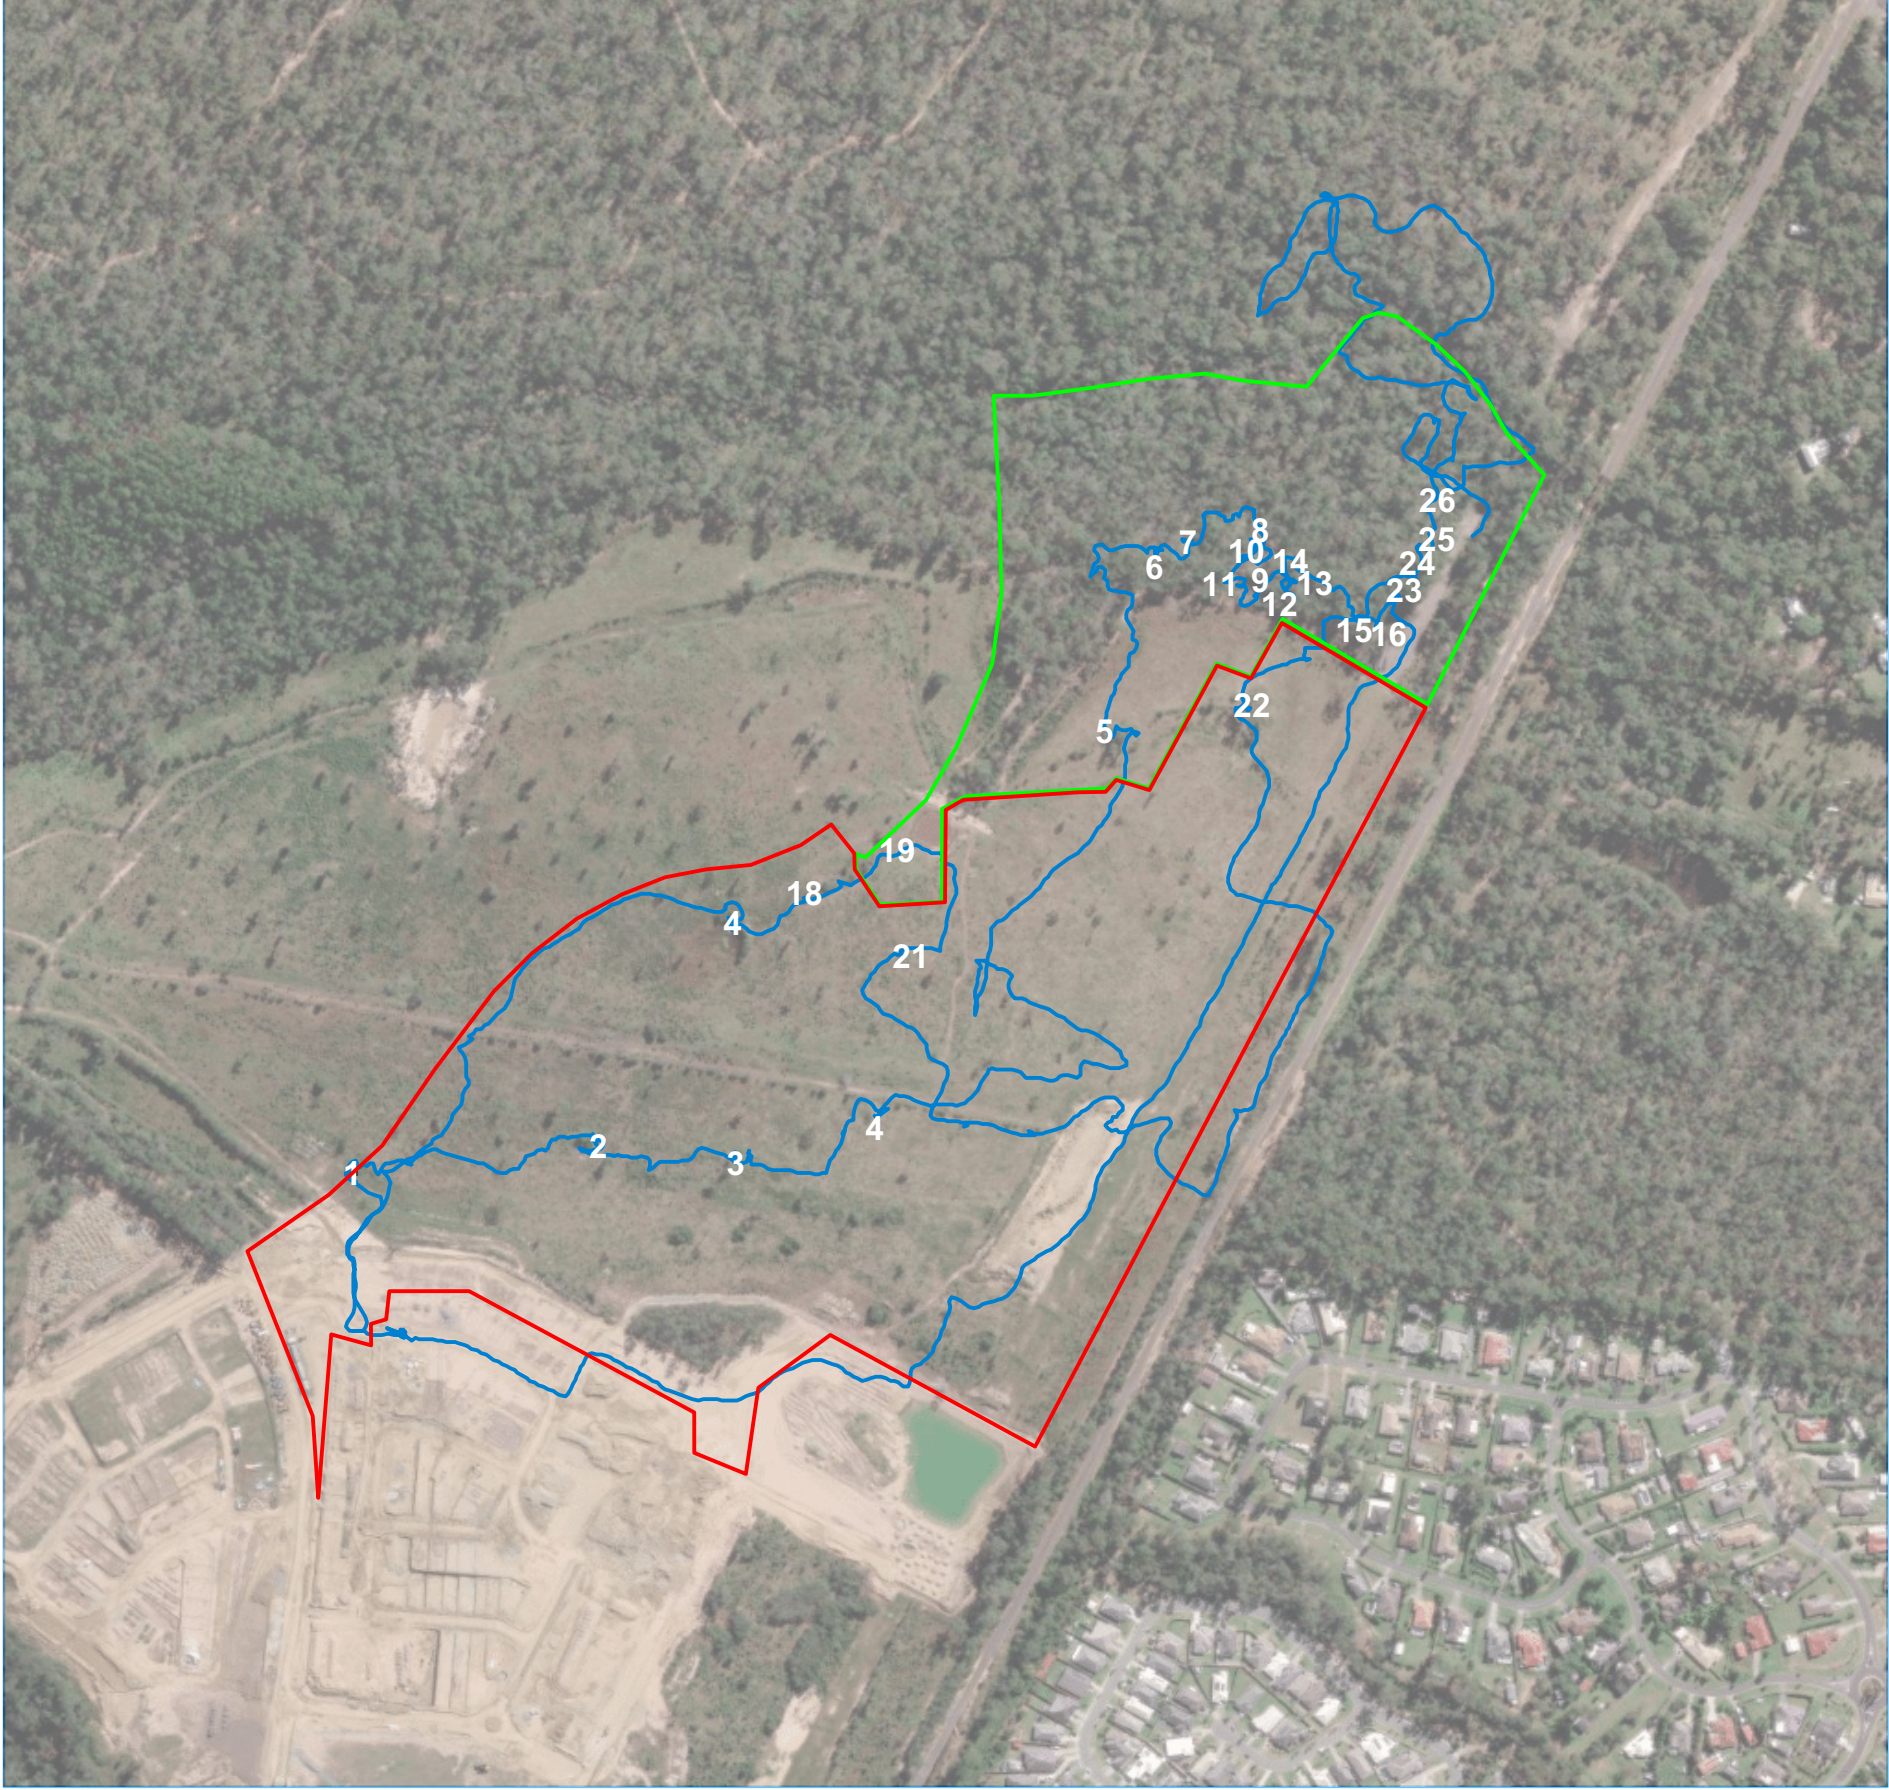
Attachment 1 – Maps

Points of Interest #	Description
1	Wren Habitat, Thick Grassland
2	Thicket, Kangaroo Scat and Tracks
3	Magpie Nest
4	Stag
5	Termitarium
6	Termitarium, Stag
7	Termitarium, Ground Hollow
8	Thicket
9	Termitarium
10	Hollow Bearing Tree
11	Termitarium/Hollow
12	Stag
13	Arboreal Termitarium
14	Arboreal Termitarium
15	Stag
16	Kingfisher Nest in Arboreal Termitarium
17	Fairy Wren habitat, Dam
18	Gilgai
19	Dam
21	Crow Nest
22	Gilgai, Burrow
23	Treefall, Tree hollow
24	Stag
25	Treefall, Chimney, Arboreal Termitarium
26	Stag

Besides the two identified actual habitat features in the Clearing Area, other vegetation in the clearing area does not need additional management. A detailed survey of the Future Clearing Area is recommended at least two weeks before the Future Clearing Area is scheduled for clearing.

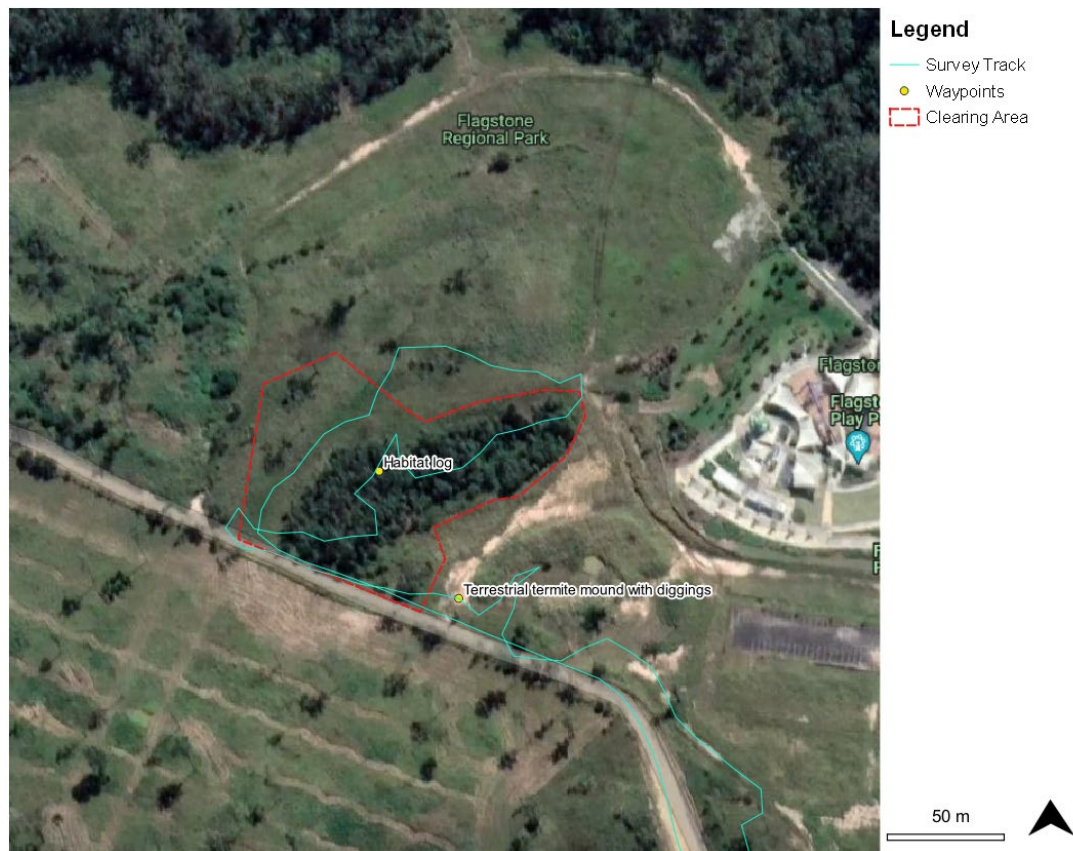
The survey consisted of a meander through vegetation in the Clearing Area. Fauna activity was assessed through opportunistic sightings, assessment of potential habitat, listening to calls, identifying tracks, identifying scat, and identifying scratch marks. The survey track and locations of significant

habitat were recorded with the GeoTracker app on a Samsung Galaxy 21S and are accurate to 6m. Map 3 delineates the survey track and identified habitat features.

Map 3 – Survey Track and Habitat Features
