# Annual Compliance Report

10 June 2022 to 9 June 2023 EPBC 2014/7206  
Flagstone West Urban Development Project,  
Flagstone, Queensland  
PEET Flagstone City Pty Ltd  
31 August 2023

Document: Annual Compliance Report 10 June 2022 to 9 June 2023 EPBC 2014/7206, prepared by Saunders Havill Group for PEET Flagstone City Pty Ltd.

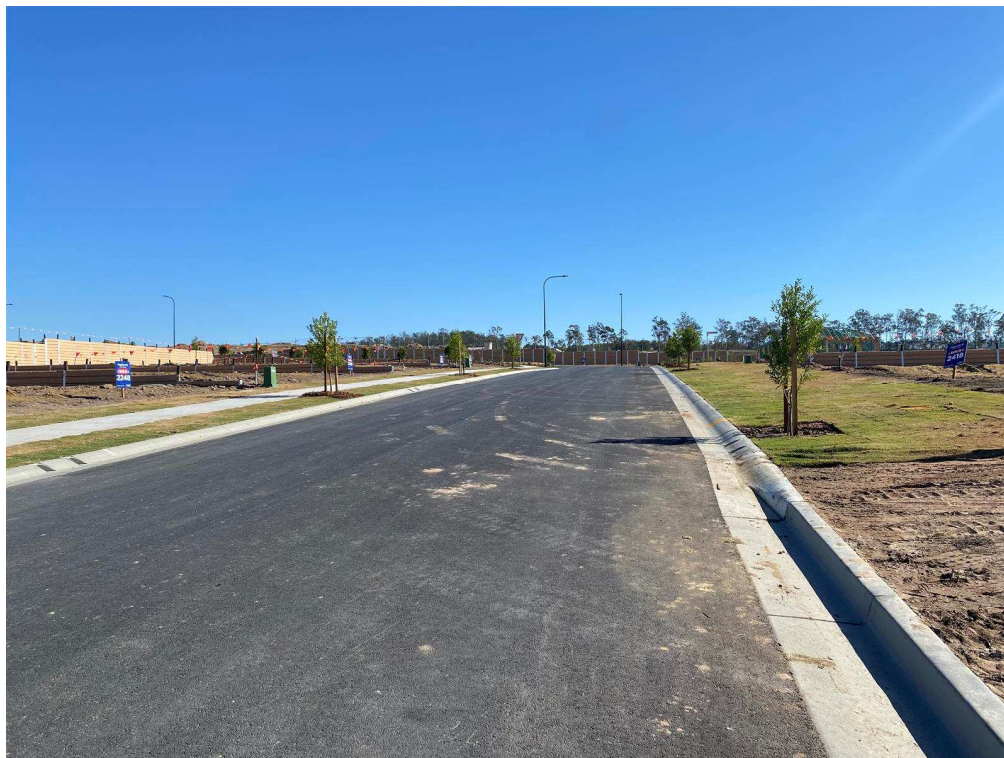
**Photo 1: Progress of construction in the north-west, including road network and landscaping.**

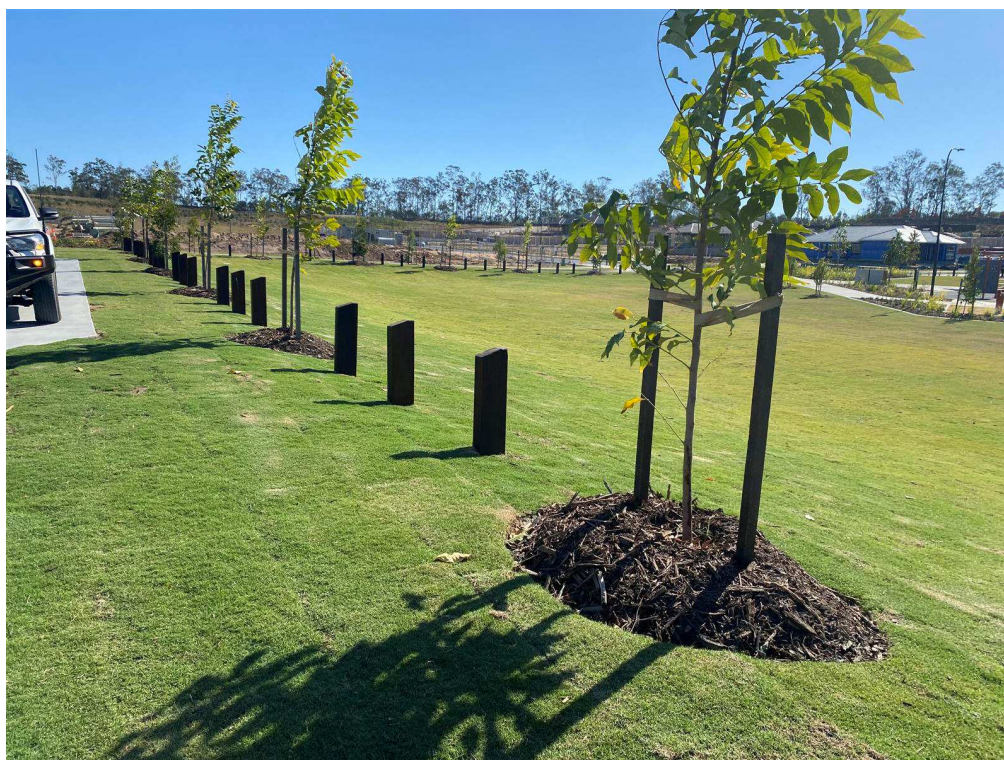
**Photo 2: Vista Park landscaping.**

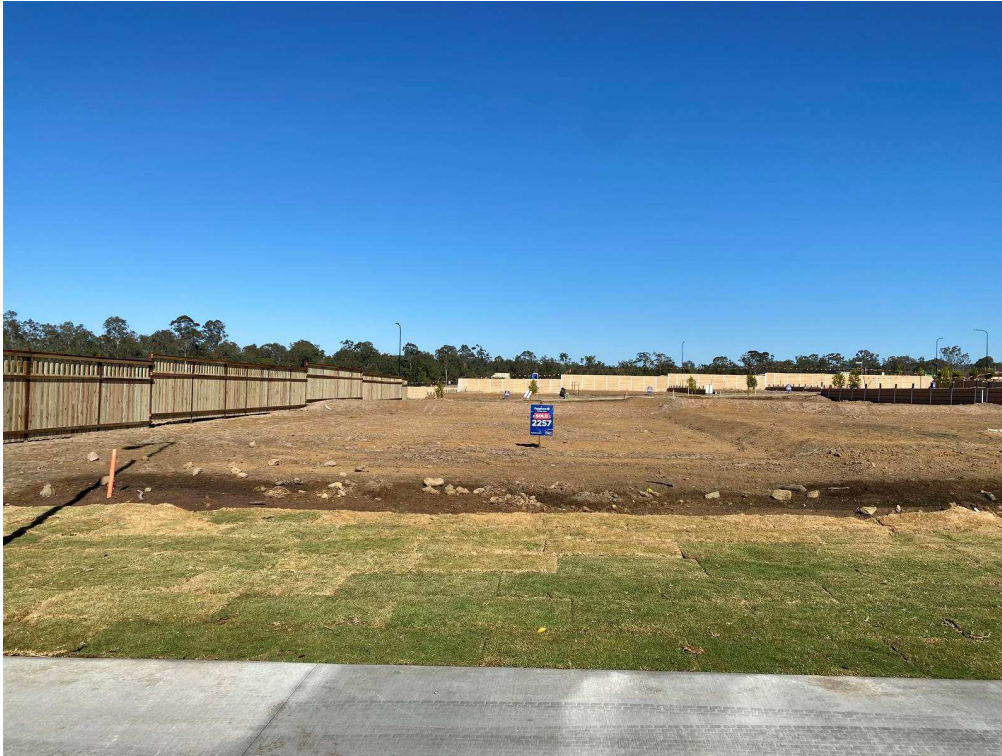
**Photo 3: Lot establishment in the north-west during reporting period.**

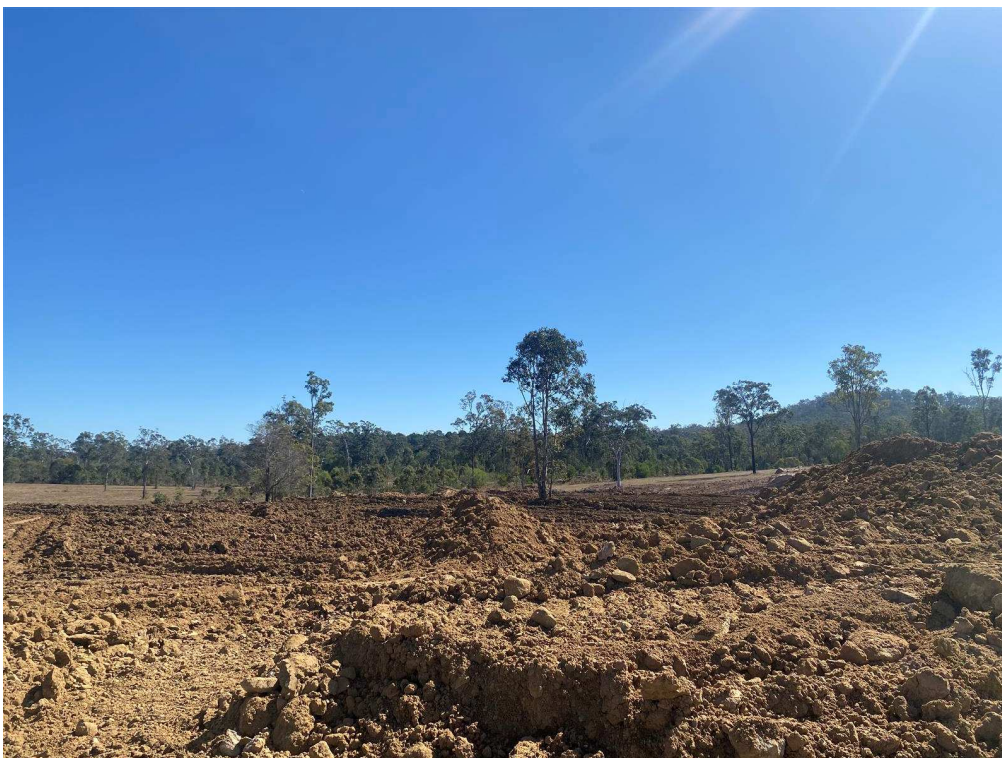
**Photo 4: Ongoing construction to the north of Aspire Release (Stage 2) – northern limits of earthworks extent.**

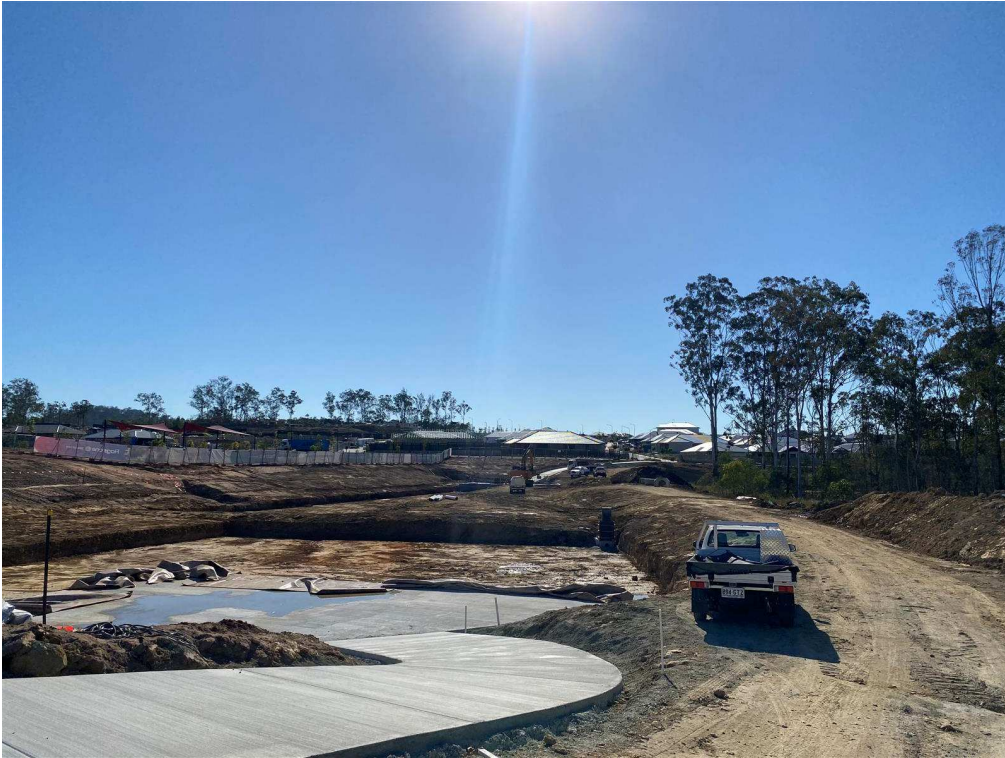
**Photo 5: Ongoing construction works.**

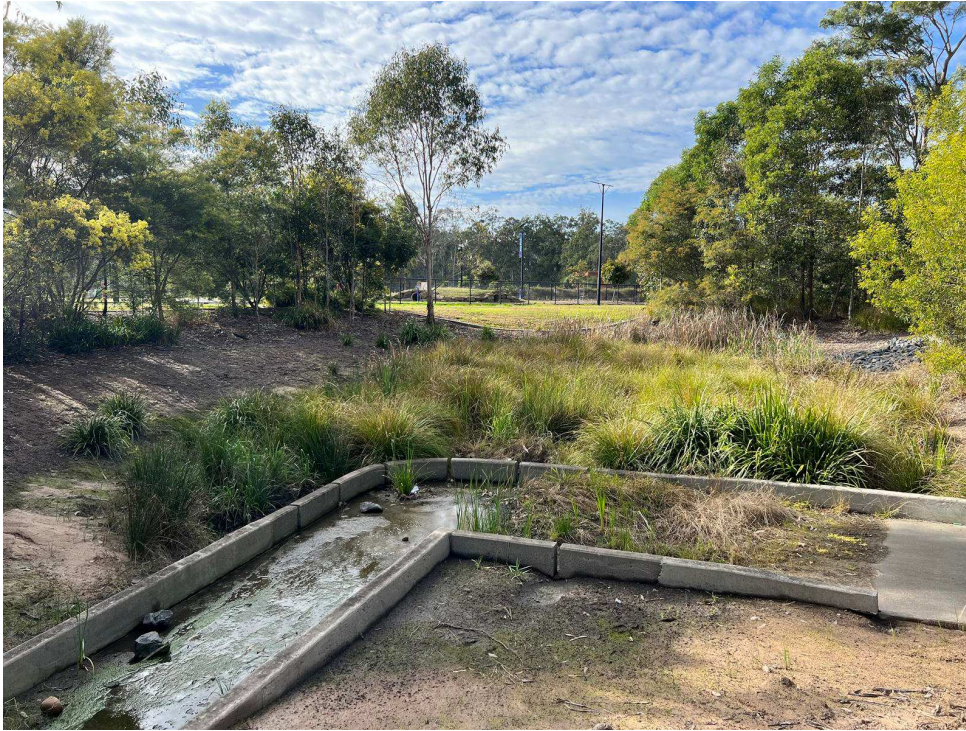
Detention basins previously established along the interface between residential development and the Sandy Creek tributary were inspected. Small amounts of sediment deposition were observed within multiple detention basins adjoining tributaries (refer **Photo 8**). The level of sediment observed is not considered to compromise the function of the detention basins, being aligned with natural variations. It is notable that many of the detention basins have now become established, with native flora present and increasing to support the function of the basins in providing enhanced water quality and filtration services. It is noted due to the lack of recent rainfall, vegetation within the detention basins appeared drier with less reported natural regeneration (refer to **Photo 6 and 7** for comparison). Overall, the basins appeared to be in good condition with minimal amounts of sediment deposition observed and reflecting seasonal variation in vegetation.

**Photo 6:** Detention basin adjacent to dog park in south-eastern extent during the last reporting period (Year 6).

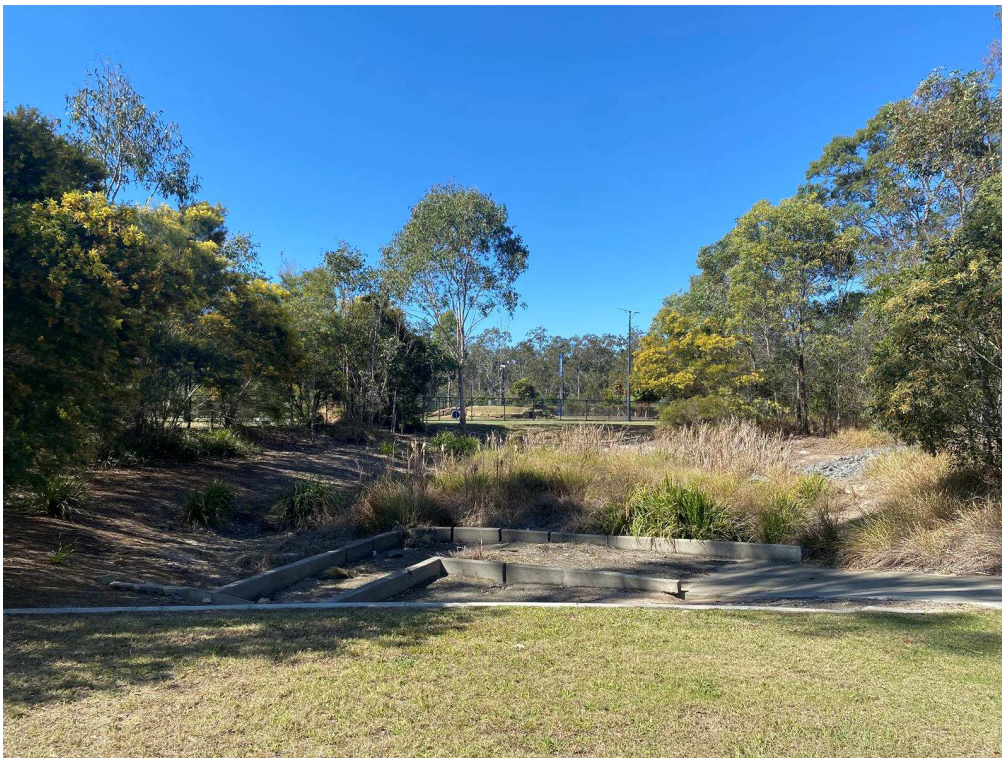
**Photo 7:** Detention basin adjacent to dog park in south-eastern extent showing evidence of recent low rainfall events (Year 7).

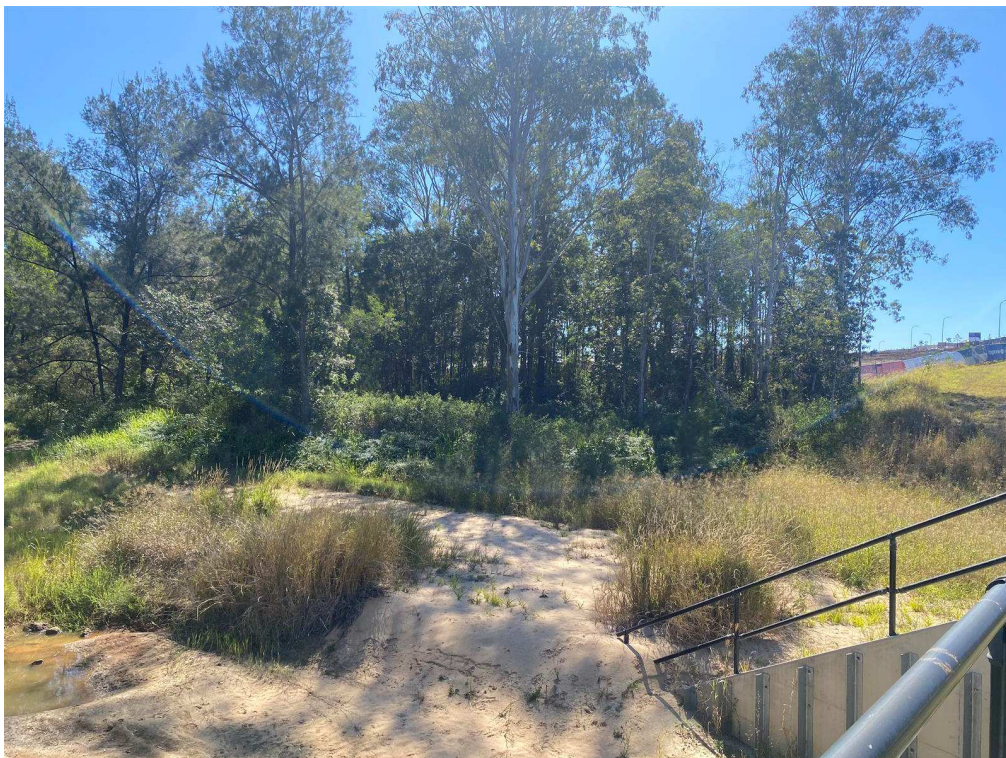
**Photo 8: Evidence of sediment deposition within tributary branching from Sandy Creek.**

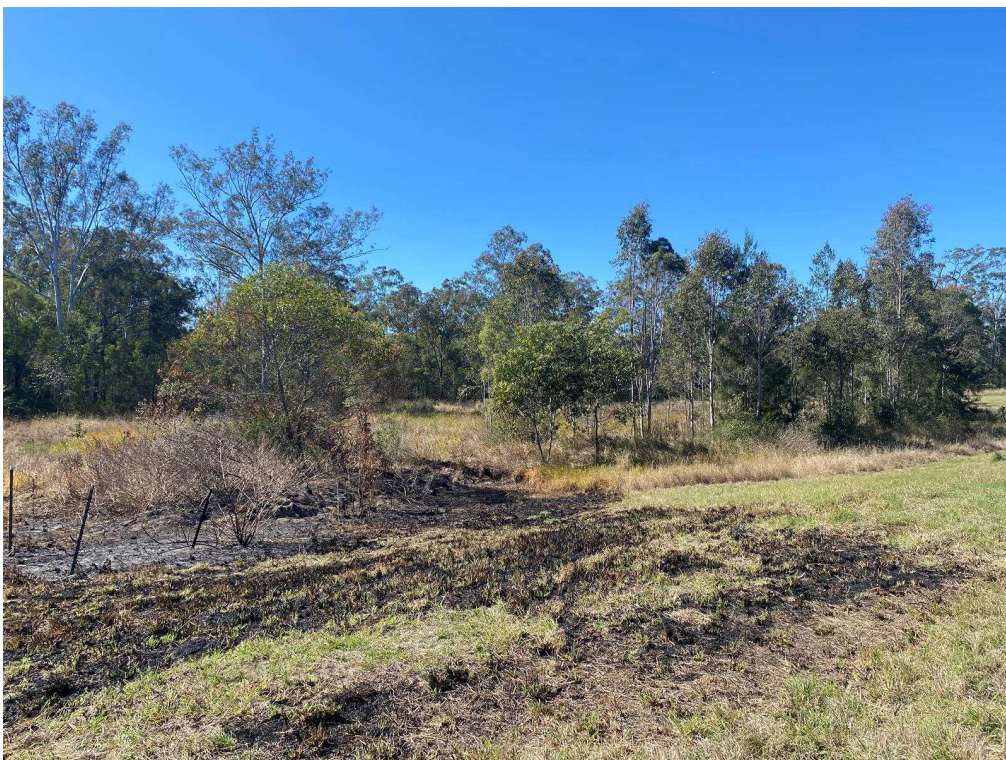
Previously established flora species such as *Lomandra* sp., sedges and grasses continued to be observed within the waterway channel, providing enhanced stability for surface soils during rainfall events and assisting in slowing water velocity. Evidence of natural regeneration is present with numerous eucalypt and *Acacia* sp. saplings observed. Weed removal is still required, as evidence of weed recruitment was identified, however weed management and fire prevention evidence was observed alongside detention basin in the south-west of Context Area 1.

**Photo 9: Evidence of weed maintenance and fire prevention alongside detention basin in south-west.**

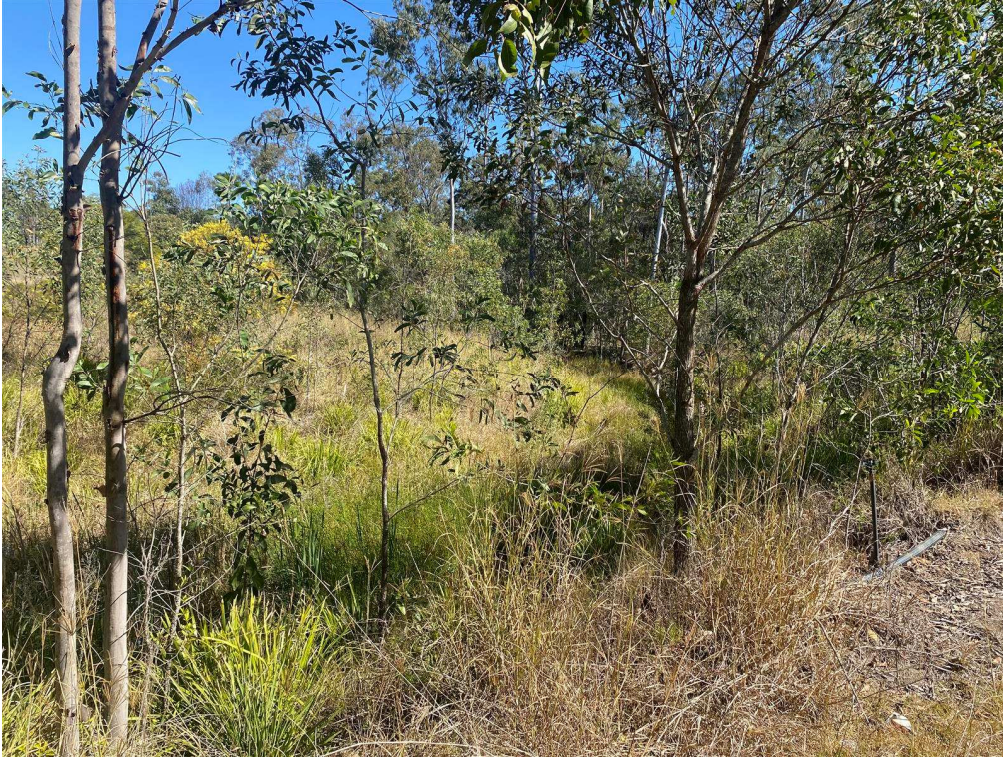
The status of previously completed rehabilitation efforts continued to be documented along both the southern and northern banks of the Sandy Creek tributary during the site visit. Rushes and sedges have become well-established throughout the tributary centreline and riparian area, with grasses dominant on the outer edges (refer **Photos 10 to 11**). Further, regrowth eucalypts and *Acacia* sp. were observed to be regenerating throughout the riparian zone of the tributary (refer **Photo 11**).

**Photo 10:** Continued regeneration within the tributary – rushes and sedges established within the creek corridor, with grasses dominant away from the channel and regrowth eucalypt species present.

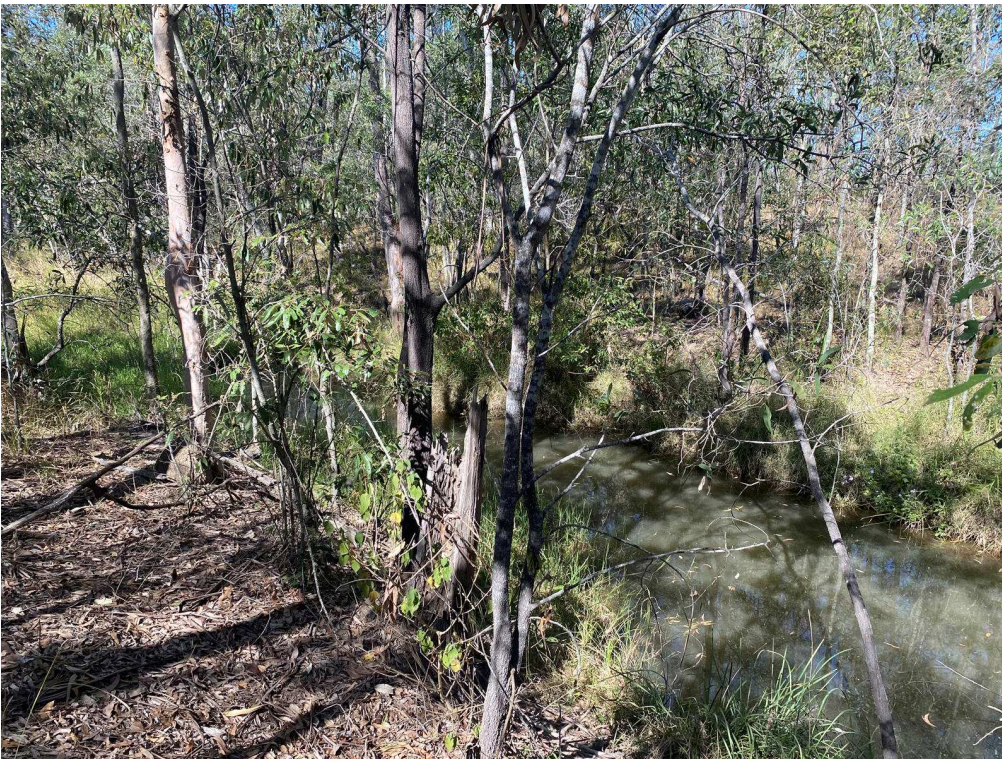
There was little difference in weed presence observed since the last reporting period with some minor ground and shrub layer weed incursion. Species observed included Lantana (*Lantana camara*) and Blue Billygoat Weed (*Ageratum houstonianum*) at varying densities within the tributary creek channel (refer **Photo 13**). Corky Passionflower (*Passiflora suberosa*) and Red Natal Grass (*Melinis repens*) were also observed at select locations along the riparian corridor. Weed species present will be managed by PEET as part of usual management efforts. Evidence of rehabilitation works were observed, with evidence of *Lantana camara* dieback due to weed spraying efforts identified. Overall, rehabilitation efforts were mostly observed to be in good condition, where native flora and bank stabilisation measures were continued to be observed and in good condition.

The previously installed bank stabilisation mechanisms along the tributary were observed to be present. Several of the coir logs have decomposed further. It is noted that the vegetation along the tributary banks associated with the coir log locations has become increasingly established to provide bank stability. Rocks placed as bank stabilisation mechanisms in the previous reporting period continued to be observed and have continued to stabilise locations of the bank that would likely have eroded during increased rainfall events if they were not present. No newly eroded locations along the channel were observed, where in-stream flora has become reflective of a natural state (refer **Photo 11**).

**Photo 11:** Continued presence of *Lomandra* sp. as part of filtration and stability with regrowth *Acacia* sp. also present. Slight incursion of Lantana along creek line evident.

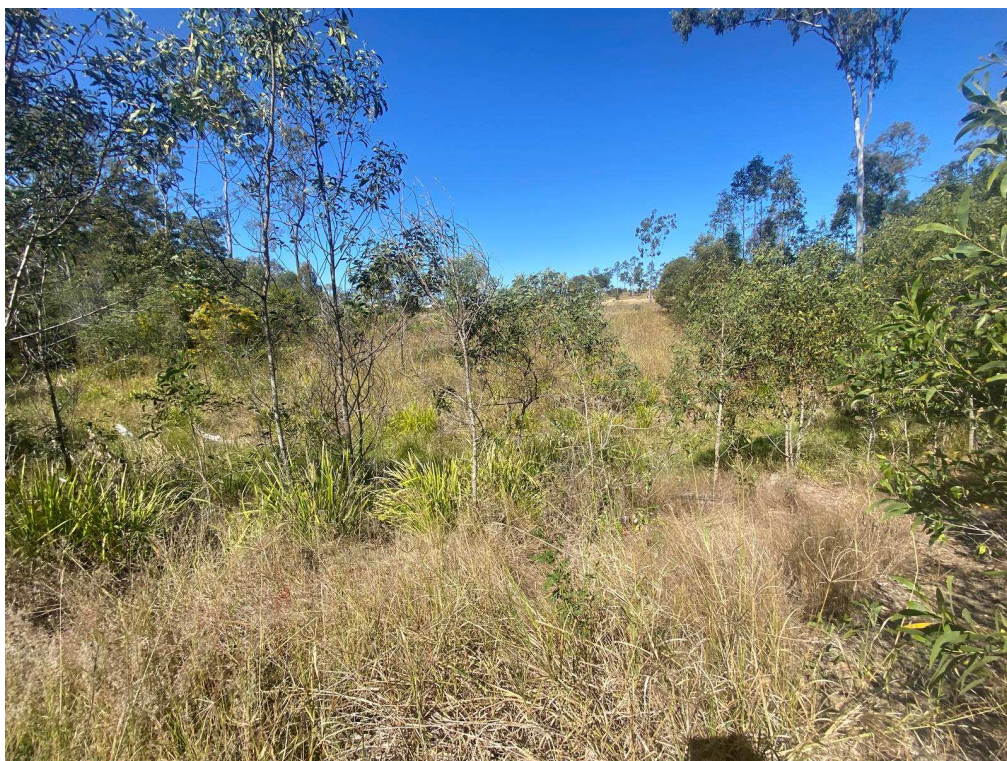
**Photo 12: Evidence of rehabilitated vegetation along the tributary channel.**

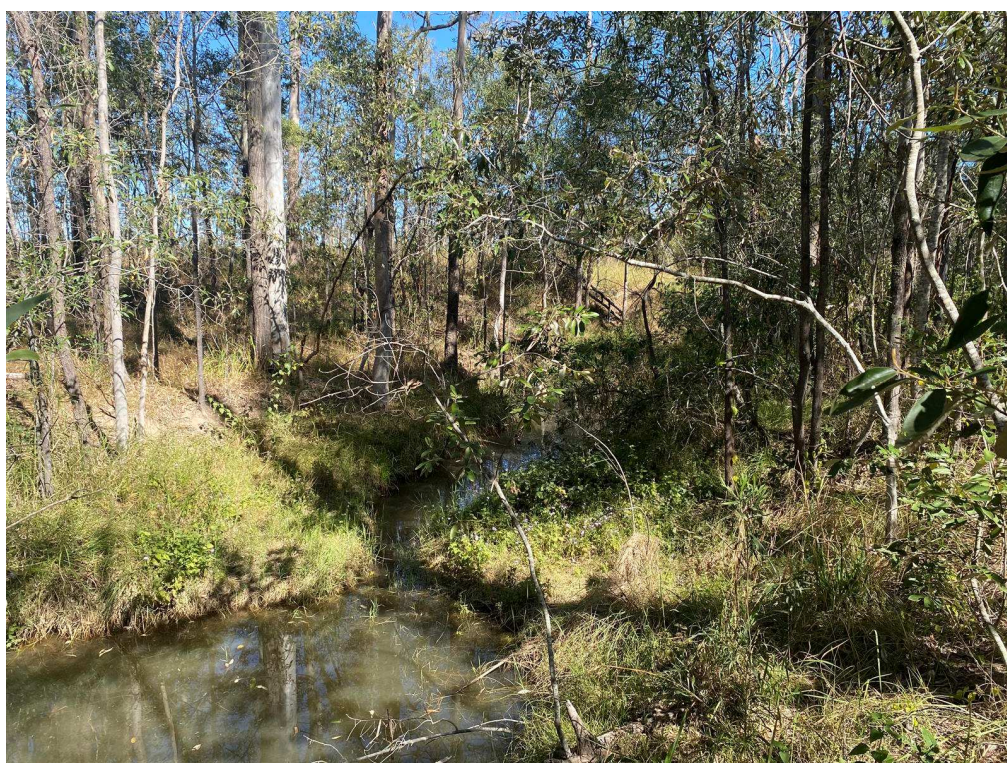
**Photo 13: Tributary channel with low levels of Blue Billygoat Weed presence.**

Rehabilitation efforts previously completed abutting the bridge crossing, which connects to the currently under construction Aspire release situated in the northern areas of the development, continue to be observed. Flora species present consists of *Lomandra* spp. and native sedges, with a slight incursion of introduced species *Chloris gayana* (Rhodes Grass) and *Lantana camara* (Lantana) regrowth also observed (refer **Photo 14**). It is therefore recommended that weed management be conducted in this area.

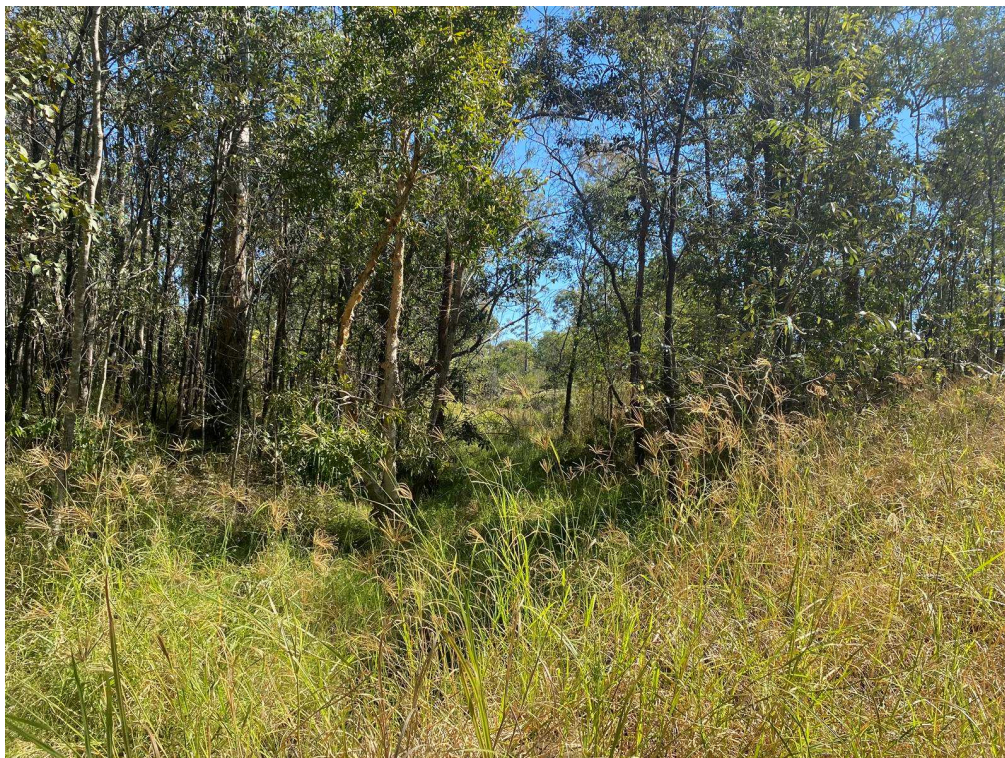
**Photo 14: Vegetation looking north along the tributary centreline with some emergence of exotic grass species *Chloris gayana*.**

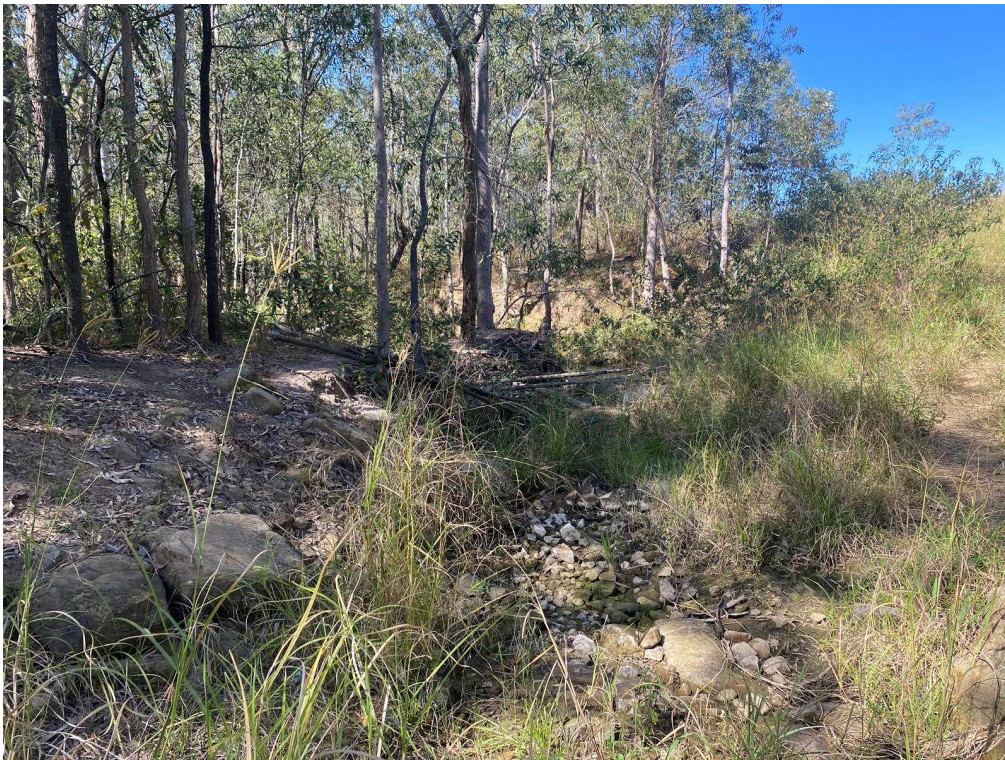
Pre-existing fauna management measures were continued to be observed along and abutting the banks of the Sandy Creek tributary which consisted largely of the placement of logs and woody debris derived from previously felled trees (refer **Photos 15 and 16**). The logs continue to decompose over time, and are considered to have the potential to provide suitable refuge for reptile species. Further, evidence of fauna usage was observed along the tributary in the form of small diggings, likely attributable to bandicoots. Two (2) terrestrial termite mounds with excavates providing potential denning habitat were identified along the creek line (refer **Photo 17**).

**Photo 15: Habitat features and bank stabilisation within the tributary corridor.**

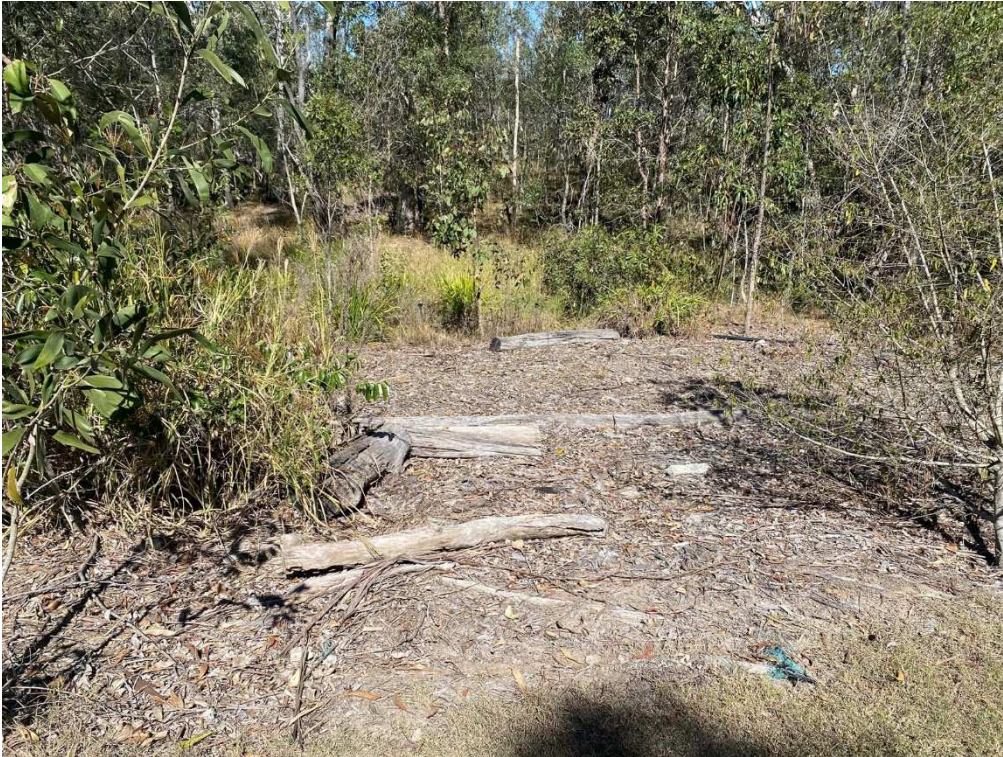
**Photo 16: Log piles previously placed for fauna habitat.**

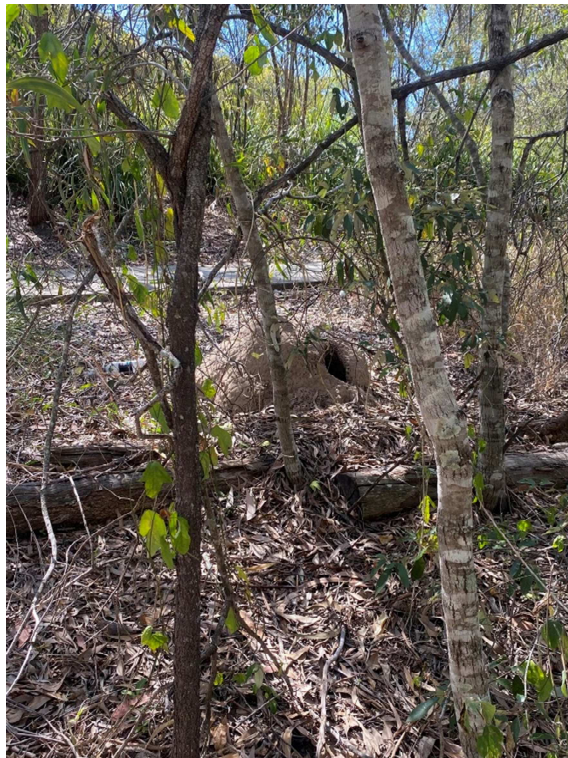
**Photo 17: Evidence of potential fauna habitat – terrestrial termite mound with excavate.**

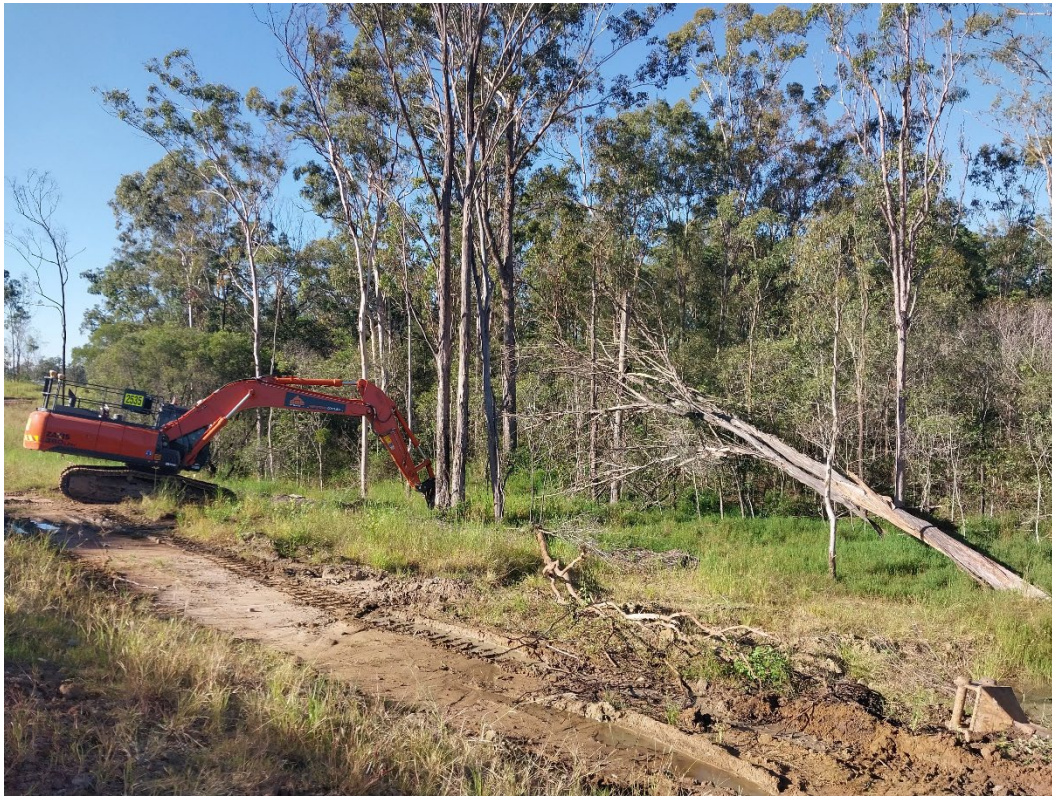
Clearing was conducted in accordance with the recommendations listed in the WHIMP and Project Wildlife Habitat Impact Mitigation Plan (WHIMP, Boyd's Bay Environmental, 2022). A suitably qualified Fauna Spotter Catcher (FSC) inspected the clearing area to identify any resident fauna and flag potential and actual habitat immediately prior to clearing commencement. The FSC was present throughout clearing works to ensure fauna or habitat were not harmed. The FSC performed a final walk through of the cleared area to ensure no wildlife was left exposed, injured, or deceased. Clearing was conducted by an excavator.

*Photo 3 Clearing in progress*

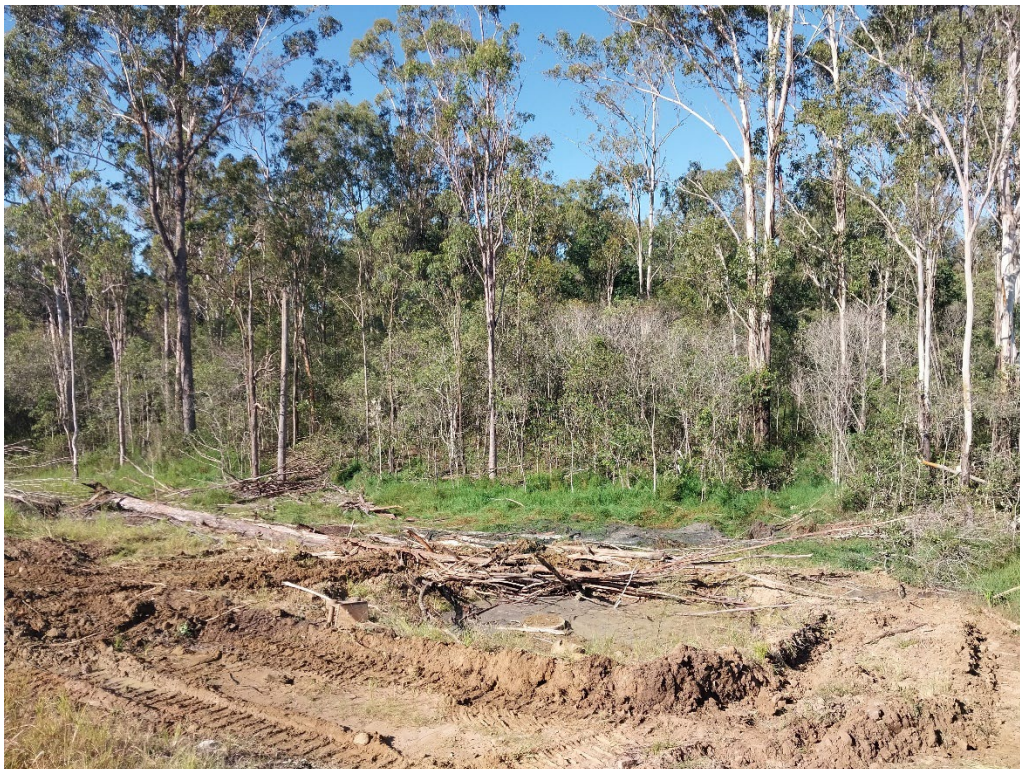
Clearing began on April 3<sup>rd</sup> 2023 at approximately 8am and concluded at approximately 10am. No Fauna was captured during the clearing and clearing did not harm any fauna and proceeded in accordance with the recommendations of the WPMP and WHIMP.

*Photo 4 Clearing Complete*
