# AUSTRALIAN STANDARD 3959:2018 CONSTRUCTION OF BUILDINGS IN BUSHFIRE-PRONE AREAS

## **BUSHFIRE ATTACK LEVEL REPORT v2**

Lot 1001 SP315955 Village Green Bvd PALMVIEW, QLD

**Document:** Bushfire Attack Level Report

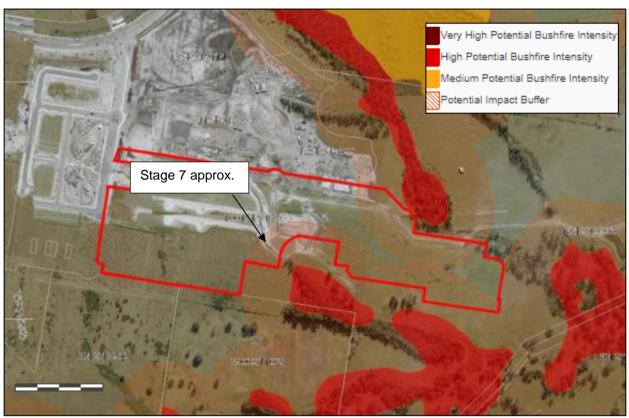
Plate 1 - Bushfire Intensity overlay (State Planning Policy Interactive Mapping System)

The Bushfire Intensity Overlay Map on the *State Planning Policy (SPP)* Interactive Mapping System identifies that the eastern portion of Stage 7 is affected by a Potential Impact Buffer (refer to Plate 1). Several build site(s) are therefore located in a *designated bushfire prone* hence the relevant Class 1 dwellings must be constructed to satisfy AS 3959.

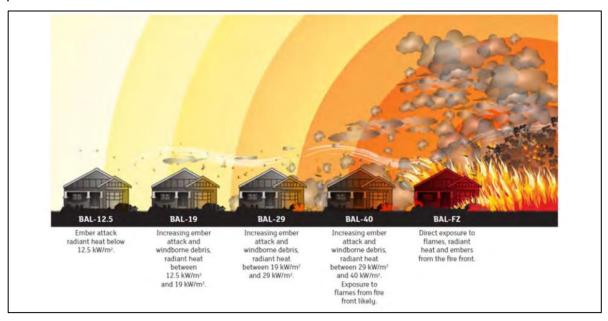
Plate 2 – BAL's and Bushfire Attack Mechanisms (Source: Victorian Country Fire Authority 2012)

AS 3959:2018 provides minimum construction requirements for assessable building works in Designated Bushfire Prone Areas. Dwellings (and renovated parts of existing dwellings) in Designated Bushfire Prone Areas must be built to the BAL construction standard relevant to the dwelling as identified by AS 3959:2018. The different BAL's prescribed by AS 3959 are pictorially represented in Plate 2.

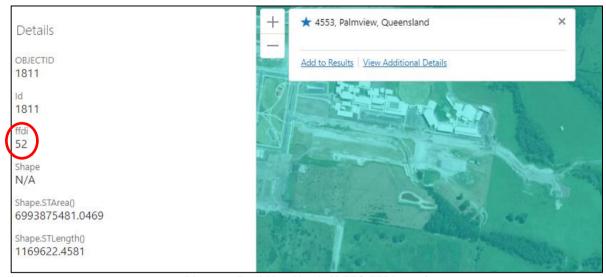
Plate 3 - Redi Map North (QFES FFDI 2019)

QFES Forest Fire Danger Index (FFDI): 52 (refer to Plate 3)

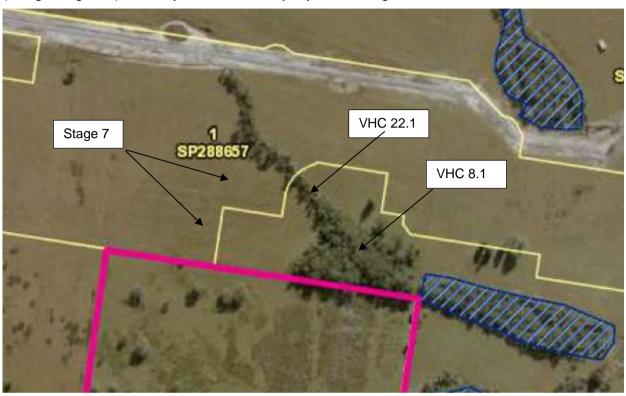
Plate 4 – Type A Forest to south-east of Stage 7 (Source – Approved Concept Rehabilitation Strategy by Saunders Havill Group)

The only current assessable vegetation within 100m of the site comprises a small stand of VHC 8.1 Wet eucalypt forest located approximately 50m to the south-east of the Stage 7A south-east boundary corner. A narrow strip of regrowth paperbark open forest; VHC 22.1, flanks a drainage line which extends beyond the main stand of VHC 8.1 to within approximately 20m of the south-east corner of Stage 7a (refer Plate 4). Non-assessable VHC 40.4 Continuous low grass cover (i.e., grazing land) currently borders the majority of the Stage 7 boundaries.

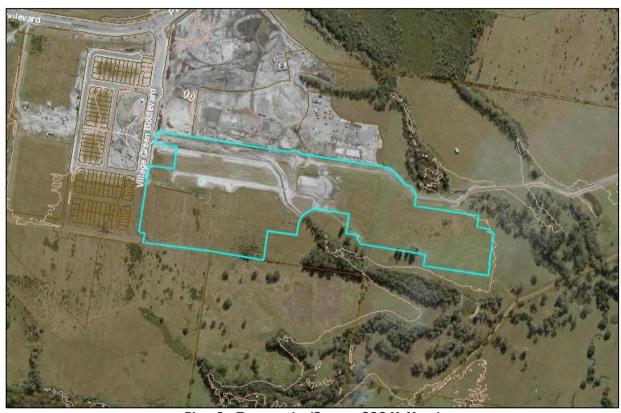
Plate 5 – Topography (Source: SCC MyMaps)

The identified assessable vegetation is positioned across slope from the site for assessment purposes (i.e., 1º slope). Plate 5 depicts topographic conditions within and adjacent to the site.

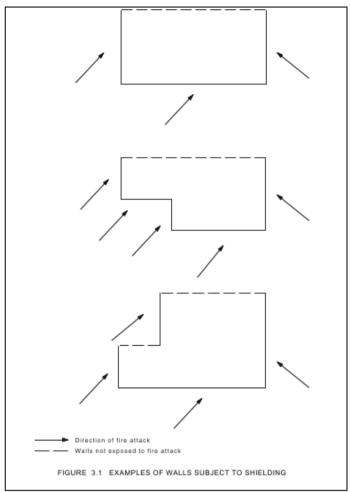
Plate 6 - Shielding (Source AS3959 2018)

In accordance with AS3959 2018, the most severe BAL acting on a building is applied to the whole dwelling with all new building works to be constructed to that BAL, precluding any parts of the building which are shielded from the direction of attack (refer Plate 6). Elevations shielded from the direction of attack can be built to the next lowest BAL but no lower than BAL 12.5.

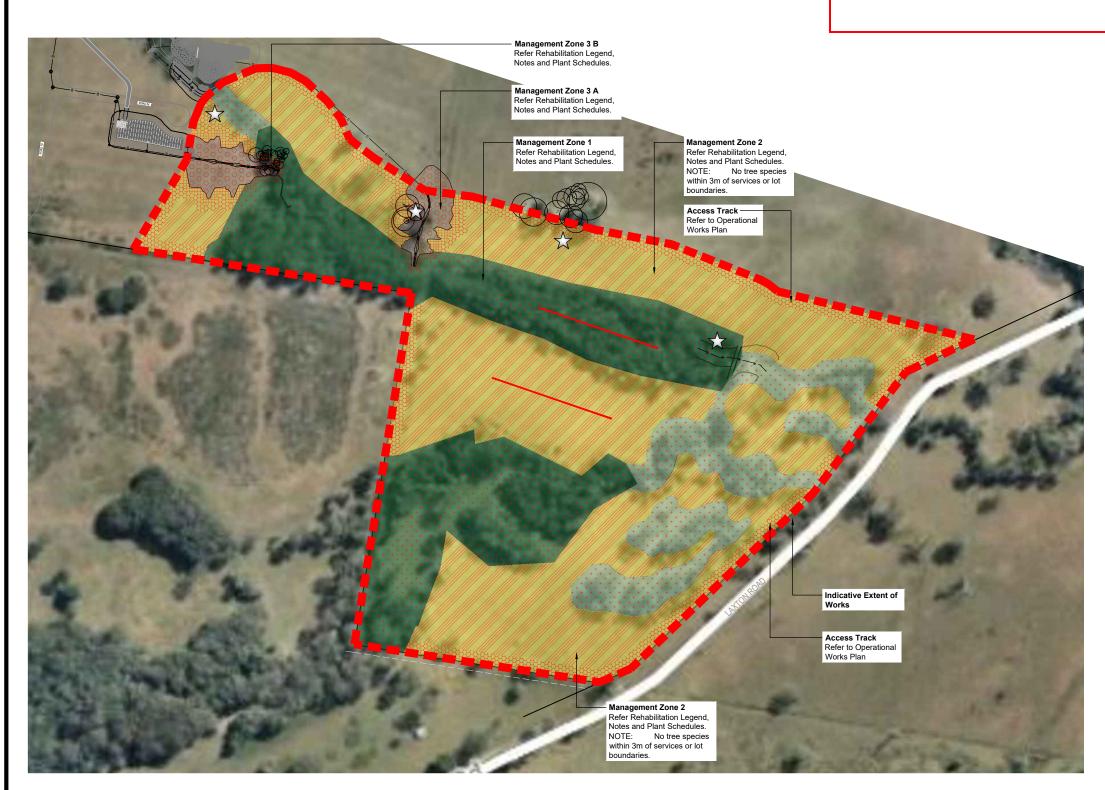
#### MANAGEMENT ZONE

Existing native trees, shrubs and groundcovers to be protected and retained. Weed management to entire zone to encourage natural regeneration by reducing competition. Appropriate (sensitive) weed management methodology within this zone to minimize any native vegetation damage / losses.

All bare / denuded areas to be appropriately cultivated, topsoiled and blanket mulched (100mm depth) or jutenetting (1:3 batters and locations prone to erosion) as required. All jutenetting to be installed to manufacturer's recommendations. Reconstruction of natural environment to be undertaken via tubestock installation including a diversity of tree, shrub and groundcover species to match regional ecosystem mapping for site.
