**Geotechnical Report
Level One Inspection and Testing**

**Summerhill Estate Stage 4
Cranbourne South**

Project 9897

9 March 2018

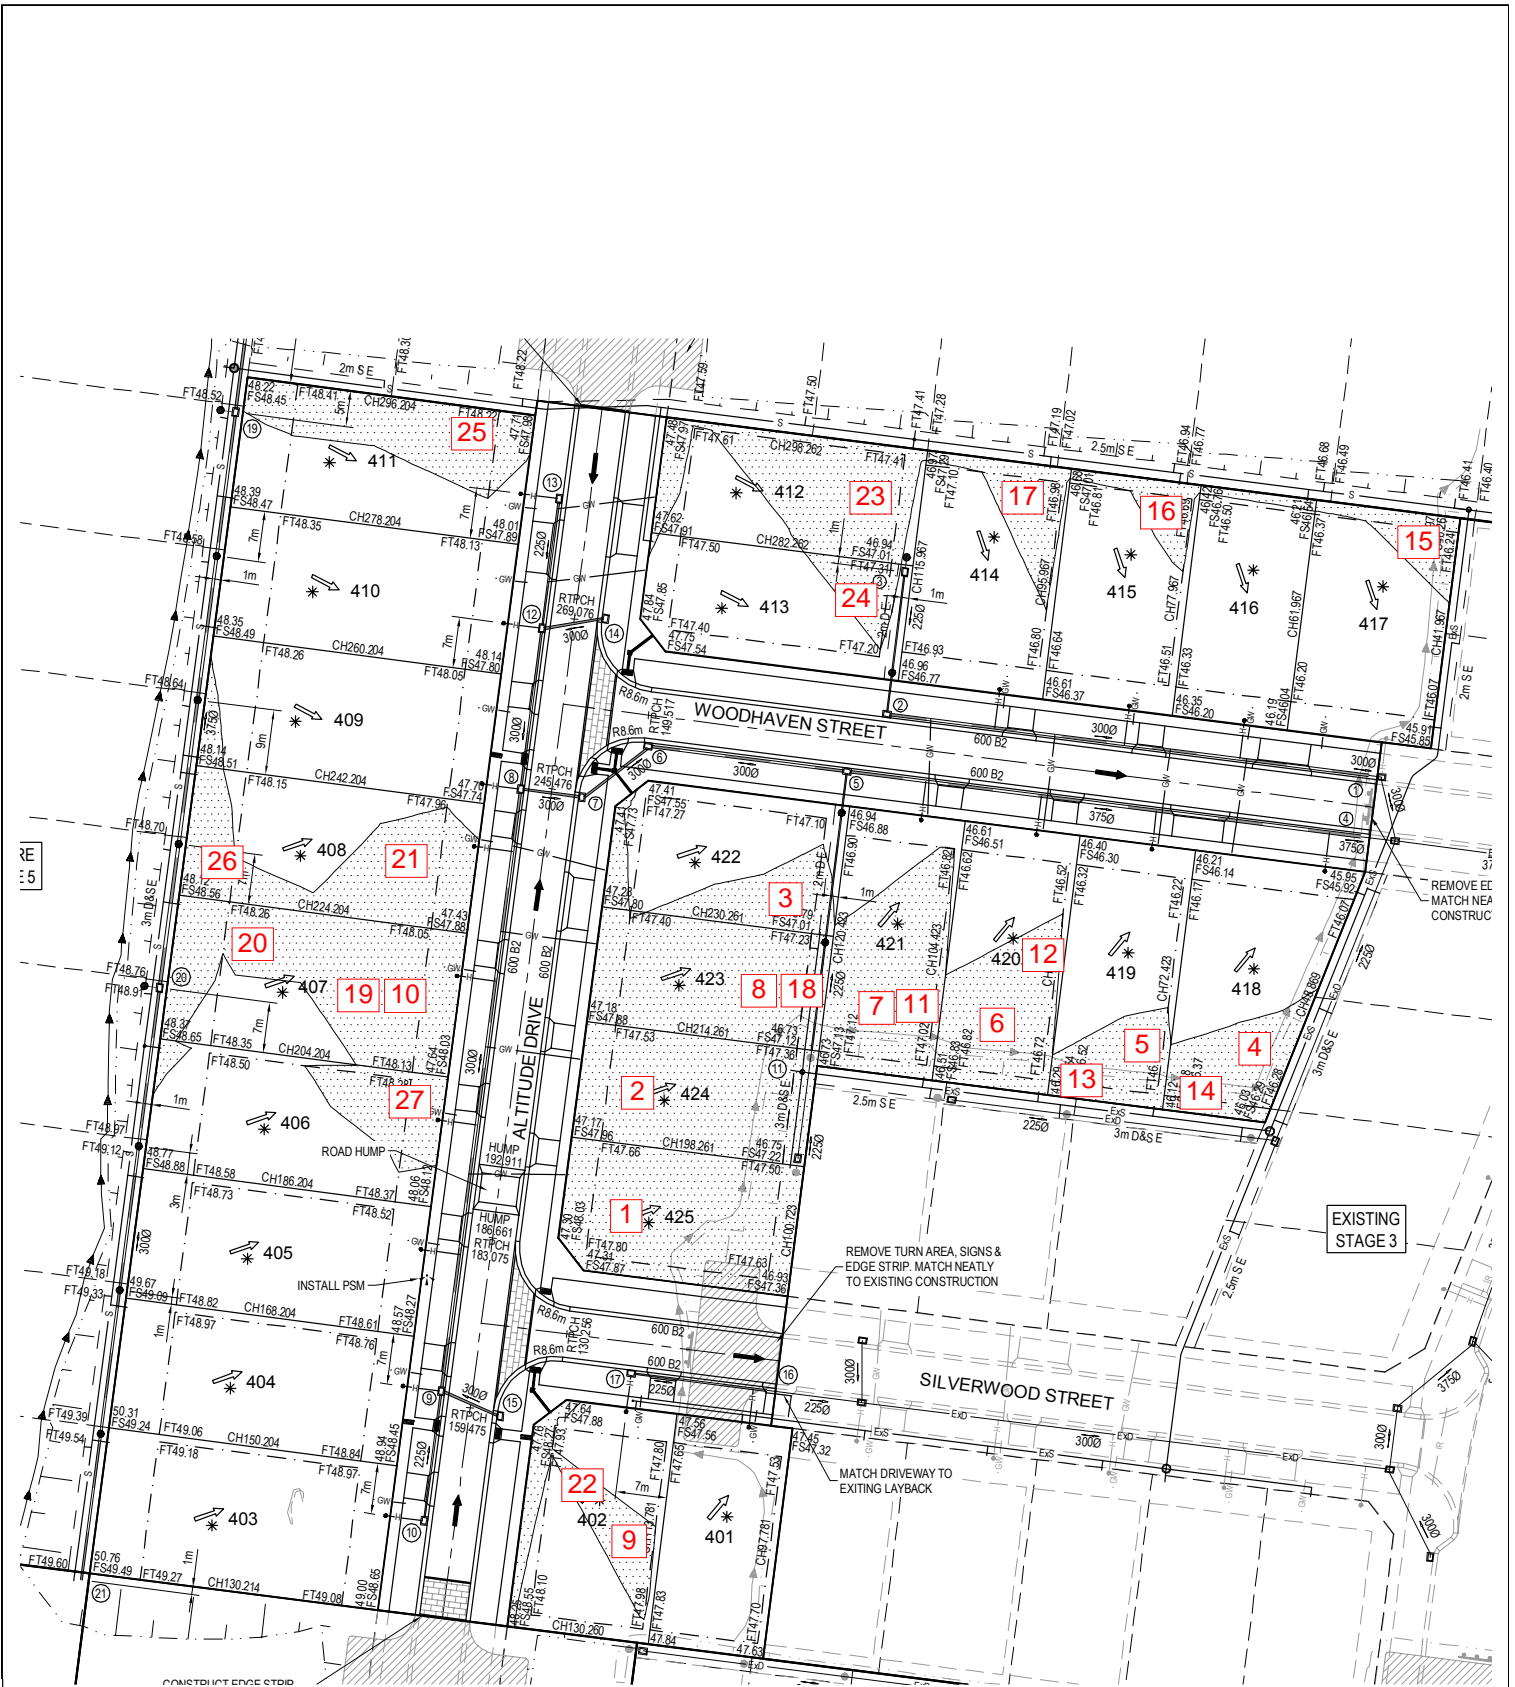
Test Location Plan

The area on which fill was placed is shown on site plan (Appendix 1) based on drawings prepared by GPR Consulting and provided by Streetworks Pty Ltd.

It was observed that finished levels were in accordance with levels marked on site by survey. These levels are shown on site plans attached in Appendix 1.

Inspections and testing of the fill areas at this site indicate that both sub grade preparation and fill placement have been conducted in accordance with the specification and that the completed fill areas of greater than 300mm, as shown on the site plan attached, and not any preceding the 28/09/2017 or work completed after the 20/2/2018, may be certified as being compliant with the specification.
